ATTACHMENT B

Five Existing Diversions

Coal Mine Wash Diversion Channel

PEABODY COAL COMPANY

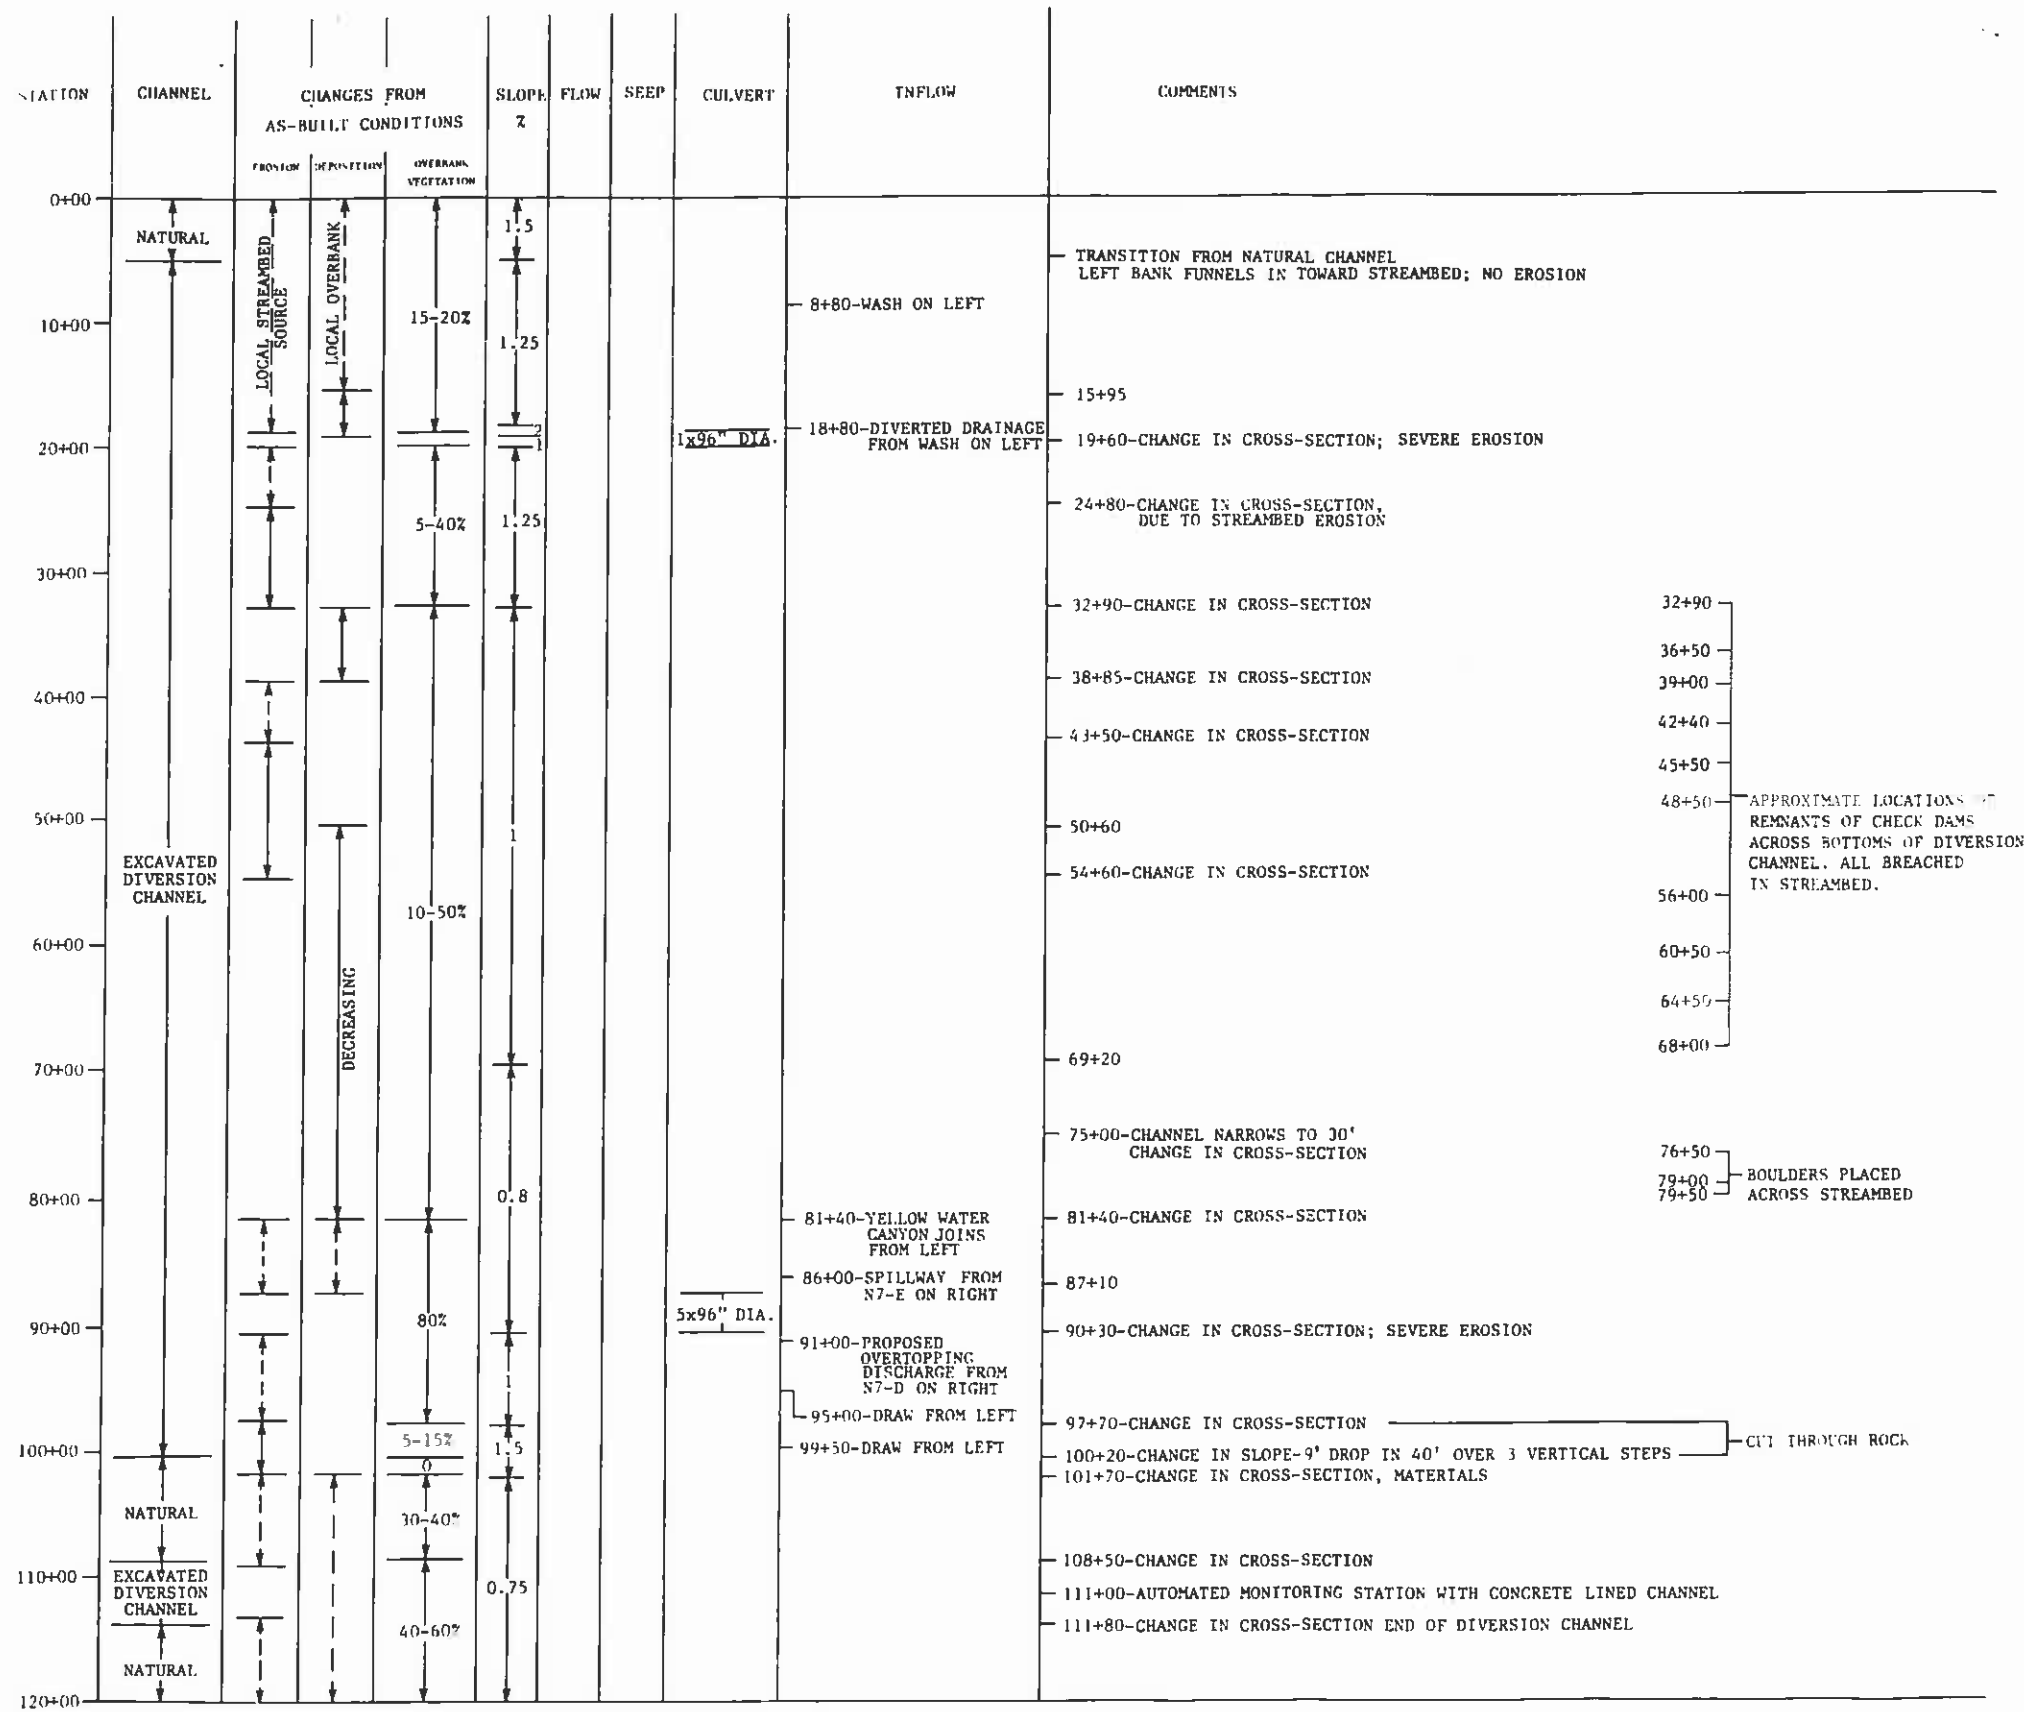
APPROXIMATE LOCATIONS OF REMNANTS OF CHECK DAMS ACROSS BOTTOMS OF DIVERSION CHANNEL. ALL BREACHED IN STREAMBED.

BOULDERS PLACED ACROSS STREAMBED

The diversion channel transitions with the natural channels are smooth, and the diversion channel itself lacks evidence (determined by physical inspection or mathematical modeling) of severe erosion or deposition, with the exceptions discussed in the preceding paragraph. Therefore, no substantial remedial action is necessary to make the diversion channel behave hydraulically like the replaced natural channel. Areas of local streambed incision should be monitored for excessive erosion, and the culverts at Station 88+00 should be maintained (cleaned out when necessary) to prevent excessive upstream siltation.
