INSPECTION REPORT
Sedimentation Structure
BM-A1
Black Mesa Mine
Navajo County, Arizona
for
PEABODY COAL COMPANY

Dames & Moore
10139-011-22

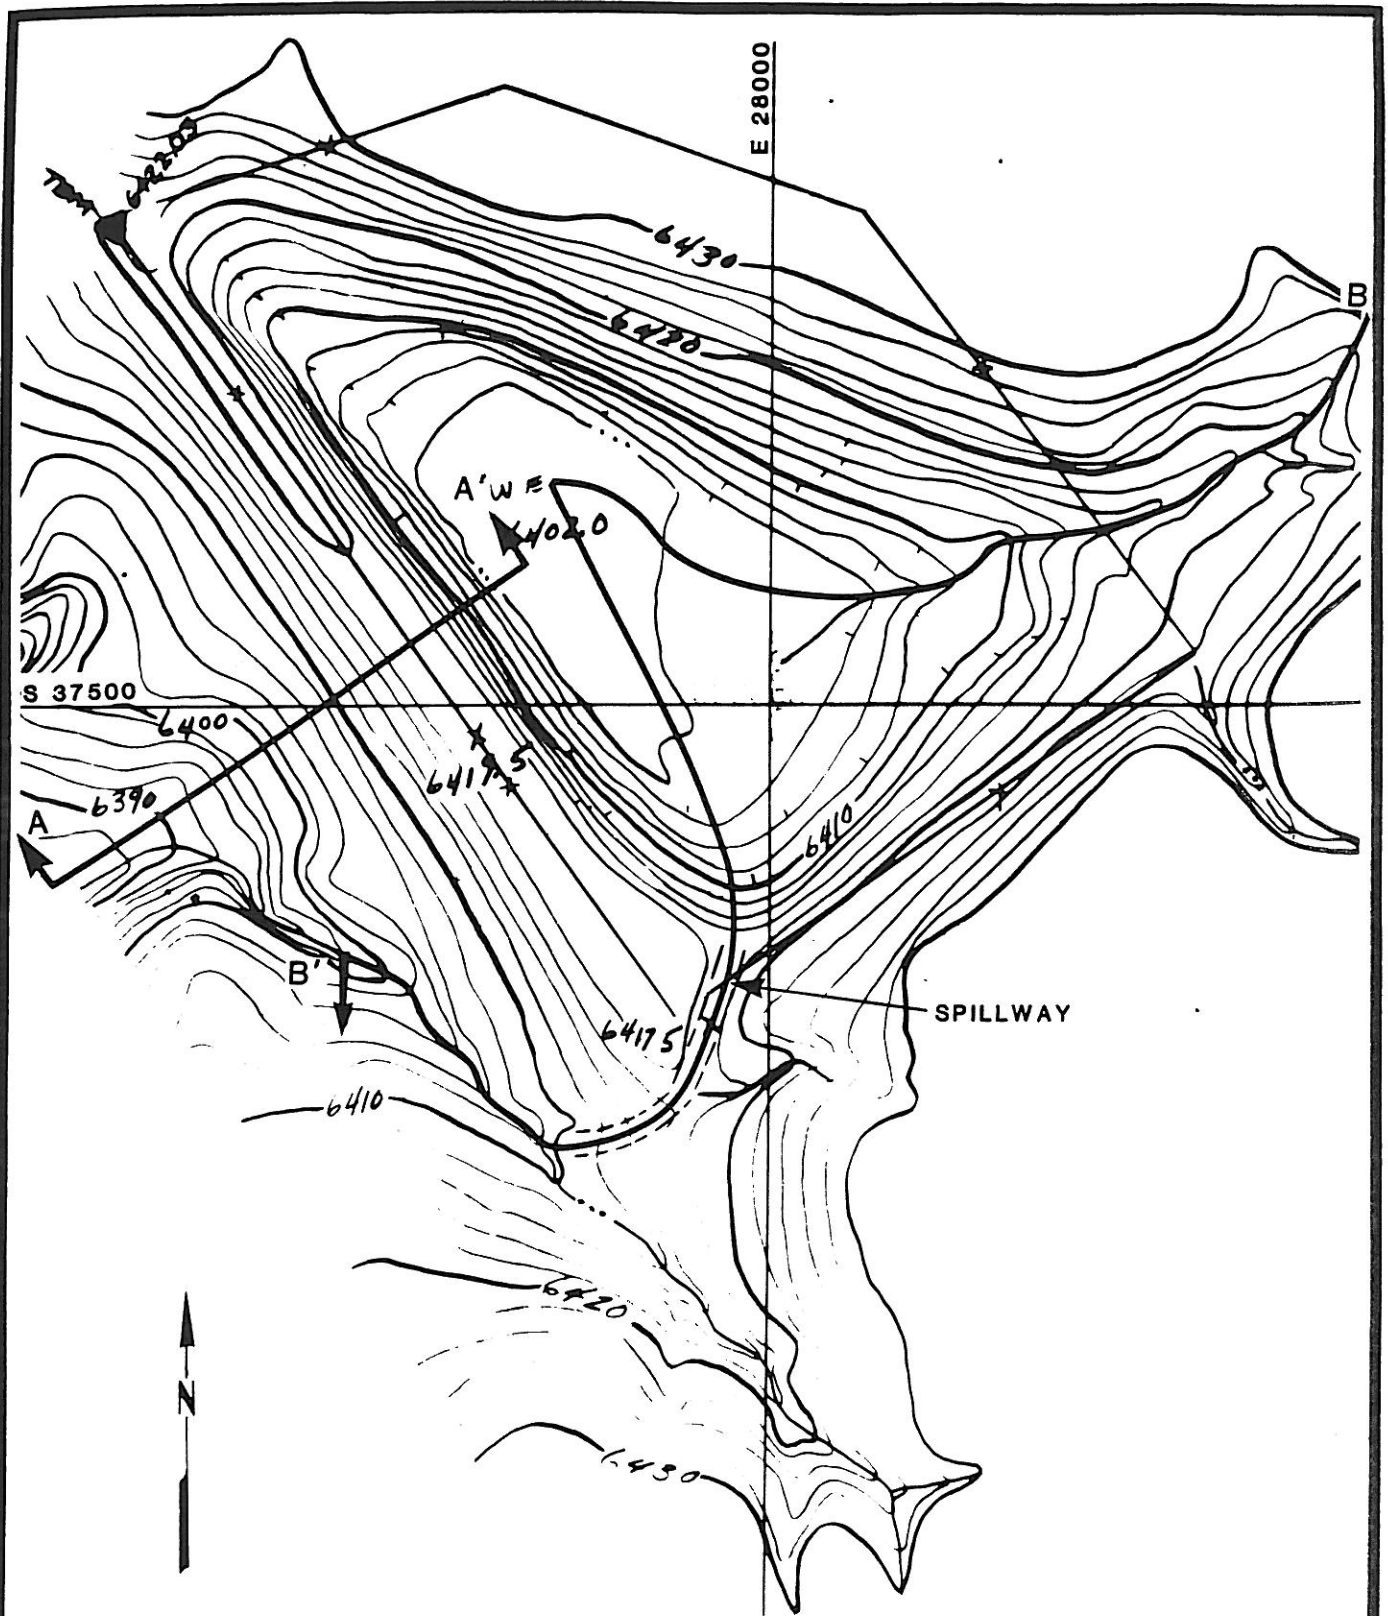
SITE PLAN
BM-A1

Sedimentation Structure BM-A1 is an earthen embankment, designed and constructed in 1980 by Peabody Coal Company as a temporary sedimentation structure to control runoff and sediment from the disturbed mining areas of the Black Mesa Mine. The location of Structure BM-A1 is shown on Plate 1, Site Plan.

The storage capacity and spillway capacity of Structure BM-A1 are adequate; however, the spillway does not have an adequate outflow channel or adequate erosion protection. A trapezoidal outflow channel should be constructed along the alignment B-B' shown in Plate 1. The channel profile is shown in Plate 4 and the required dimensions are shown in Plate 5. Both the spillway and outflow channel should be protected against erosion using geotextile and riprap as shown in Plate 5.

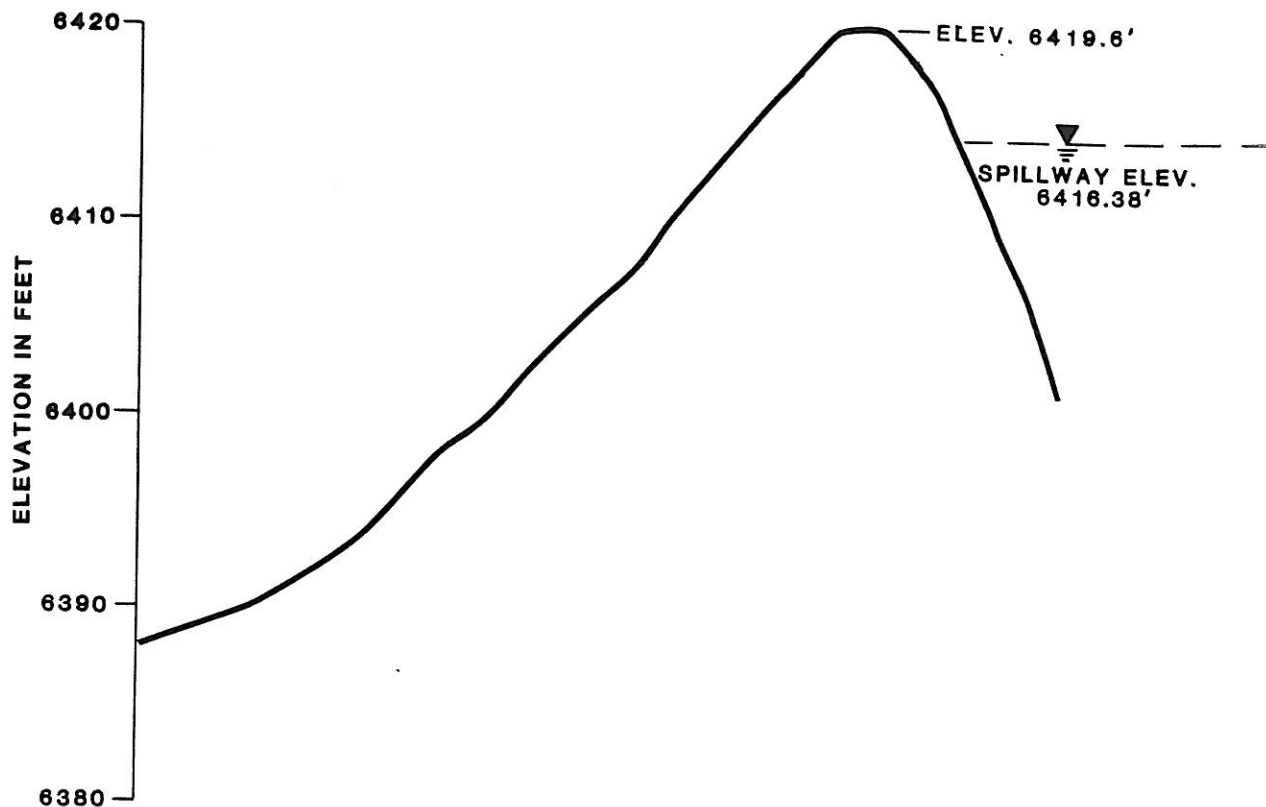
EXISTING
MAXIMUM CROSS-SECTION
A-A'
BM-A1

A cross-section of the embankment is shown on Plate 2, Existing Maximum Cross Section BM-A1, A-A'. Grass provides erosion protection on the upstream slope of the embankment.

The BM-A1 embankment is lower in height and has flatter slopes than the category standard; therefore, the embankment has factors of safety greater than the design minimum.

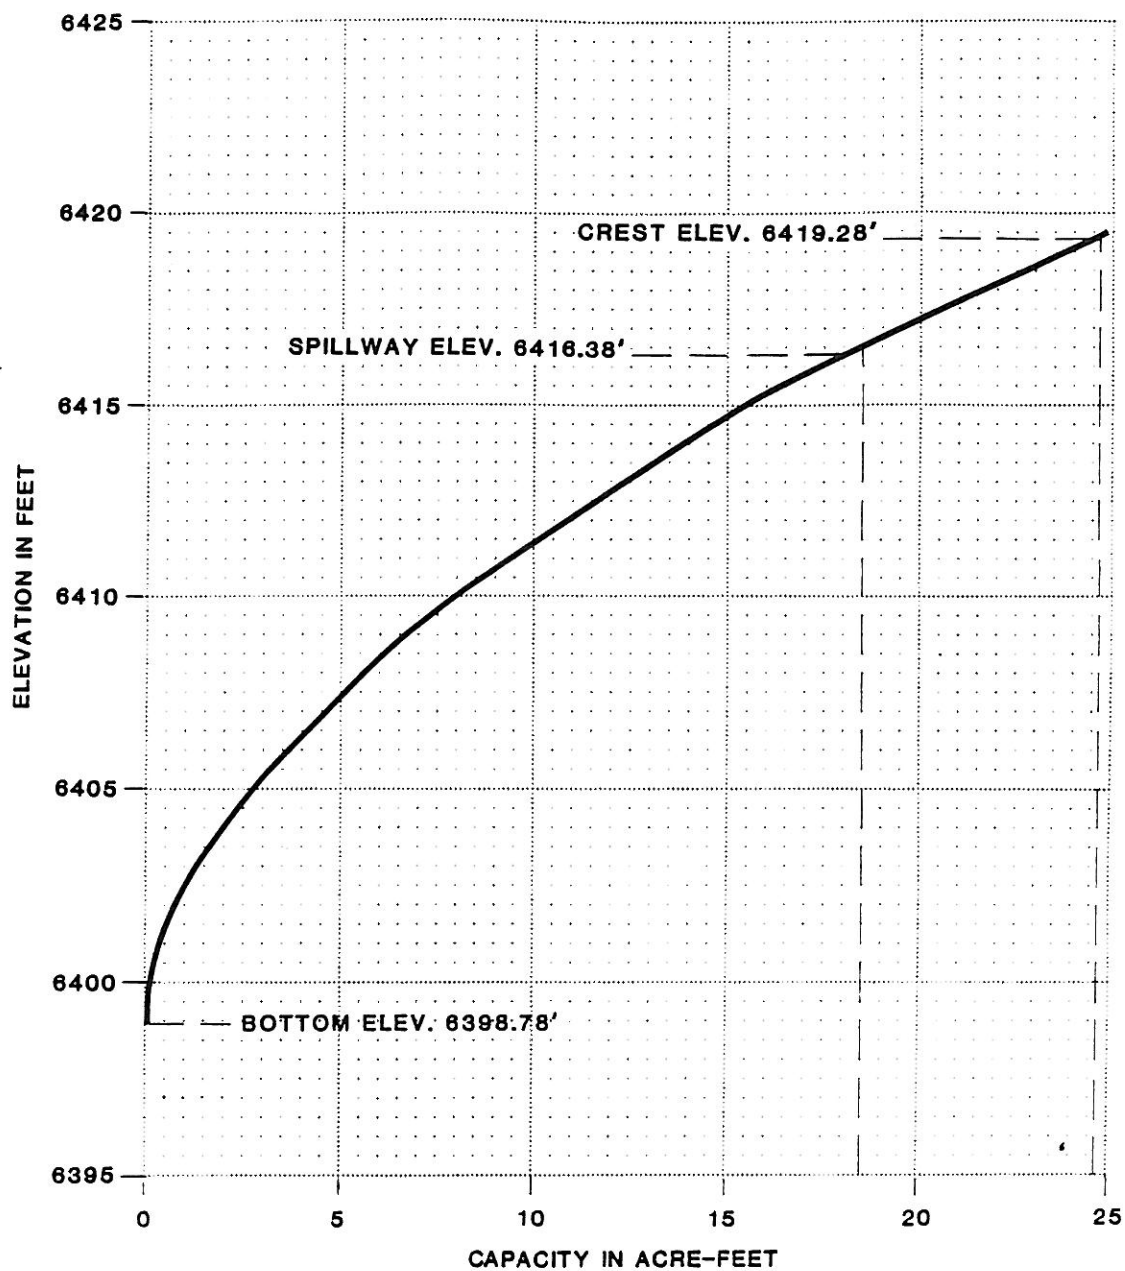
VOLUME-ELEVATION
CURVE
BM-A1

The impoundment volume-elevation curve is based on site specific surveys conducted for Peabody Coal Company's August 1984 inspection, and 1985 resurveys, where available. Additionally, the most current topographic maps available were used in developing Plate 3, Volume-Elevation Curve, BM-A1.

Total Storage Capacity	18.6	acre-ft
10-year, 24-hour Storm Inflow	5.98	acre-ft
Available Sediment Storage Capacity . .	12.6	acre-ft
Sediment Inflow Rate	0.780	acre-ft/yr
Sediment Storage Life	16	yrs

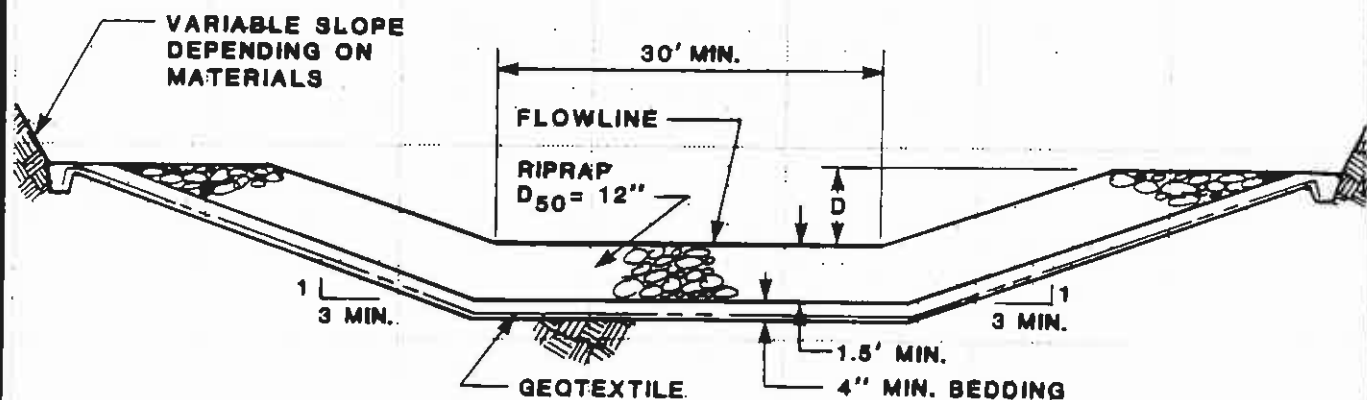
SPILLWAY AND
OUTFLOW CHANNEL
CROSS SECTION
BM-A1

There is presently no erosion protection within the channel.
