INSPECTION REPORT
Sedimentation Structure
BM-B
Black Mesa Mine
Navajo County, Arizona
for
PEABODY COAL COMPANY

Dames & Moore
10139-011-22

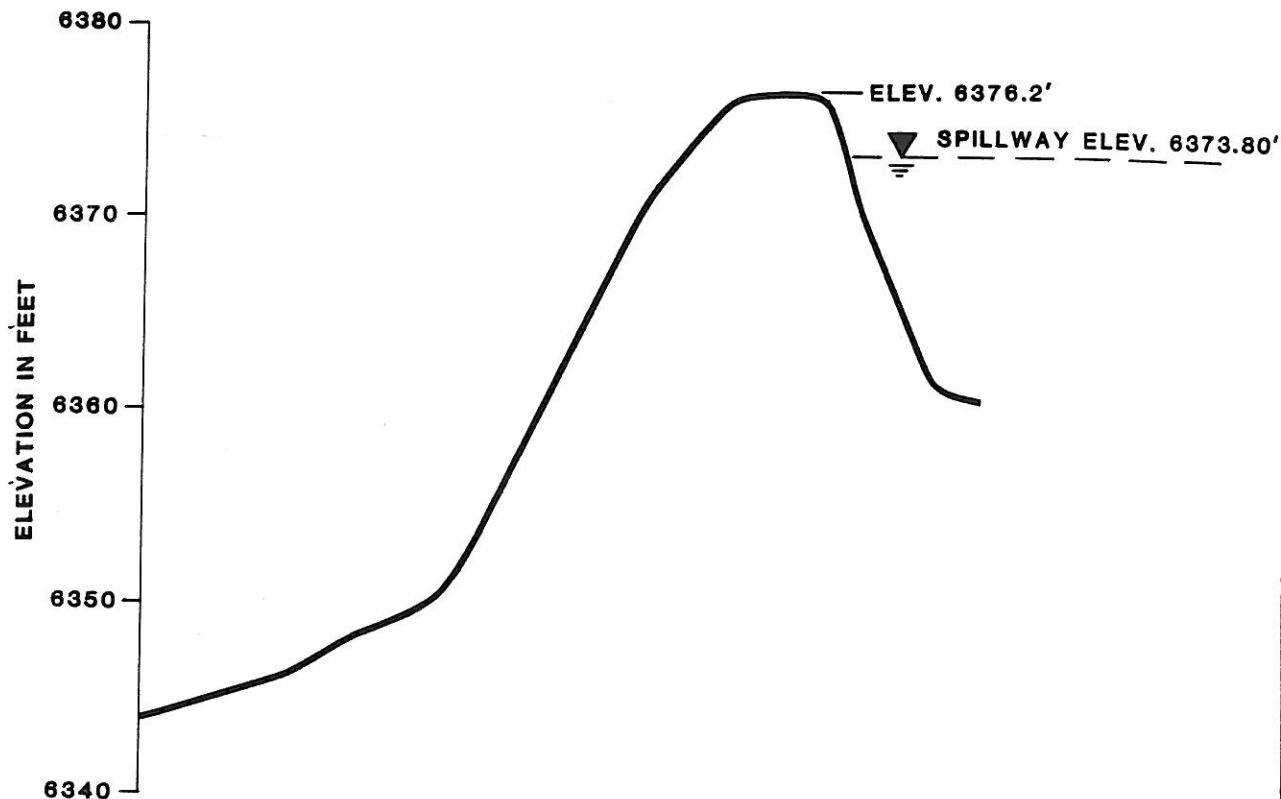
Plate 2

Structure BM-B is a homogeneous earthen embankment classified as a cross-valley embankment. Physical characteristics of the embankment are listed in the following table:

Embankment	Residual Sandstone Soils
Foundation	Sandstone
Right Abutment	Residual Sandstone Soils
Left Abutment	Residual Sandstone Soils
Height	7.5 ft
Crest Width	14.0 ft
Upstream Slope	2.2 H : 1 V
Downstream Slope	2.75 H : 1 V

A cross-section of the embankment is shown on Plate 2, Existing Maximum Cross Section BM-B, A-A'.

The BM-B embankment is lower in height and has flatter slopes than the category standard; therefore, the embankment has factors of safety greater than the design minimum.

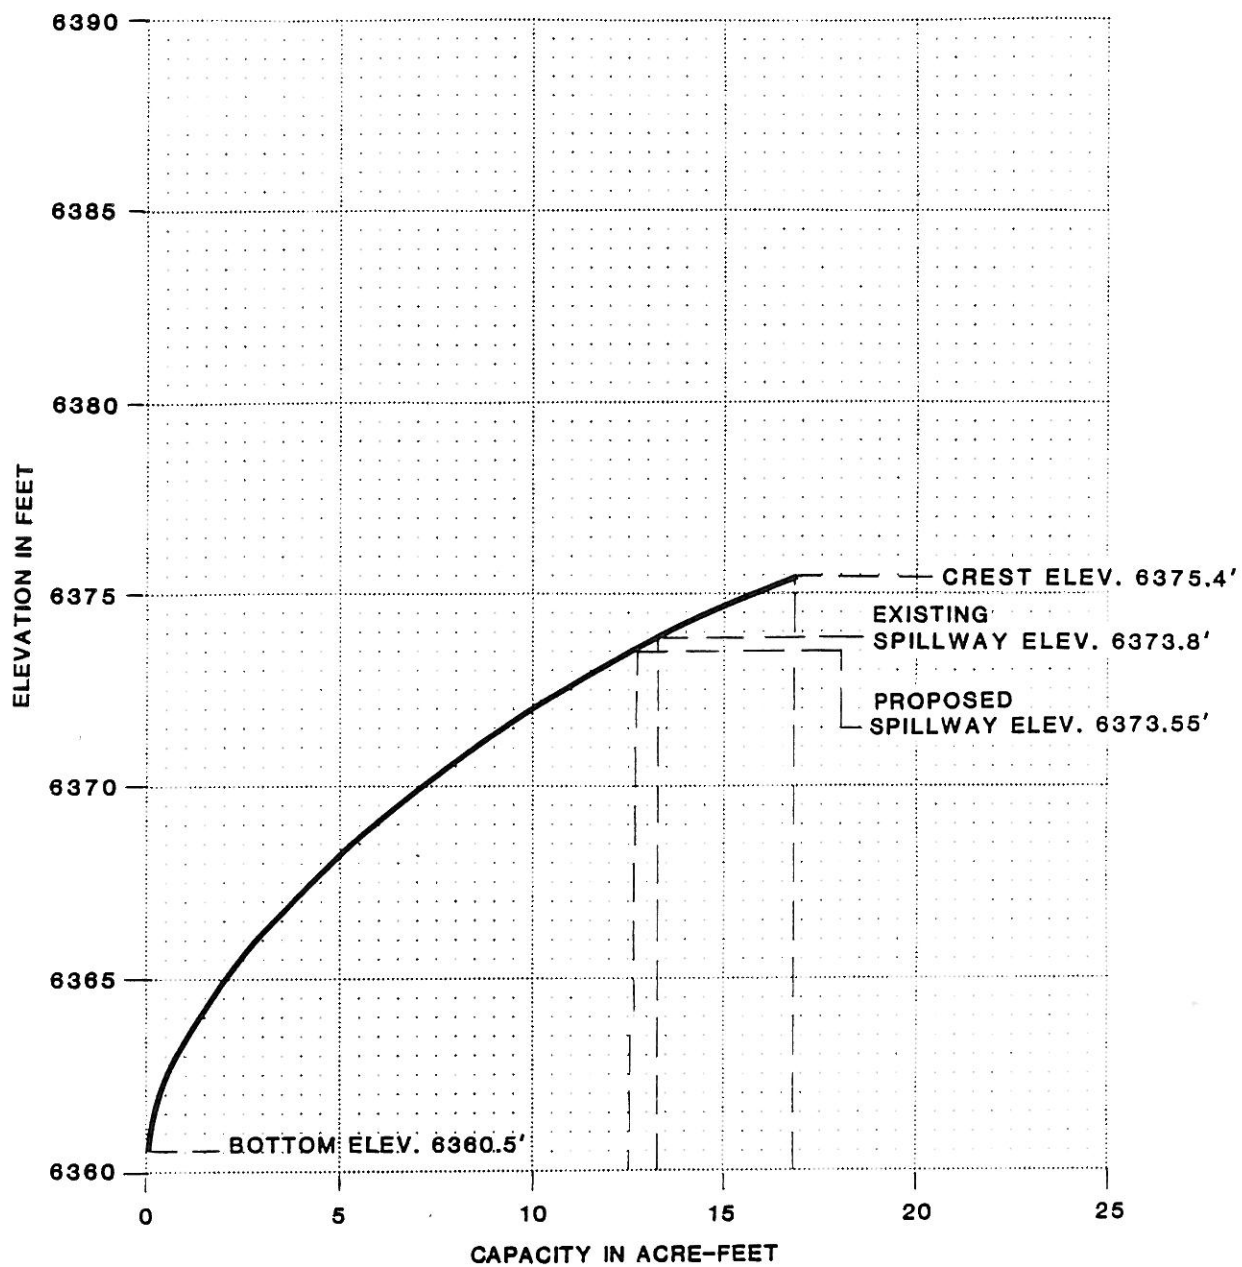
VOLUME-ELEVATION
CURVE
BM-B

The impoundment volume-elevation curve is based on site specific surveys conducted for Peabody Coal Company's August 1984 inspection, and 1985 resurveys, where available. Additionally, the most current topographic maps available were used in developing Plate 3, Volume-Elevation Curve, BM-B.

Total Storage Capacity	12.76	acre-ft
10-year, 24-hour Storm Inflow	3.3	acre-ft
Available Sediment Storage Capacity	9.46	acre-ft
Sediment Inflow Rate	0.372	acre-ft/yr
Sediment Storage Life	25	yrs

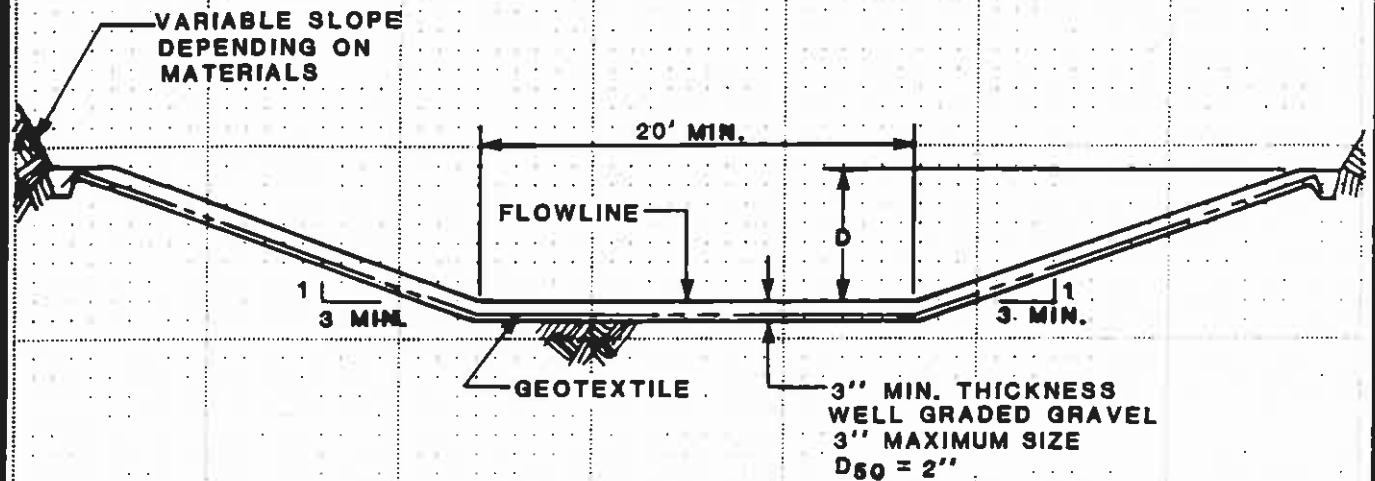
**SPILLWAY AND
OUTFLOW CHANNEL
CROSS SECTION
BM-B**

The storage capacity of Structure BM-B is adequate but the spillway capacity is inadequate. The structure does not have an adequate outflow channel. The bottom elevation of the existing spillway channel should be lowered to elevation 6373.55 while maintaining the bottom width of 20 feet as shown on Plate 5. A trapezoidal outflow channel with the same bottom width as the spillway should be constructed along the alignment shown in Plate 1. The channel profile is shown in Plate 4 and the required dimensions are shown in Plate 5. Both the spillway and outflow channel should be protected against erosion using geotextile and gravel as shown in Plate 5.

Lowering the spillway elevation to 6373.55 feet decreases the storage capacity and increases the freeboard. The analysis of these conditions is summarized in the following table.
