INSPECTION REPORT
Sedimentation Structure
BM-SS
Black Mesa Mine
Navajo County, Arizona
for
PEABODY COAL COMPANY

Dames & Moore
10139-011-22

Sedimentation Structure BM-SS is a partially incised structure with an earthen embankment, designed and constructed in 1980 by Peabody Coal Company as a temporary sedimentation structure to control runoff and sediment from the disturbed mining areas of the Black Mesa Mine. The location of Structure BM-SS is shown on Plate 1, Site Plan.

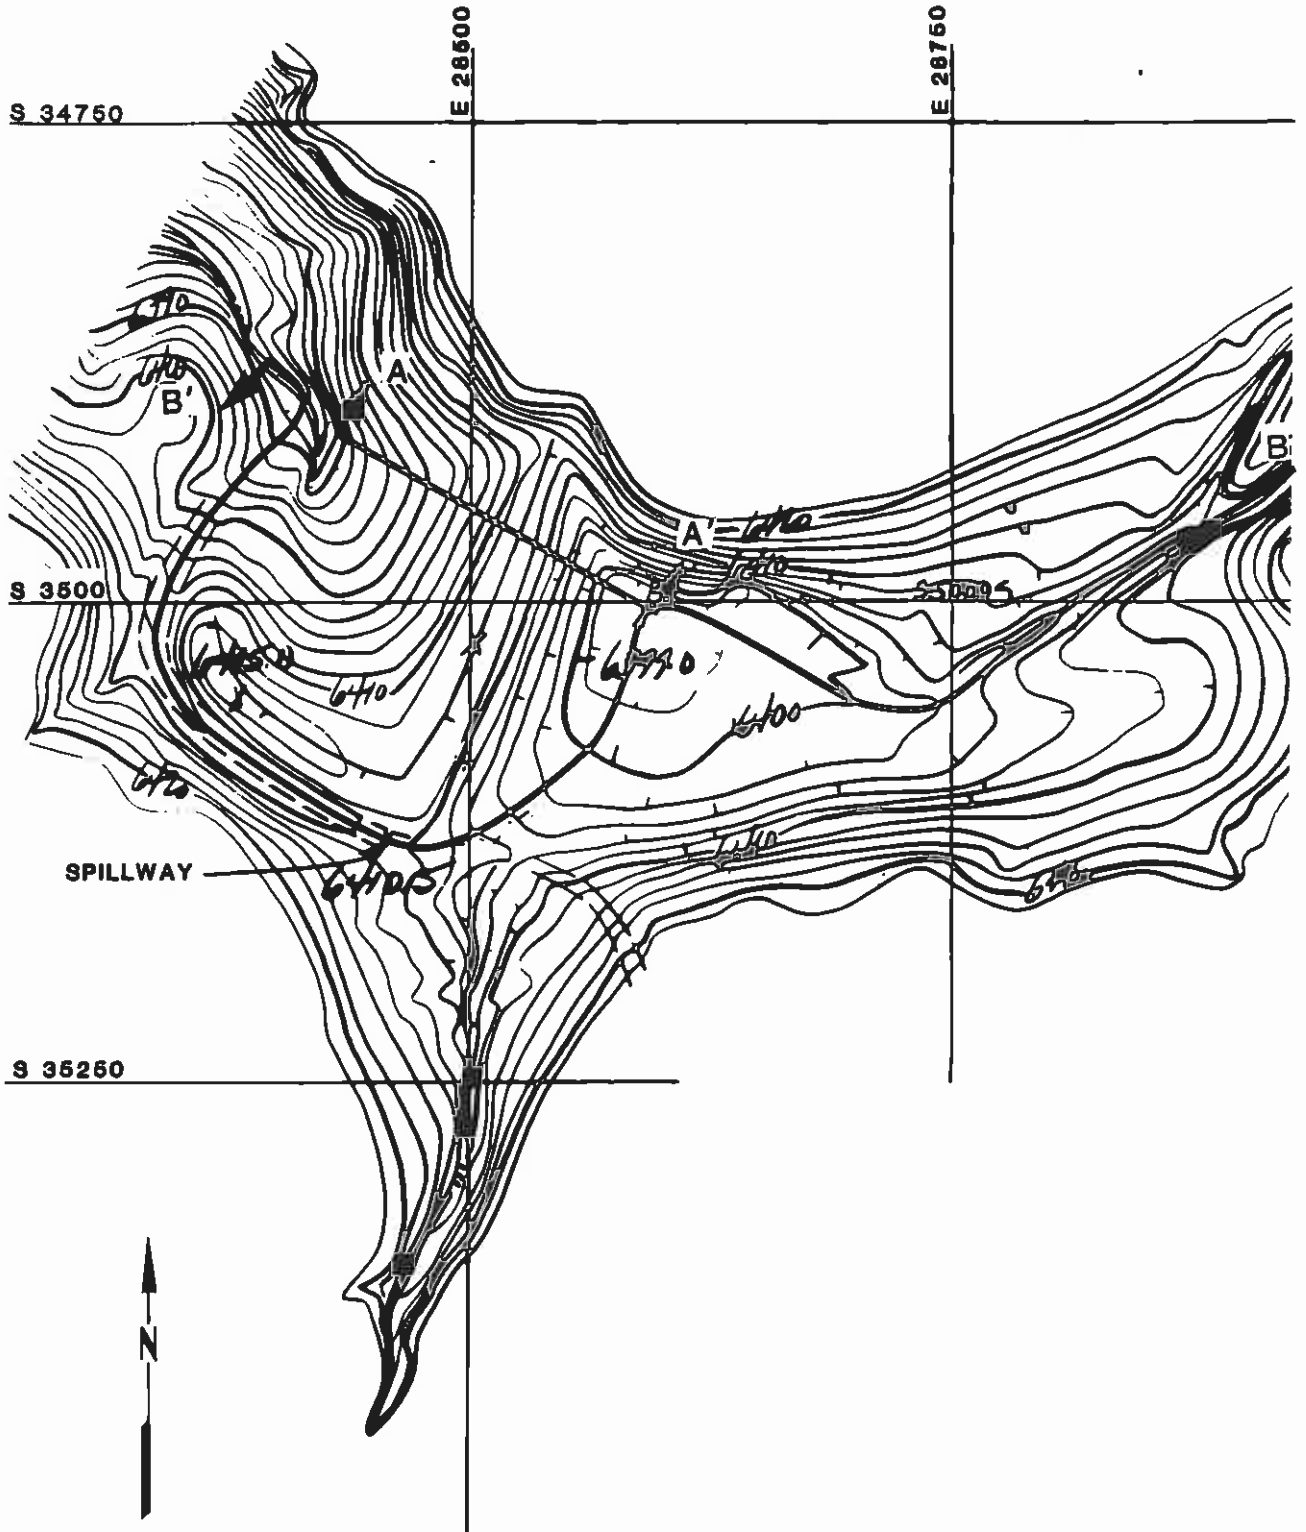
Plate 1

SITE PLAN
BM-SS

The storage capacity and spillway capacity of Structure BM-SS are adequate; however, the spillway does not have an adequate outflow channel or adequate erosion protection. A trapezoidal outflow channel should be constructed along the alignment B-B' shown in Plate 1. The channel profile is shown in Plate 4 and the required dimensions are shown in Plate 5. Both the spillway and outflow channel should be protected against erosion using geotextile and gravel as shown in Plate 5.

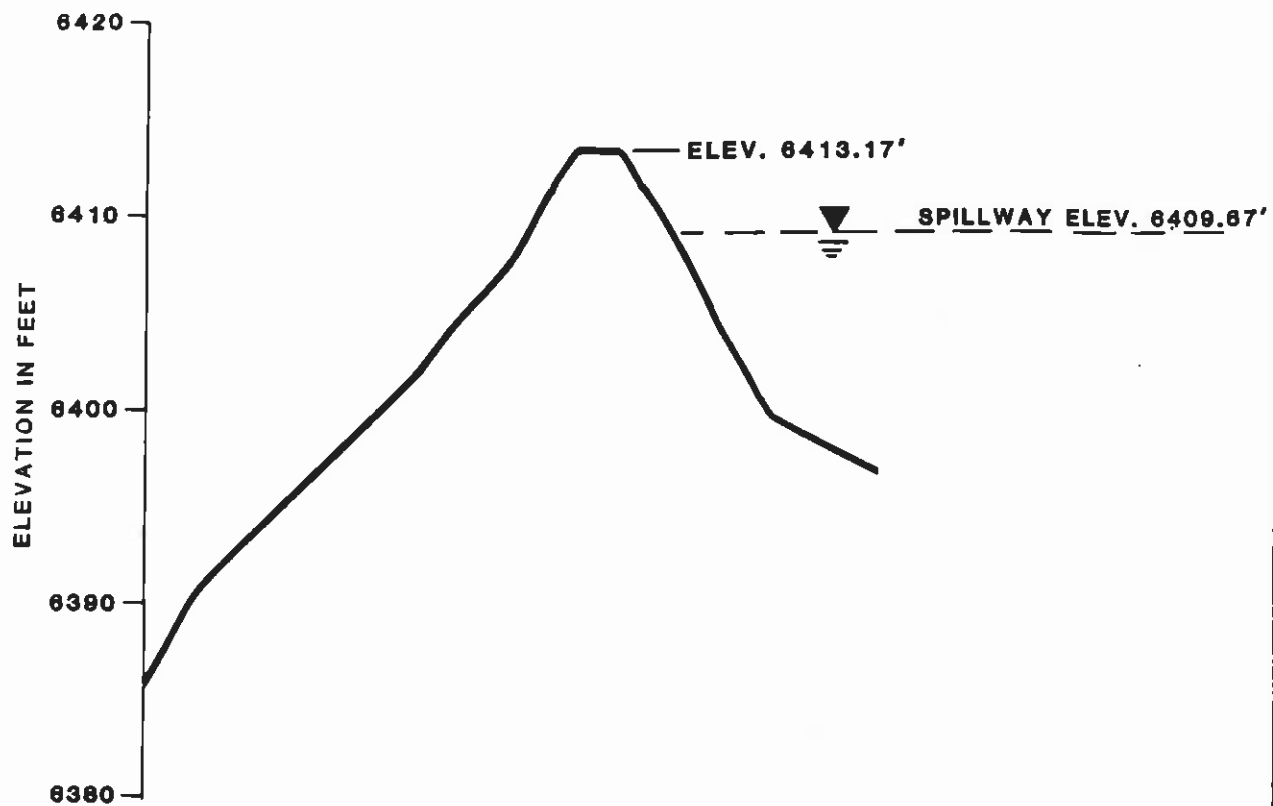
Plate 2

Embankment	Residual Sandstone Soils
Foundation	Sandstone
Right Abutment	Sandstone/Residual Sandstone Soils
Left Abutment	Residual Sandstone Soils
Height	9.2 ft
Crest Width	15 ft
Upstream Slope	2.9 H : 1 V
Downstream Slope	3.5 H : 1 V

A cross-section of the embankment is shown on Plate 2, Existing Maximum Cross Section BM-SS, A-A'.

EXISTING
MAXIMUM CROSS-SECTION
A-A'
BM-SS

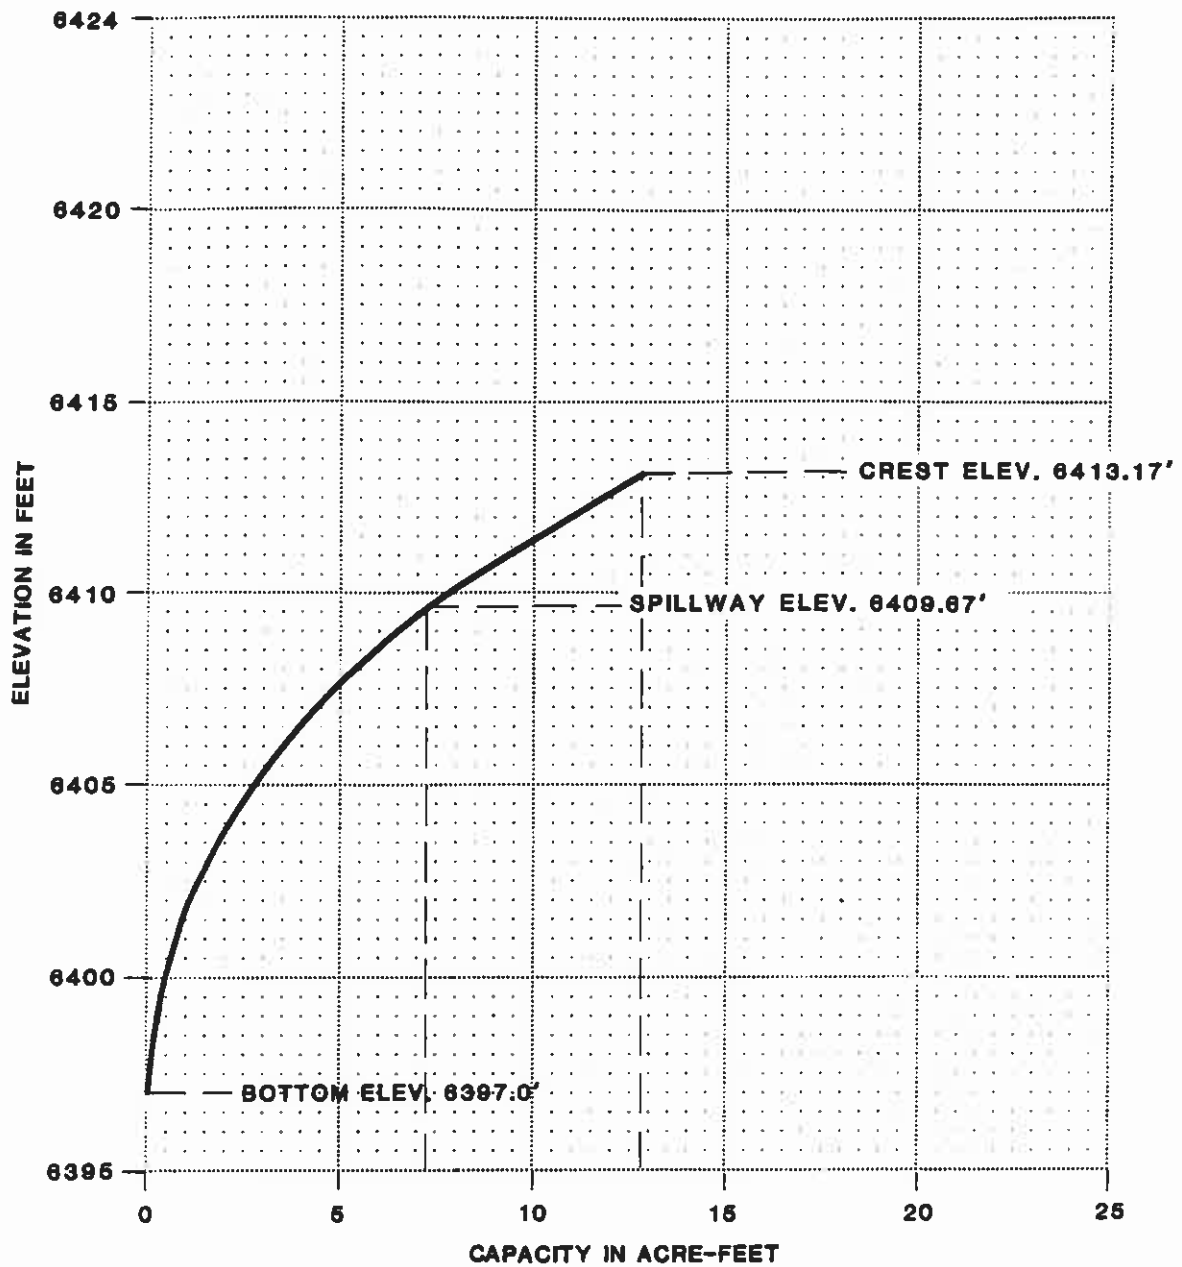
**VOLUME-ELEVATION
CURVE
BM-SS**

The impoundment volume-elevation curve is based on site specific surveys conducted for Peabody Coal Company's August 1984 inspection, and 1985 resurveys, where available. Additionally, the most current topographic maps available were used in developing Plate 3, Volume-Elevation Curve, BM-SS.

Total Storage Capacity	7.25	acre-ft
10-year, 24-hour Storm Inflow	2.10	acre-ft
Available Sediment Storage Capacity . .	5.11	acre-ft
Sediment Inflow Rate	0.477	acre-ft/yr
Sediment Storage Life	11	yrs

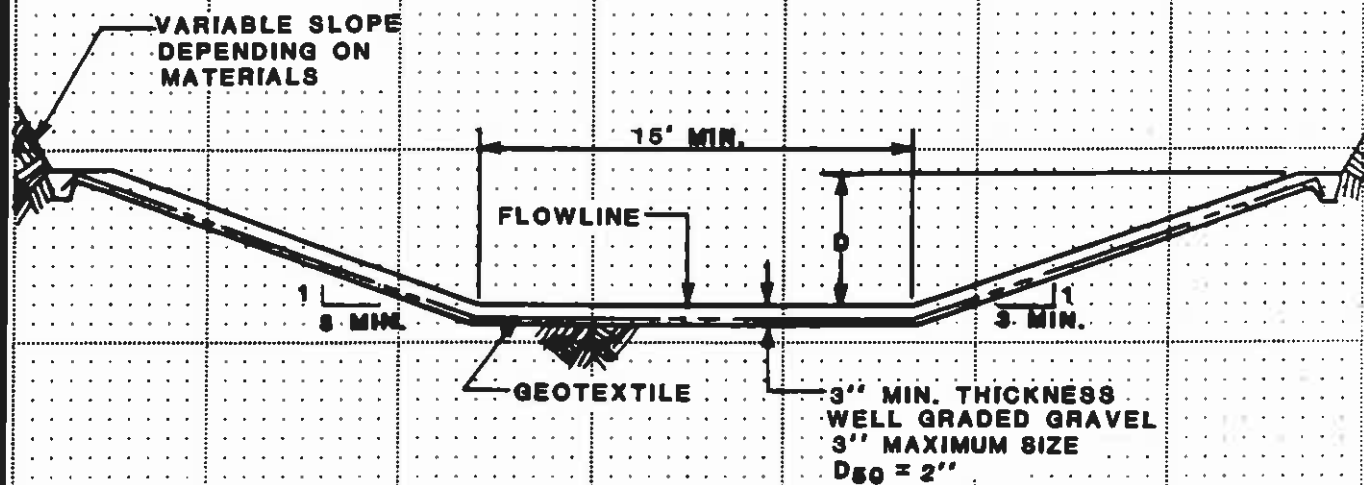
**SPILLWAY AND
 OUTFLOW CHANNEL
 CROSS SECTION
 BM-SS**

There is presently no erosion protection within the channel.

SPILLWAY CHANNEL

$D = 1.7'$
 LENGTH = 30'
 FLOWLINE ELEV. = 6409.67'

OUTFLOW CHANNEL

$D = 1'$
