INSPECTION REPORT
Sedimentation Structure
J3-A
Black Mesa Mine
Navajo County, Arizona
for
PEABODY COAL COMPANY

Dames & Moore
10139-011-22

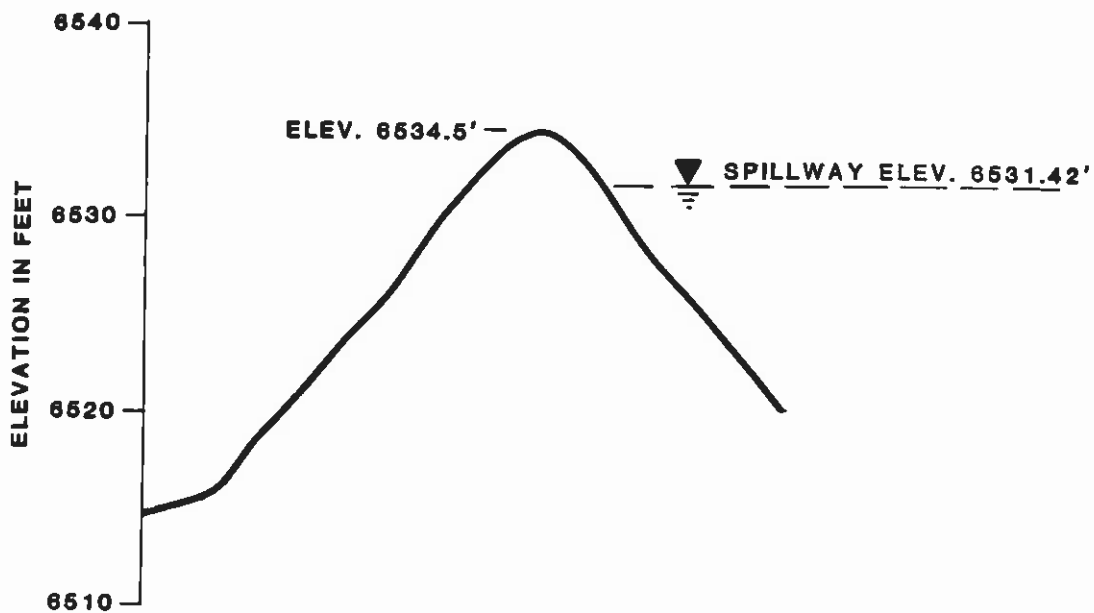
EXISTING
MAXIMUM CROSS-SECTION
A-A'
J3-A

A cross-section of the embankment is shown on Plate 2, Existing Maximum Cross Section J3-A, A-A'. Grass provides erosion protection on the upstream and downstream slopes of the embankment.

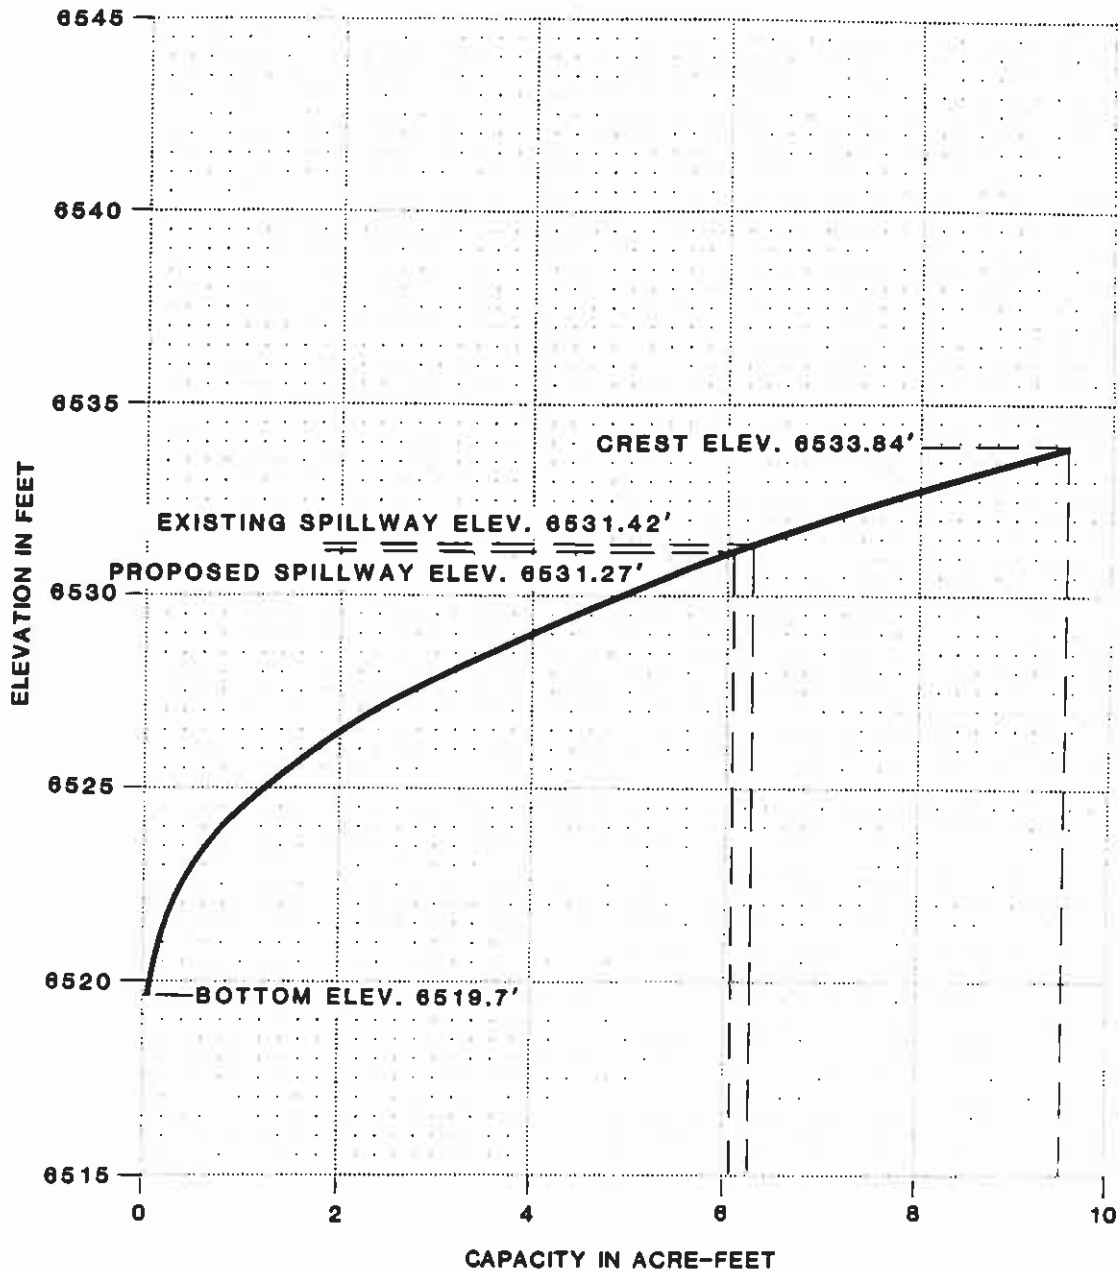
VOLUME-ELEVATION CURVE J3-A

The impoundment volume-elevation curve is based on site specific surveys conducted for Peabody Coal Company's August 1984 inspection, and 1985 resurveys, where available. Additionally, the most current topographic maps available were used in developing Plate 3, Volume-Elevation Curve, J3-A.

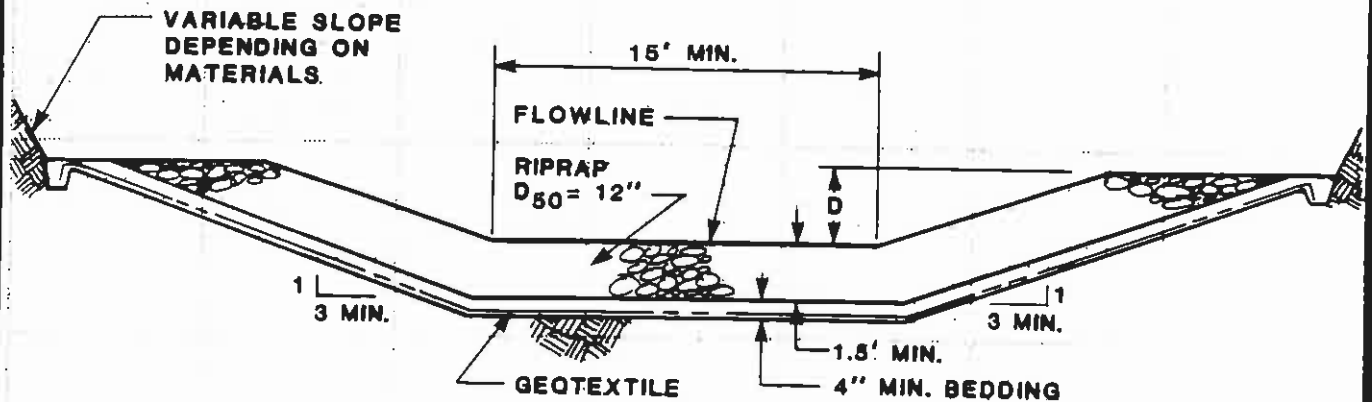
SPILLWAY AND
OUTFLOW CHANNEL
CROSS SECTION
J3-A

There is presently no erosion protection within the channel.

The storage capacity of Structure J-3A is adequate but the spillway capacity is inadequate. The structure does not have an adequate outflow channel. The bottom elevation of the existing spillway channel should be lowered to elevation 6531.27 while maintaining the bottom width of 15 feet as shown on Plate 5. A trapezoidal outflow channel with the same bottom width as the spillway and a stilling basin should be constructed along the alignment shown in Plate 1. The channel and stilling basin profile is shown in Plate 4 and required dimensions are shown in Plate 5 and Plate 6. The spillway, outflow channel and stilling basin should be protected against erosion using geotextile and riprap as shown in Plate 5.

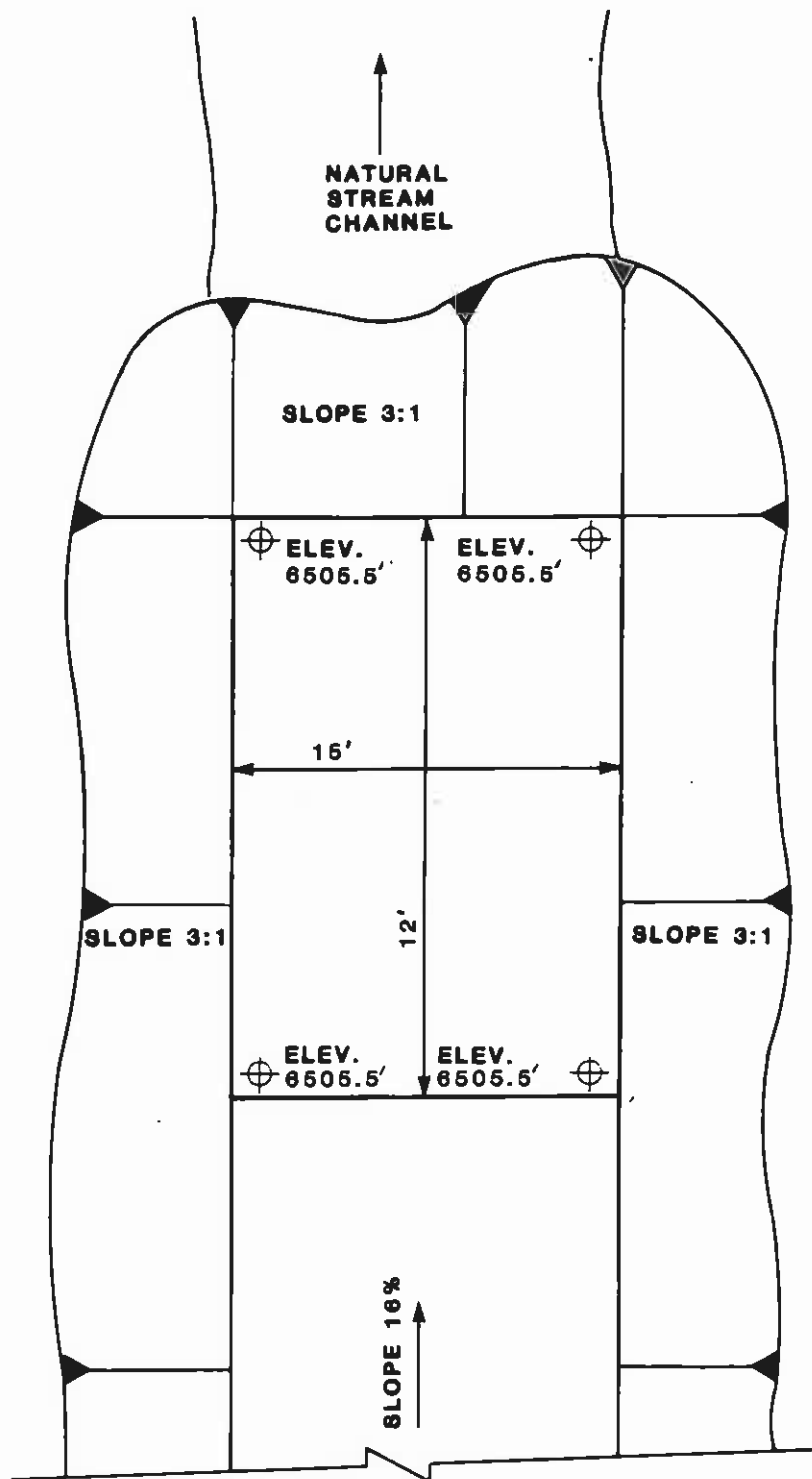
SPILLWAY STILLING BASIN PLAN J3-A

MINIMUM HEIGHT OF RIPRAP
ALONG SIDEWALLS ABOVE
THE BASIN FLOOR = 3.4'

MINIMUM DEPTH OF BASIN FLOOR
BELOW NATURAL STREAM BED = 1.8'
