INSPECTION REPORT
Sedimentation Structure
J3-B
Black Mesa Mine
Navajo County, Arizona
for
PEABODY COAL COMPANY

Dames & Moore
10139-011-22

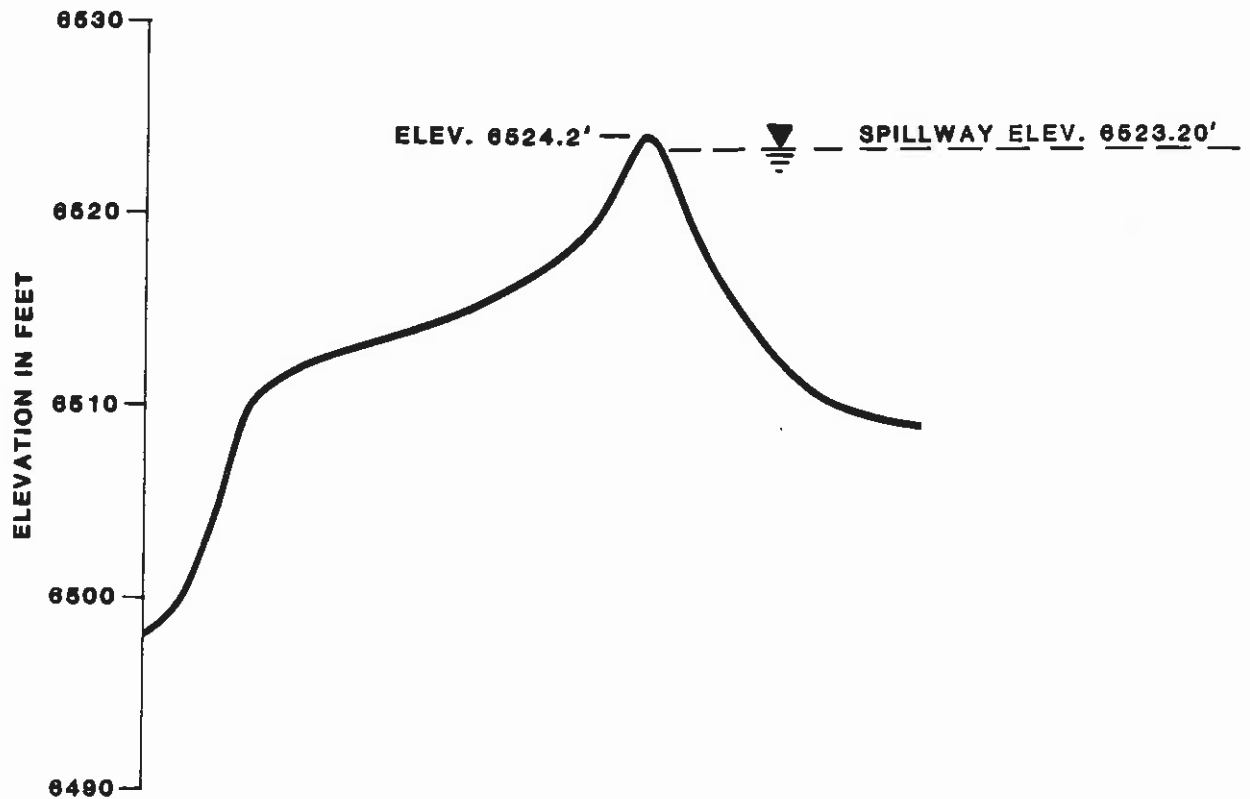
EXISTING
MAXIMUM CROSS-SECTION
A-A'
J3-B

Structure J3-B is a homogeneous earthen embankment classified as a cross-valley embankment. Physical characteristics of the embankment are listed in the following table:

Embankment	Residual Sandstone Soils
Foundation	Residual Sandstone Soils
Right Abutment	Residual Sandstone Soils
Left Abutment	Residual Sandstone Soils
Height	9.9 ft
Crest Width	12 ft
Upstream Slope	3.3 H : 1 V
Downstream Slope	4.3 H : 1 V

The J3-B embankment is lower in height and has flatter slopes than the category standard; therefore, the embankment has factors of safety greater than the design minimum.

The storage capacity of Structure J3-B is adequate but the spillway capacity is inadequate. The structure does not have an adequate outflow channel. The embankment crest should be raised to elevation 6526.10 feet. A trapezoidal outflow channel and a stilling basin should be constructed along the alignment shown in Plate 1. The channel and stilling basin profile is shown in Plate 4 and the required dimensions are shown in Plate 5 and Plate 6. The spillway, outflow channel and stilling basin should be protected against erosion using geotextile and riprap as shown in Plate 5.

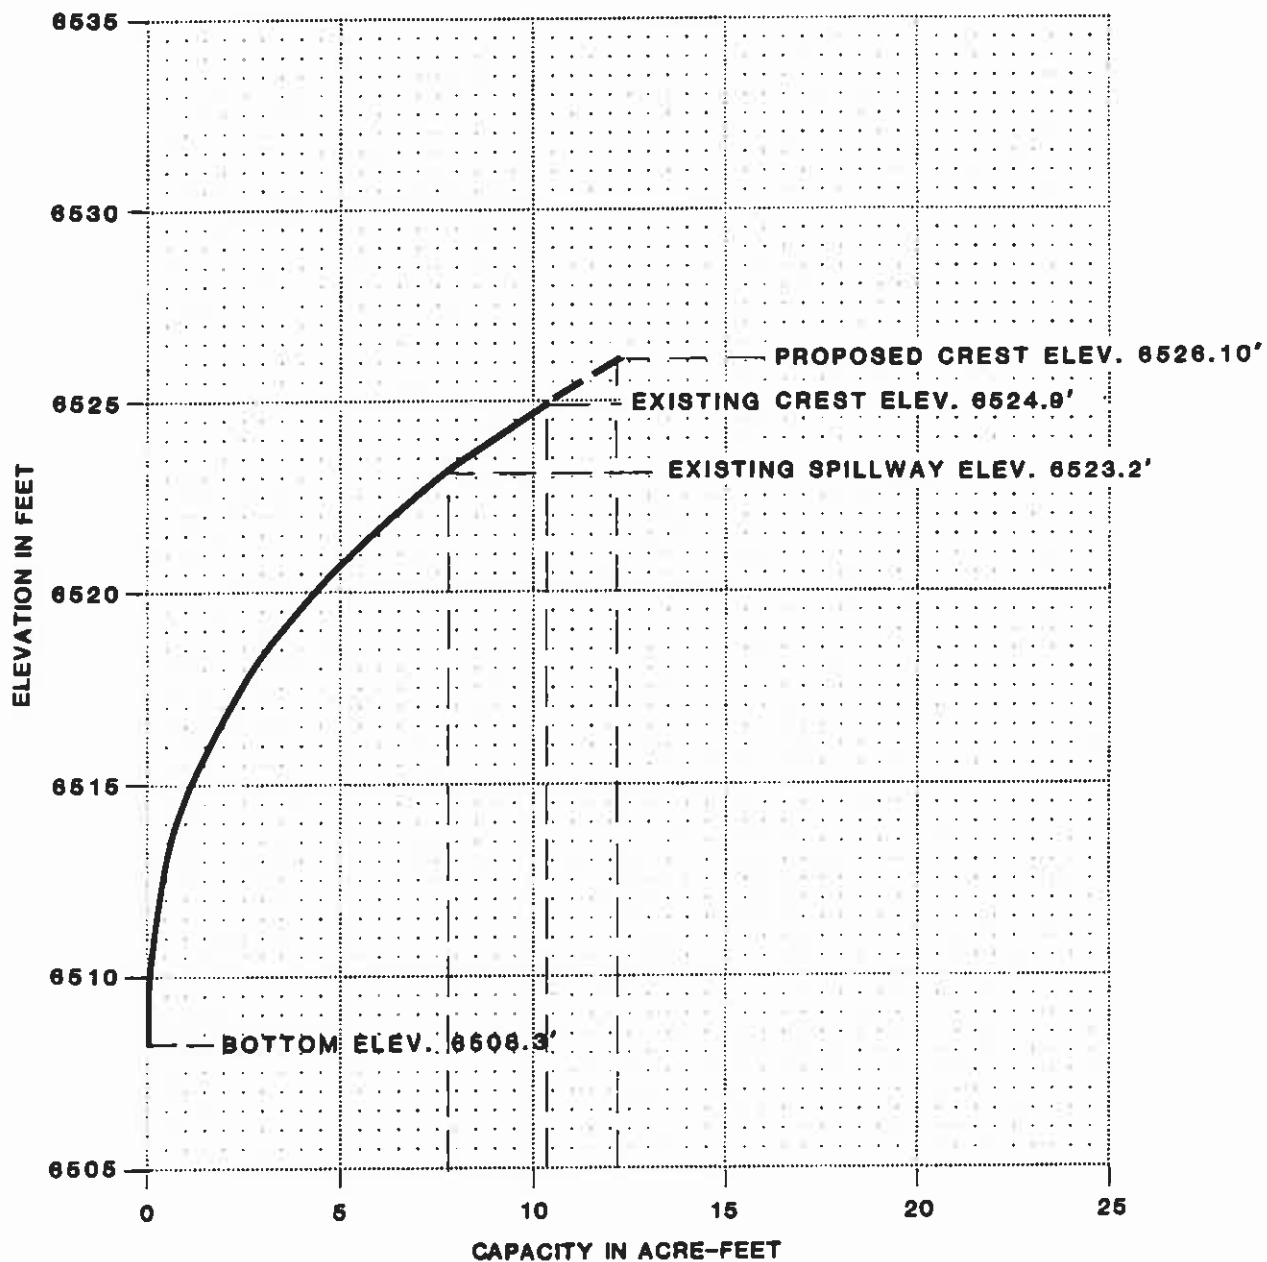
**VOLUME-ELEVATION
CURVE
J3-B**

The impoundment volume-elevation curve is based on site specific surveys conducted for Peabody Coal Company's August 1984 inspection, and 1985 resurveys, where available. Additionally, the most current topographic maps available were used in developing Plate 3, Volume-Elevation Curve, J3-B.

Total Storage Capacity	7.92	acre-ft
10-year, 24-hour Storm Inflow	6.01	acre-ft
Available Sediment Storage Capacity	1.91	acre-ft
Sediment Inflow Rate	0.273	acre-ft/yr
Sediment Storage Life	7	yrs

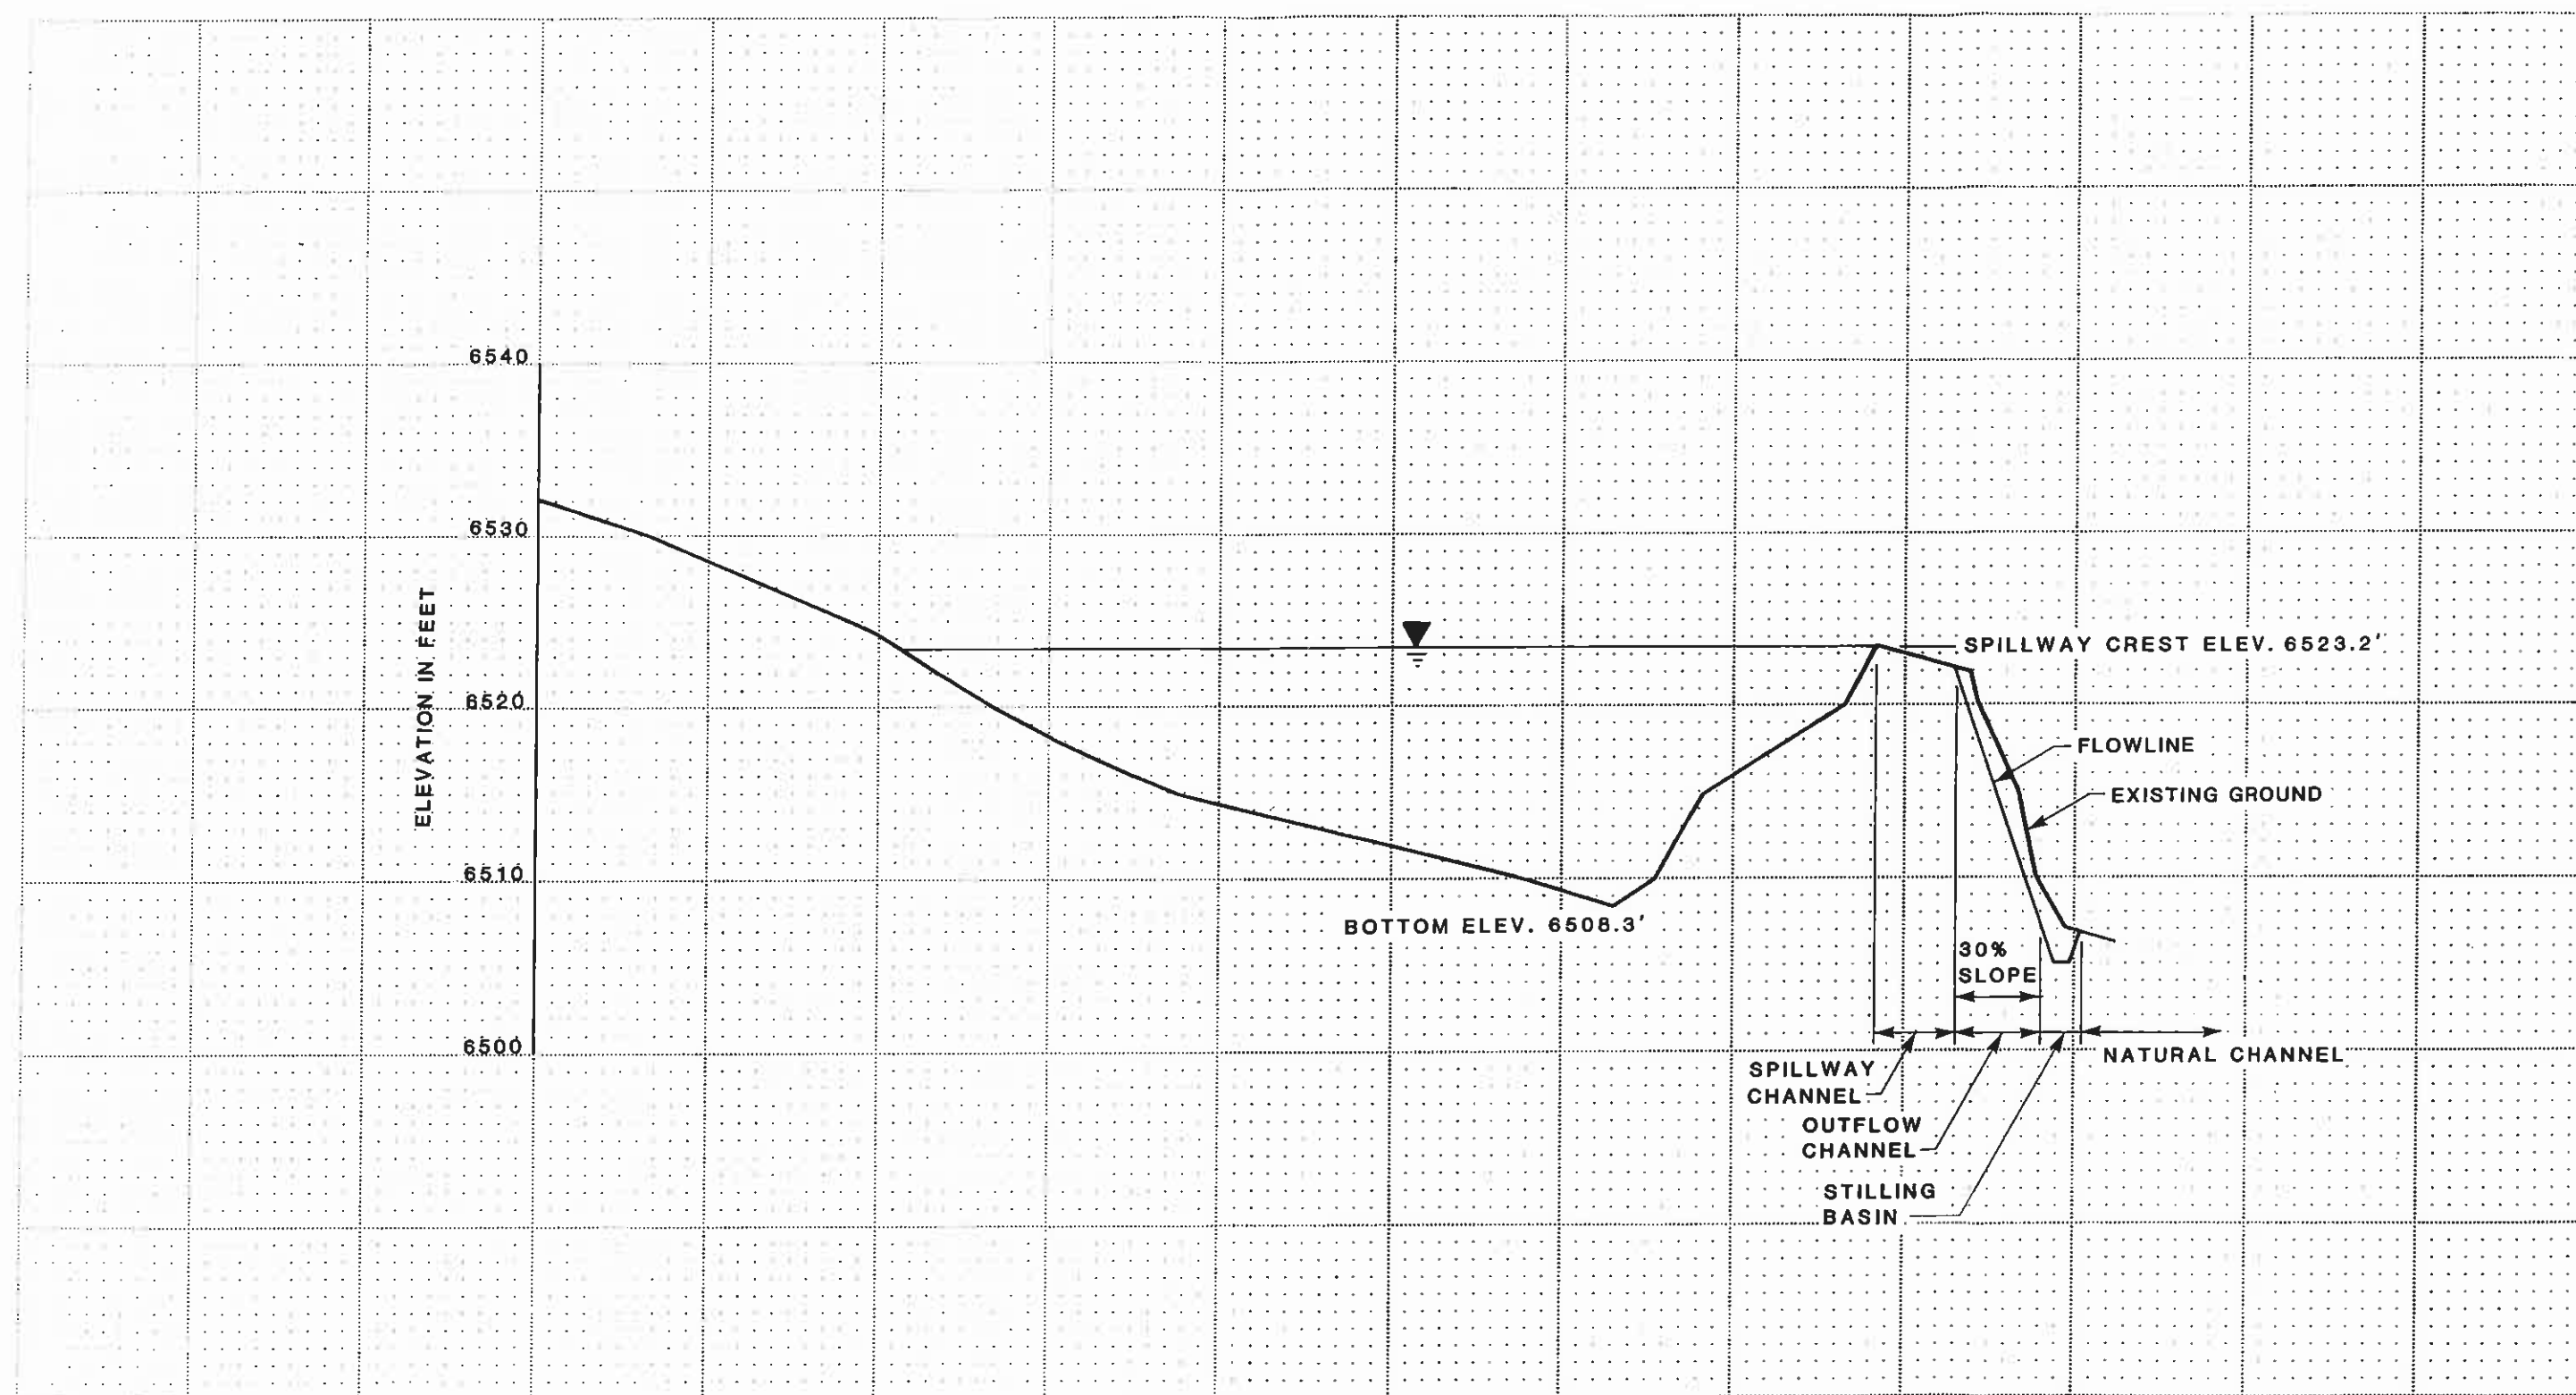
CHANNEL PROFILE B-B'
J3-B

HYDRAULICS

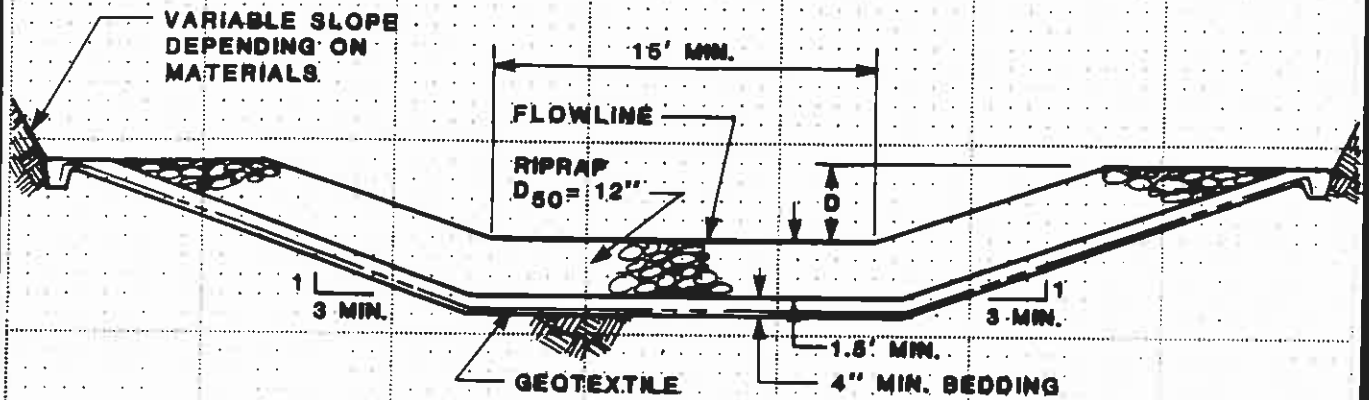
**SPILLWAY AND
OUTFLOW CHANNEL
CROSS SECTION
J3-B**

There is presently no erosion protection within the channel.

Units	25-year 6-hour Storm
Initial Reservoir Volume		
Condition		Full to the spillway elevation
Inflow		
Peak Flow	cfs	86
Volume	acre-ft	5.11
Outflow		
Peak Flow	cfs	43
Embankment Crest		
Elevation	ft	6526.10
Peak Stage	ft	6525.01
Freeboard	ft	1.09
Spillway Channel		
Flow Depth	ft	1.81
Critical Velocity. . .	fps	4.2
Manning's "n"		0.040
Outflow Channel		
Slope	%	30
Normal Velocity. . . .	fps	9.0
Normal Depth	ft	0.31
Manning's "n"		0.040
