INSPECTION REPORT
Sedimentation Structure
J3-D
Black Mesa Mine
Navajo County, Arizona
for
PEABODY COAL COMPANY

Dames & Moore
10139-011-22

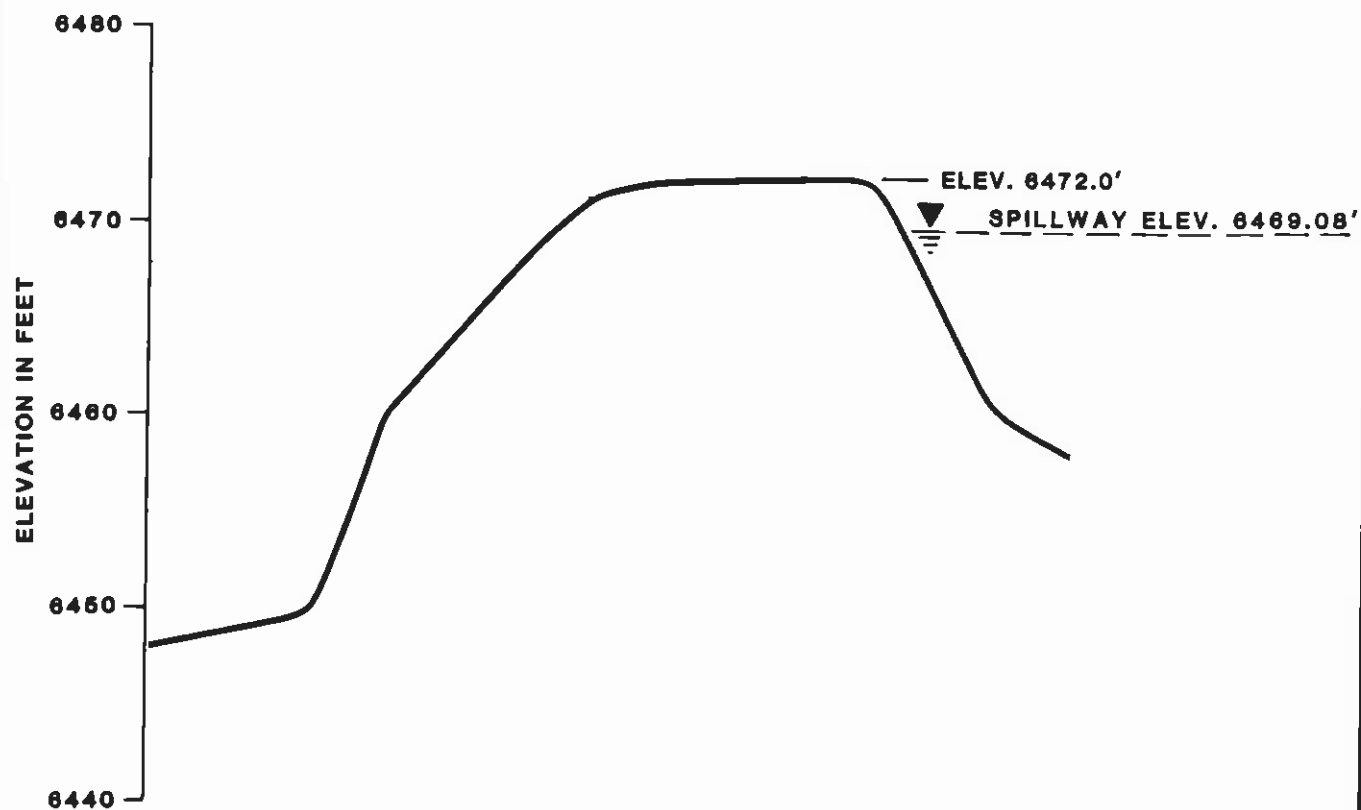
Plate 2

*Sediment removed from the structure has been placed against the downstream slope of the embankment and acts as a buttress fill against the dam.

The J3-D embankment is lower in height; however, the upstream slope is steeper than the category standard; therefore, the embankment has factors of safety less than the design minimum. The downstream slope is buttressed with material excavated from the impoundment. Although a stability analysis was not performed for this specific condition the fill acts as an added resisting force and, therefore, the downstream slope is considered stable.

EXISTING
MAXIMUM CROSS-SECTION
A-A'
J3-D

The inspection of Structure J3-D indicated that the only geotechnical problem is rill and gully erosion on the upstream slope. Correction of erosion is considered a periodic maintenance task and does not require remedial action. The upstream slope should be flattened to 2.0 horizontal to 1 vertical to meet stability requirements.

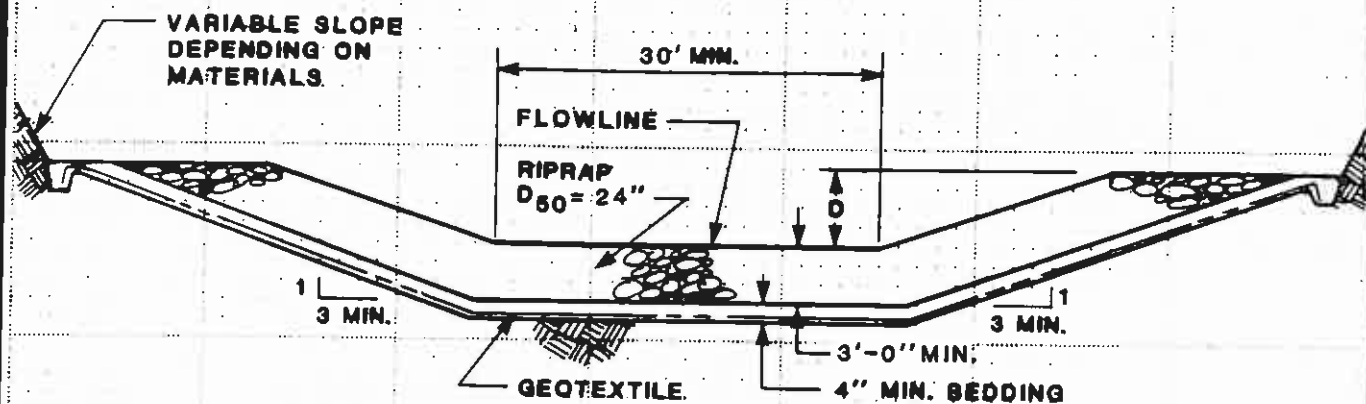
SPILLWAY AND
 OUTFLOW CHANNEL
 CROSS SECTION
 J3-D

Half the channel has rock providing some erosion protection within the channel, however the protection is inadequate based on the calculated velocities in the channel.

Rock provides some erosion protection within the channel, however the protection is inadequate based on the calculated velocities in the channel.

The storage capacity and spillway capacity of Structure J3-D are adequate; however, the spillway does not have an adequate outflow channel or adequate erosion protection. A trapezoidal outflow channel and a stilling basin should be constructed along the alignment B-B' shown in Plate 1. The channel and stilling basin profile is shown in Plate 4 and the required dimensions are shown in Plate 5 and Plate 6. The spillway, outflow channel and stilling basin should be protected against erosion using geotextile and riprap as shown in Plate 5.

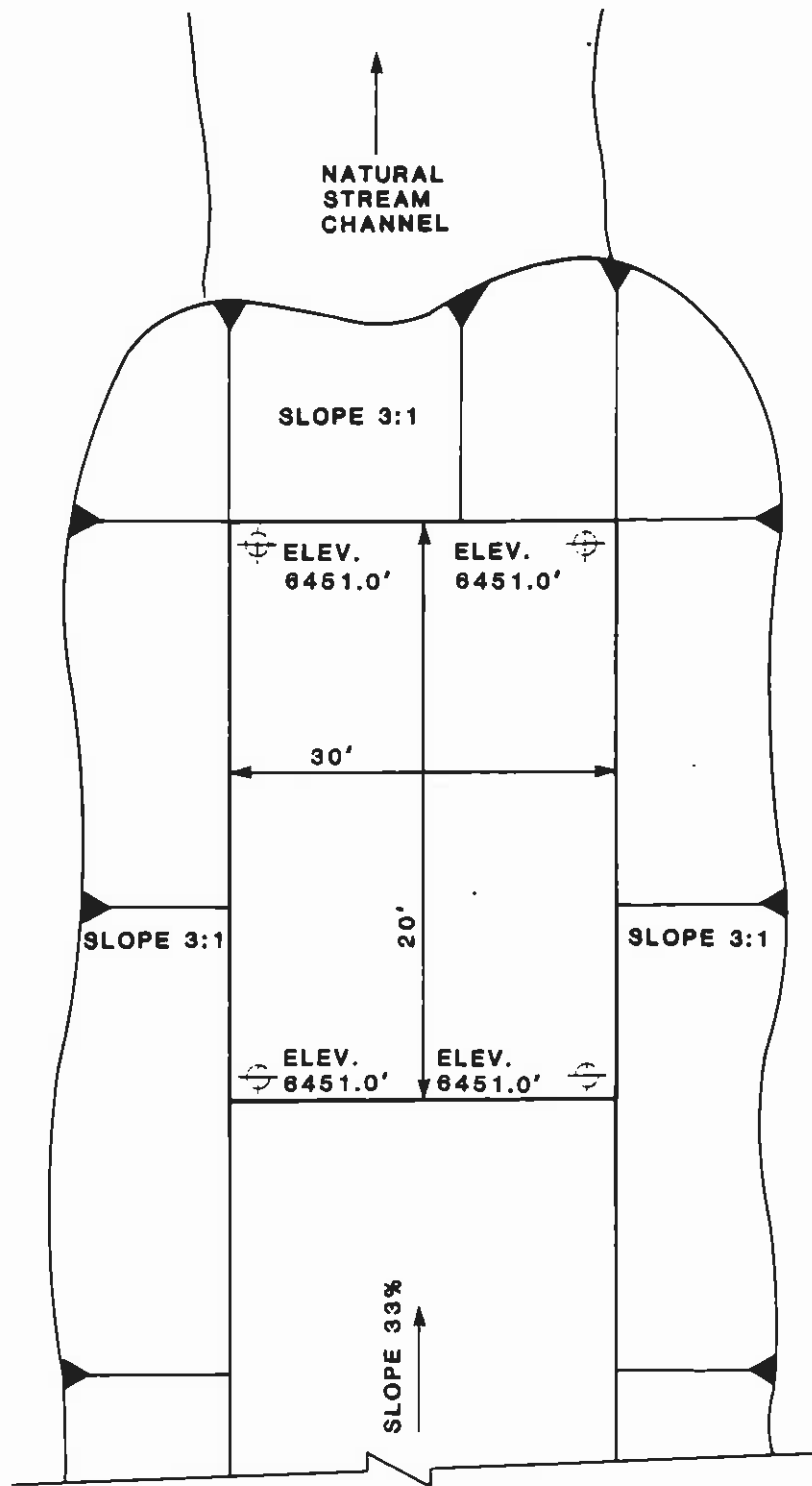
SPILLWAY STILLING BASIN PLAN J3-D

MINIMUM HEIGHT OF RIPRAP
ALONG SIDEWALLS ABOVE
THE BASIN FLOOR = 6.1'

MINIMUM DEPTH OF BASIN FLOOR
BELOW NATURAL STREAMBED = 2.7'
