INSPECTION REPORT  
Sedimentation Structure  
J3-E  
Black Mesa Mine  
Navajo County, Arizona  
for  
PEABODY COAL COMPANY

Dames & Moore  
10139-011-22

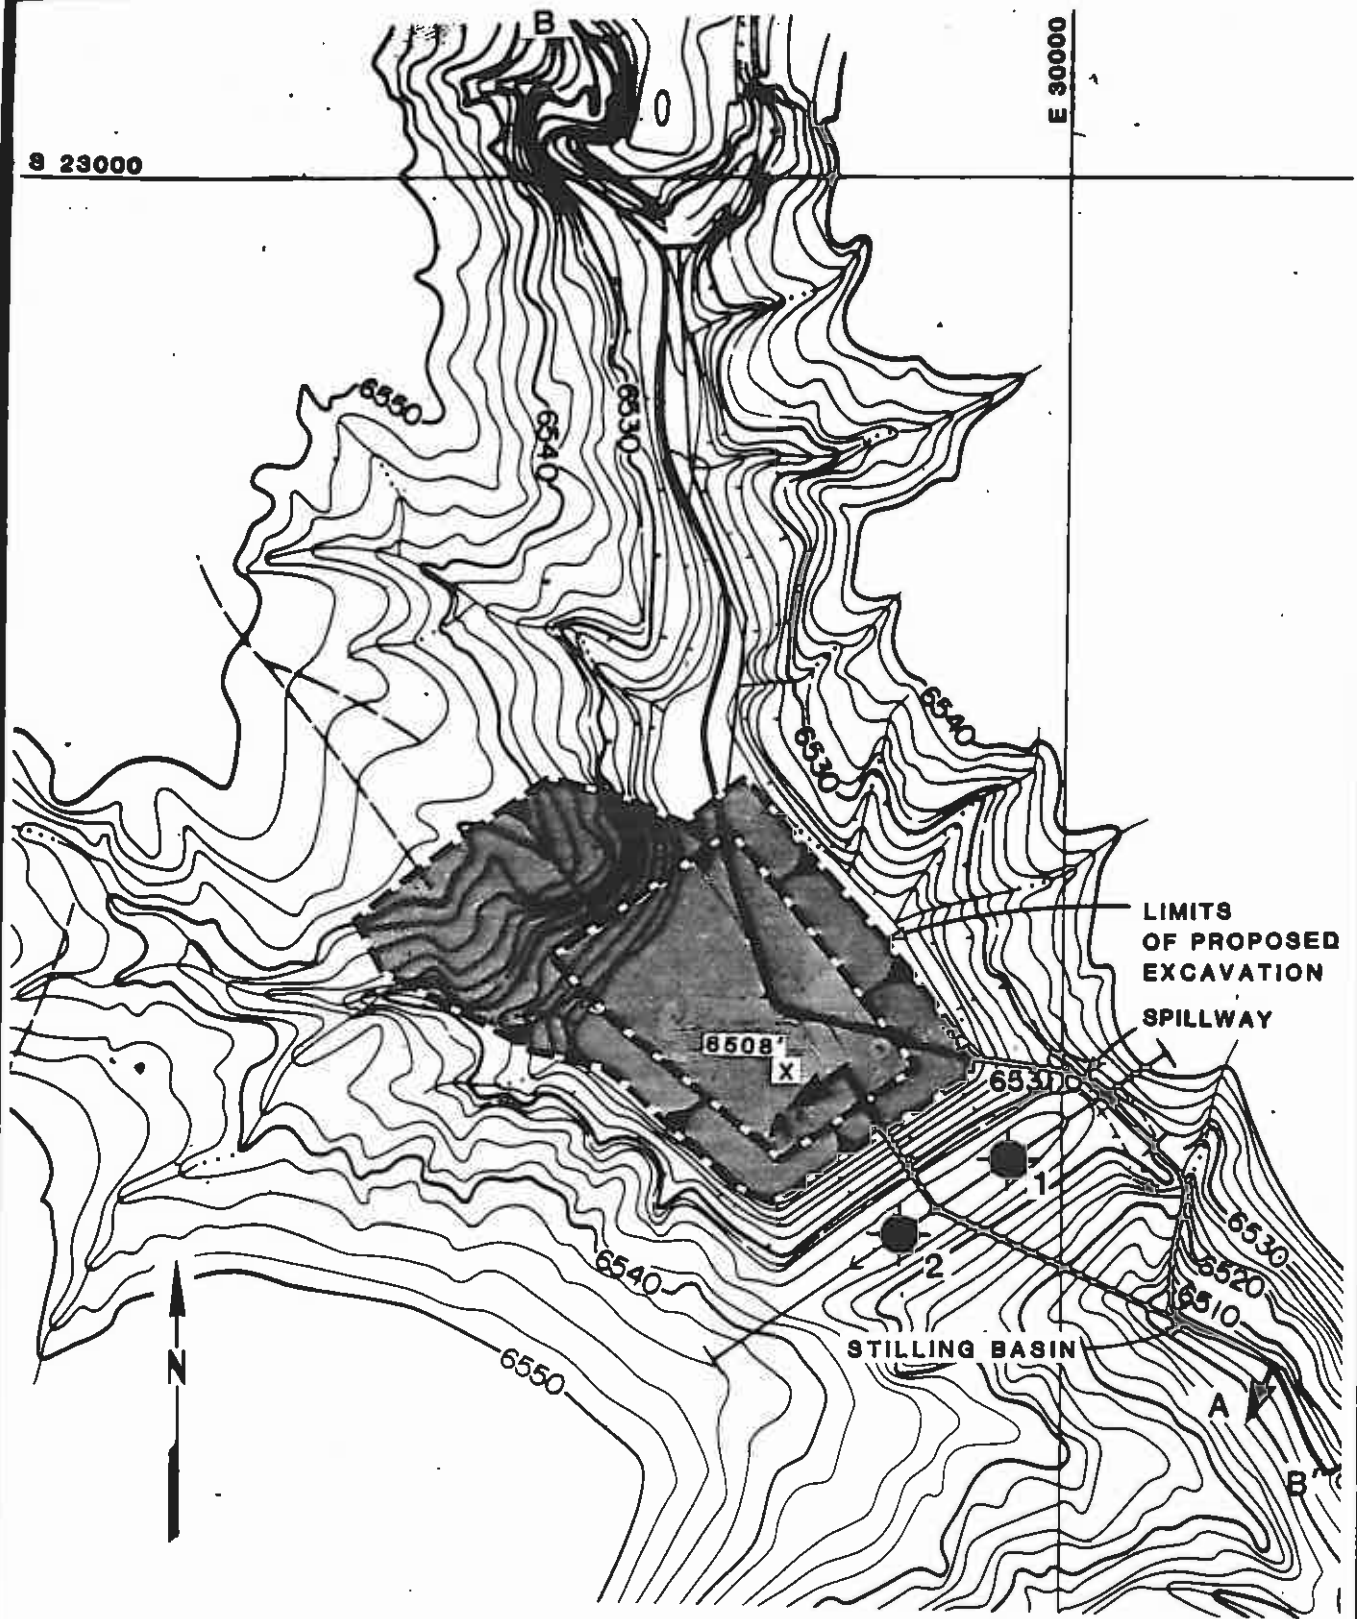
Plate 1

The spillway capacity of Structure J3-E is adequate but the storage capacity is inadequate. The structure does not have an adequate outflow channel. The storage capacity should be increased to 18.8 acre-feet by excavating the pond as shown on Plates 1 and 5. A trapezoidal outflow channel and a stilling basin should be constructed along the alignment shown in Plate 1. The channel and stilling basin profile is shown in Plate 4 and the required dimensions are shown in Plate 5 and Plate 6. The spillway, outflow channel and stilling basin should be protected against erosion using geotextile and riprap as shown in Plate 5.

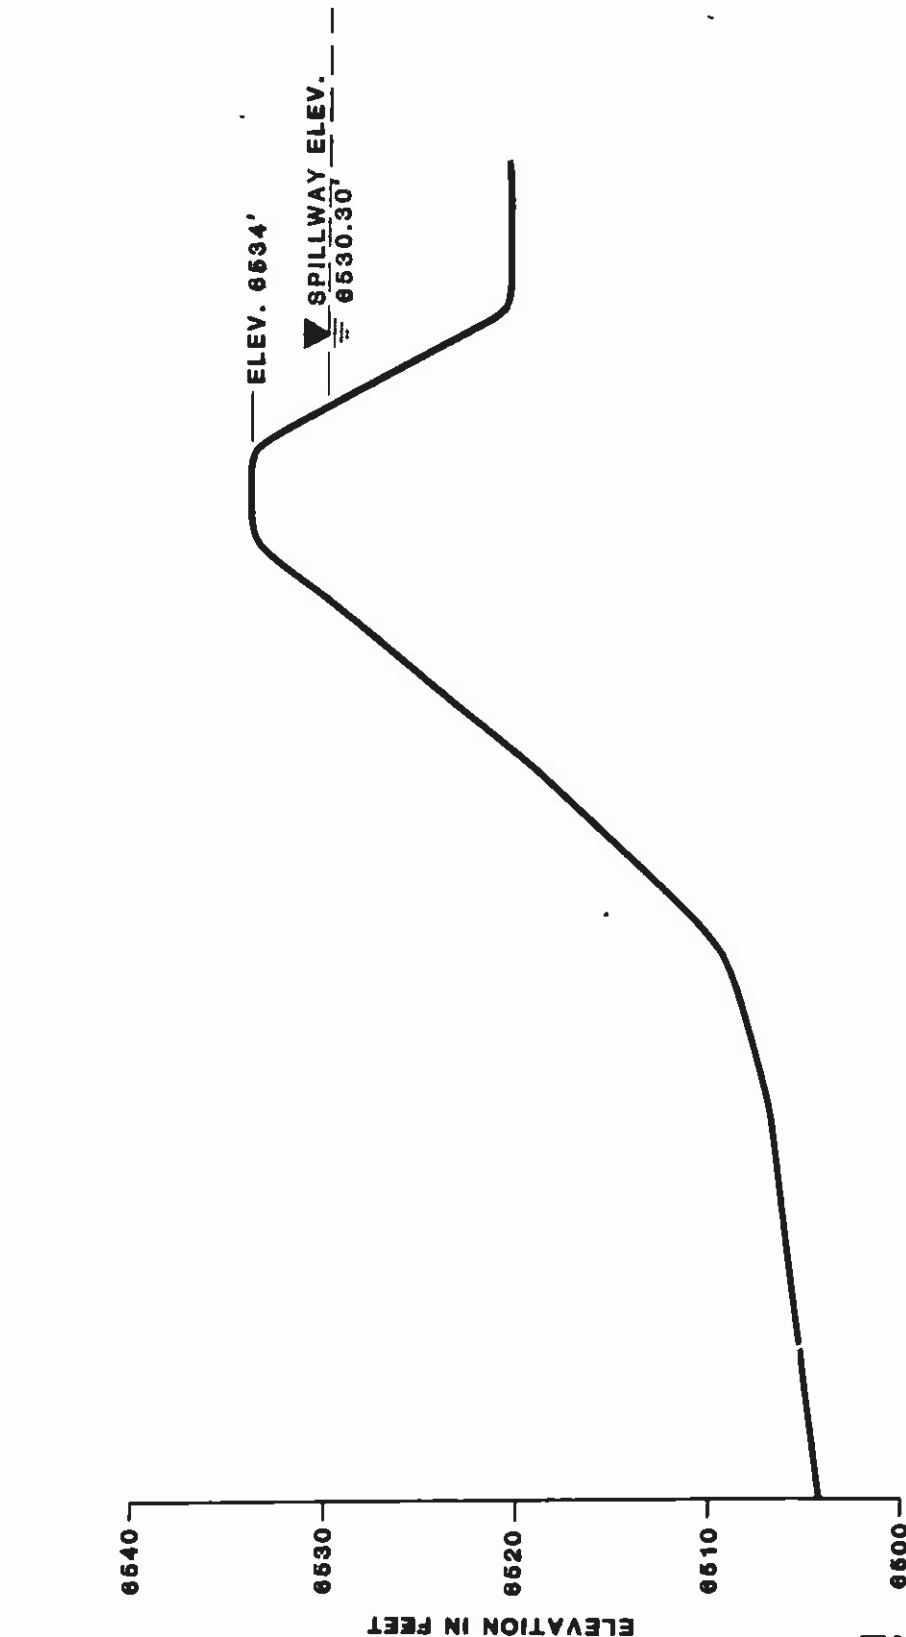
Plate 2

The upstream slope is lower in height, and flatter than the design criteria. The downstream slope is steeper than the category standard; therefore, the embankment has factors of safety less than the design minimum.

The inspection of Structure J3-E indicated that the geotechnical problems consist of rill erosion on the downstream slope and the right and left abutments; and a steep downstream slope. Correction of erosion is considered a periodic maintenance task and does not require remedial action. The downstream slope should be flattened to 4.25 horizontal to 1 vertical to meet stability requirements.

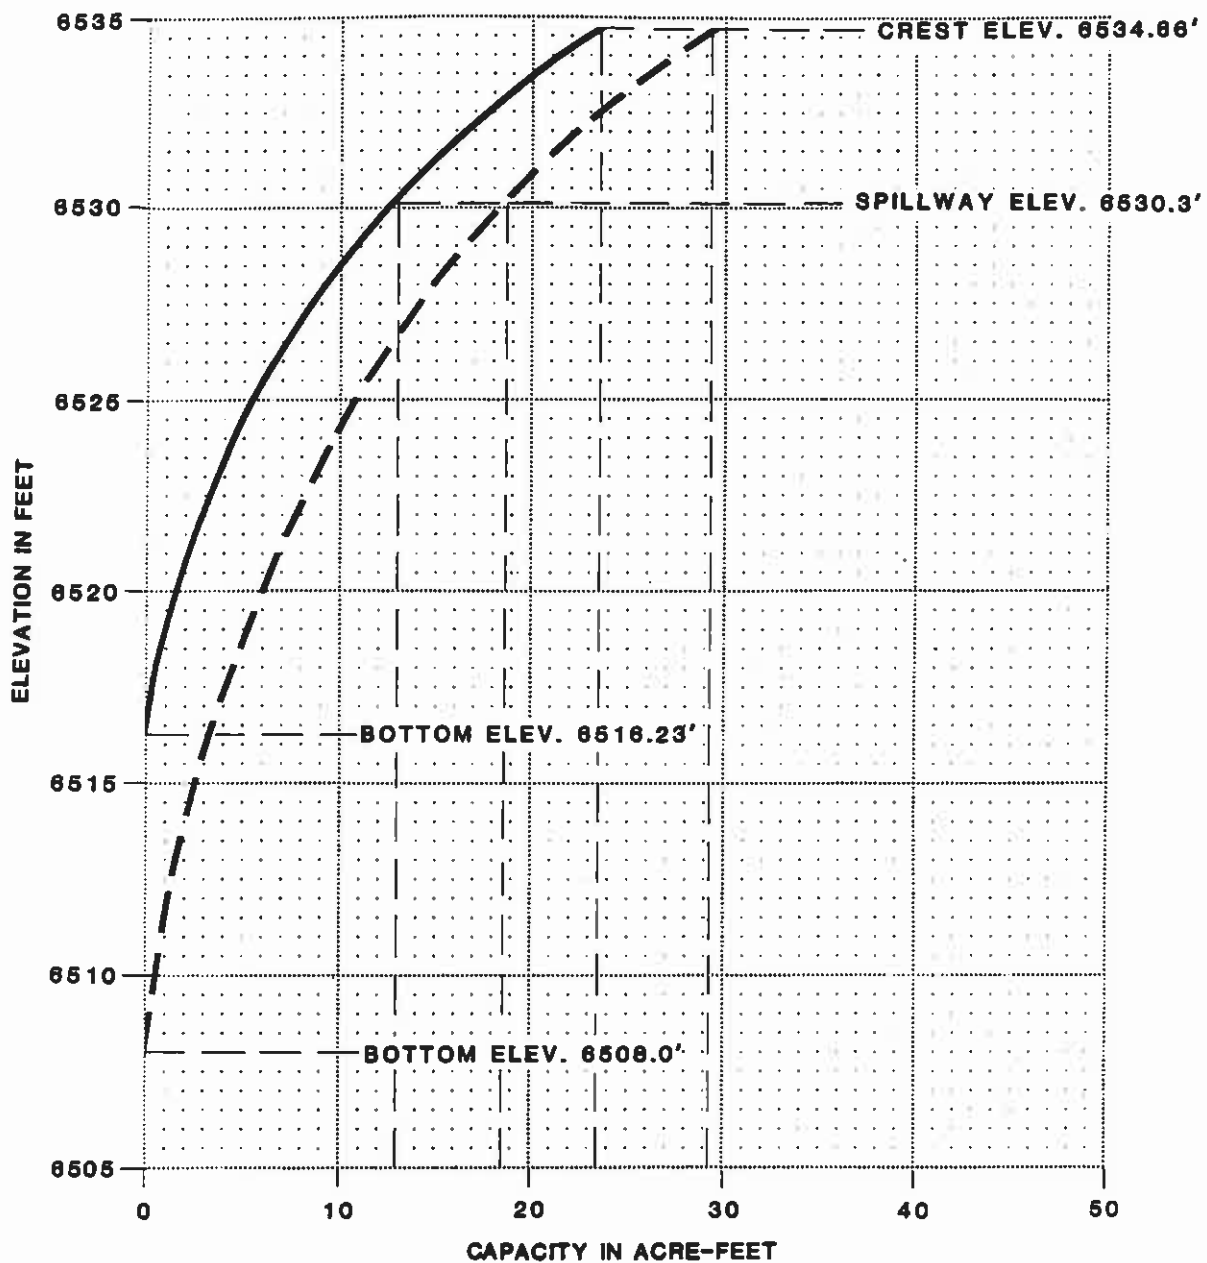
## VOLUME-ELEVATION CURVE J3-E

Total Storage Capacity . . . . .	13.0	acre-ft
10-year, 24-hour Storm Inflow . . . . .	15.9	acre-ft
Available Sediment Storage Capacity . .	0	acre-ft
Sediment Inflow Rate . . . . .	0.742	acre-ft/yr
Sediment Storage Life . . . . .	0	hrs

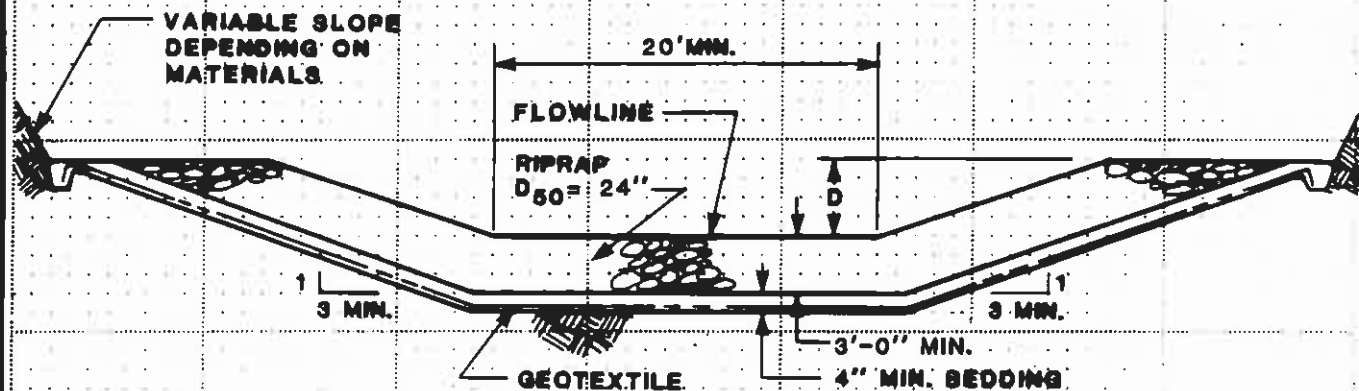
**SPILLWAY AND  
OUTFLOW CHANNEL  
CROSS SECTION  
J3-E**

There is presently no erosion protection within the channel.

Rock with a D50 of 10 inches provides some, but inadequate erosion protection within the channel.
