INSPECTION REPORT
Sedimentation Structure
J7-CD
Black Mesa Mine
Navajo County, Arizona
for
PEABODY COAL COMPANY

Dames & Moore
10139-011-22

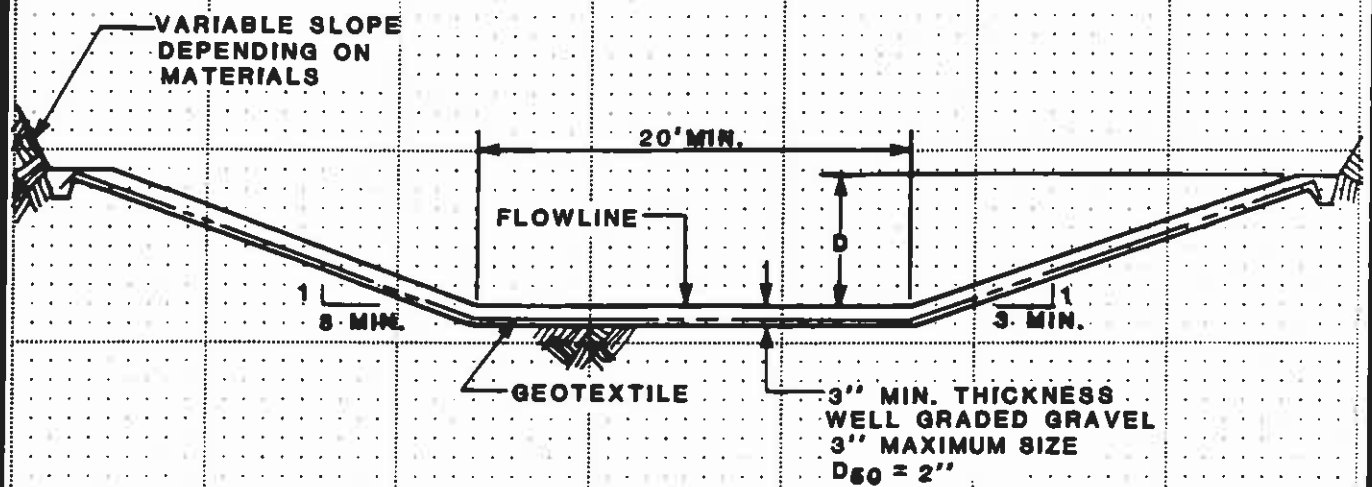
**SPILLWAY AND
 OUTFLOW CHANNEL
 CROSS SECTION
 J7-CD**

SPILLWAY CHANNEL

$D = 1.7'$
 LENGTH = 60'
 FLOWLINE ELEV. = 6538.9'

OUTFLOW CHANNEL

$D = 1'$

There is presently no erosion protection within the channel.

The structure presently has no outflow channel.

The storage capacity and spillway capacity of Structure J7-CD are adequate; however, the spillway does not have an adequate outflow channel or adequate erosion protection. A trapezoidal outflow channel should be constructed along the alignment B-B' shown in Plate 1. The channel profile is shown in Plate 4 and the required dimensions are shown in Plate 5. Both the spillway and outflow channel should be protected against erosion using geotextile and gravel as shown in Plate 5.

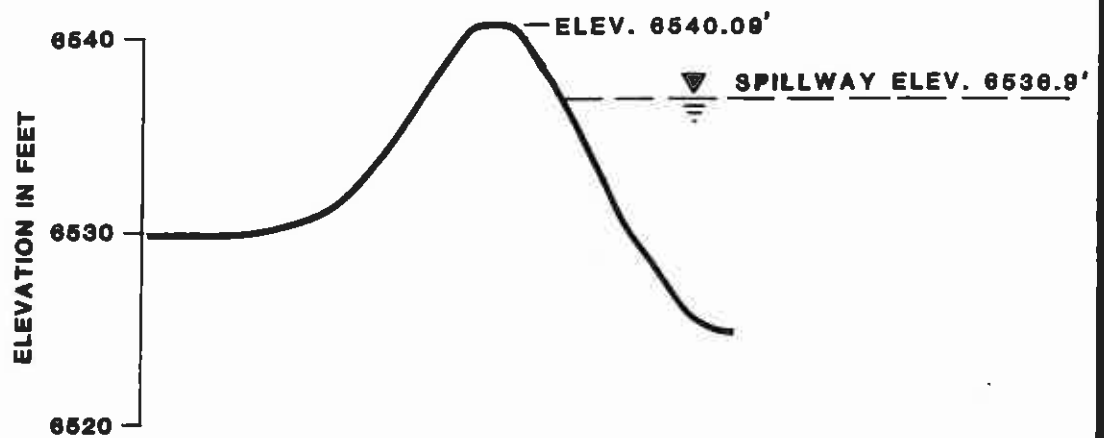
EXISTING
MAXIMUM CROSS-SECTION
A-A'
J7-CD

Embankment	Residual Shale Soils
Foundation	Residual Sandstone Soils/Sandstone
Right Abutment	Residual Sandstone Soils
Left Abutment	Residual Sandstone Soils
Height	11.7 ft
Crest Width	15 ft
Upstream Slope	1.8 H : 1 V
Downstream Slope	2.5 H : 1 V

The J7-CD embankment is lower in height; however, the upstream slope is steeper than the category standard; therefore, the embankment has factors of safety less than the design minimum.

The inspection of Structure J7-CD indicated that the geotechnical problems consist of rill erosion on the upstream and downstream slopes, the side slopes of the spillway channel and the right abutment; and the steep upstream slope. Correction of erosion is considered a periodic maintenance

task and does not require remedial action. The upstream slope should be flattened to 2.0 horizontal to 1 vertical to meet stability requirements.
