INSPECTION REPORT
Sedimentation Structure
J7-E
Black Mesa Mine
Navajo County, Arizona
for
PEABODY COAL COMPANY

Dames & Moore
10139-011-22

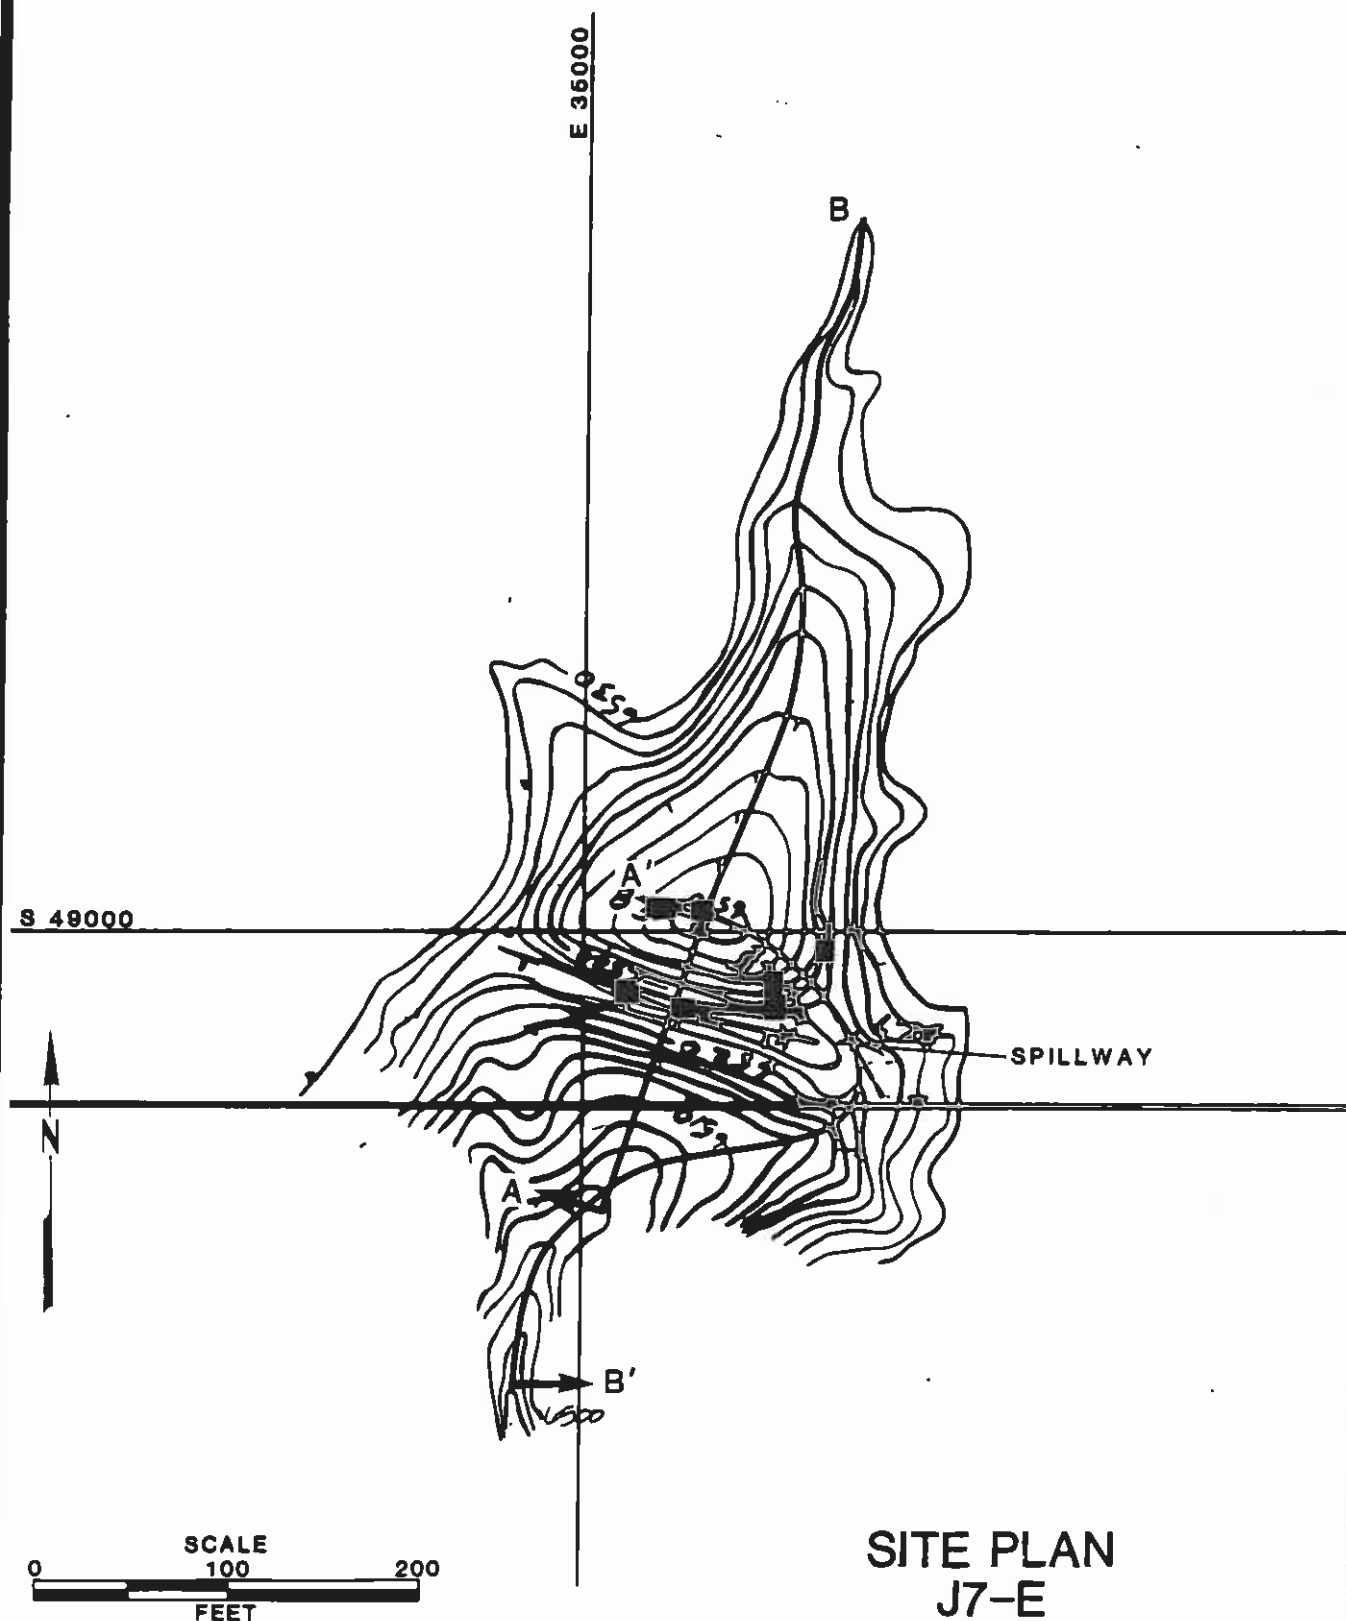
Sedimentation Structure J7-E is an earthen embankment, designed and constructed in 1980 by Peabody Coal Company as a temporary sedimentation structure to control runoff and sediment from the disturbed mining areas of the Black Mesa Mine. The location of Structure J7-E is shown on Plate 1, Site Plan.

The storage capacity and spillway capacity of Structure J7-E are adequate; however, the spillway does not have an outflow channel or adequate erosion protection. A trapezoidal outflow channel should be constructed along the alignment B-B' shown in Plate 1. The channel profile is shown in Plate 4 and the required dimensions are shown in Plate 5. Both the spillway and outflow channel should be protected against erosion using geotextile and gravel as shown in Plate 5.

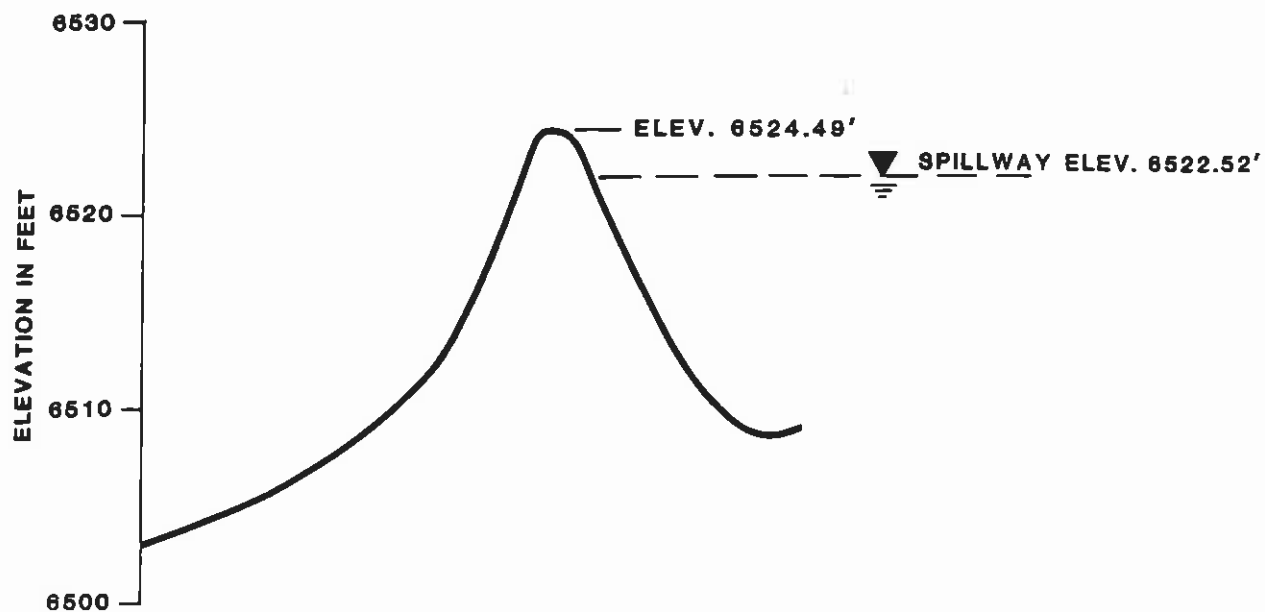
Plate 2

A cross-section of the embankment is shown on Plate 2, Existing Maximum Cross Section J7-E, A-A'. Grass provides erosion protection on the upstream and downstream slopes of the embankment.

The J7-E embankment is lower in height; however, the downstream and upstream slopes are steeper than the category standard; therefore, the embankment has factors of safety less than the design minimum.

periodic maintenance task and does not require remedial action. The downstream and upstream slopes should be flattened to 4.0 horizontal to 1 vertical and 2.0 horizontal to 1 vertical, respectively, to meet stability requirements.

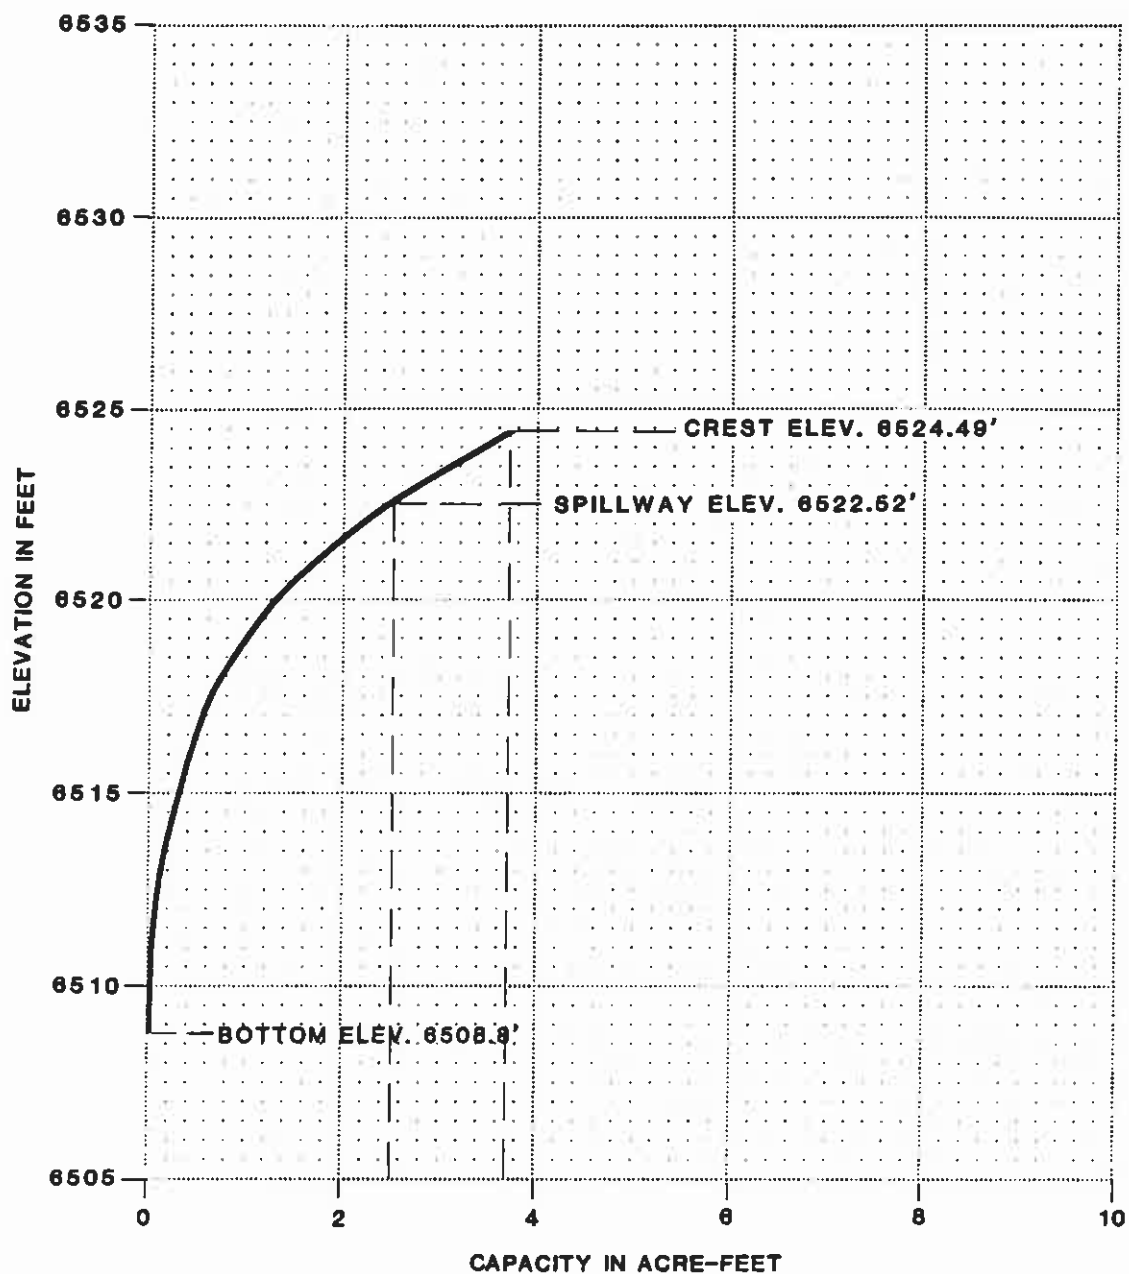
VOLUME-ELEVATION
CURVE
J7-E

The hydrologic analysis gives the storage volume required to contain the 10-year, 24-hour storm, and the remaining storage volume available for storing sediment. The existing storage capacity of J7-E is shown on Plate 3, Volume-Elevation Curve, J7-E, and the results of the analysis are summarized in the following table.

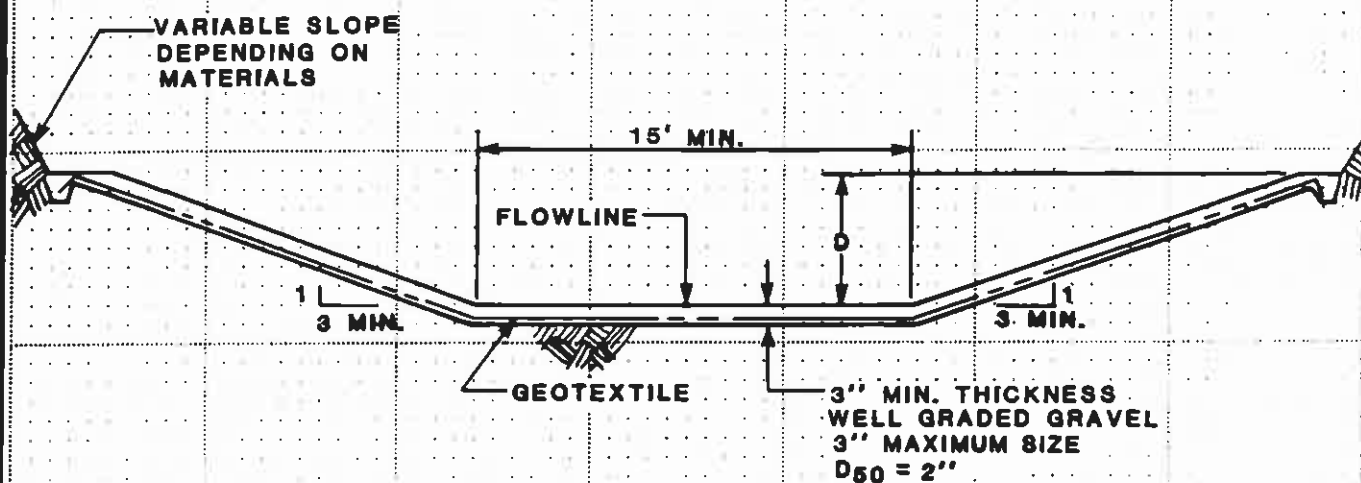
**SPILLWAY AND
OUTFLOW CHANNEL
CROSS SECTION
J7-E**

There is presently no erosion protection within the channel.

The structure presently has no outflow channel.
