INSPECTION REPORT
Sedimentation Structure
J16-D
Kayenta Mine
Navajo County, Arizona
for
PEABODY COAL COMPANY

Dames & Moore
10139-011-22

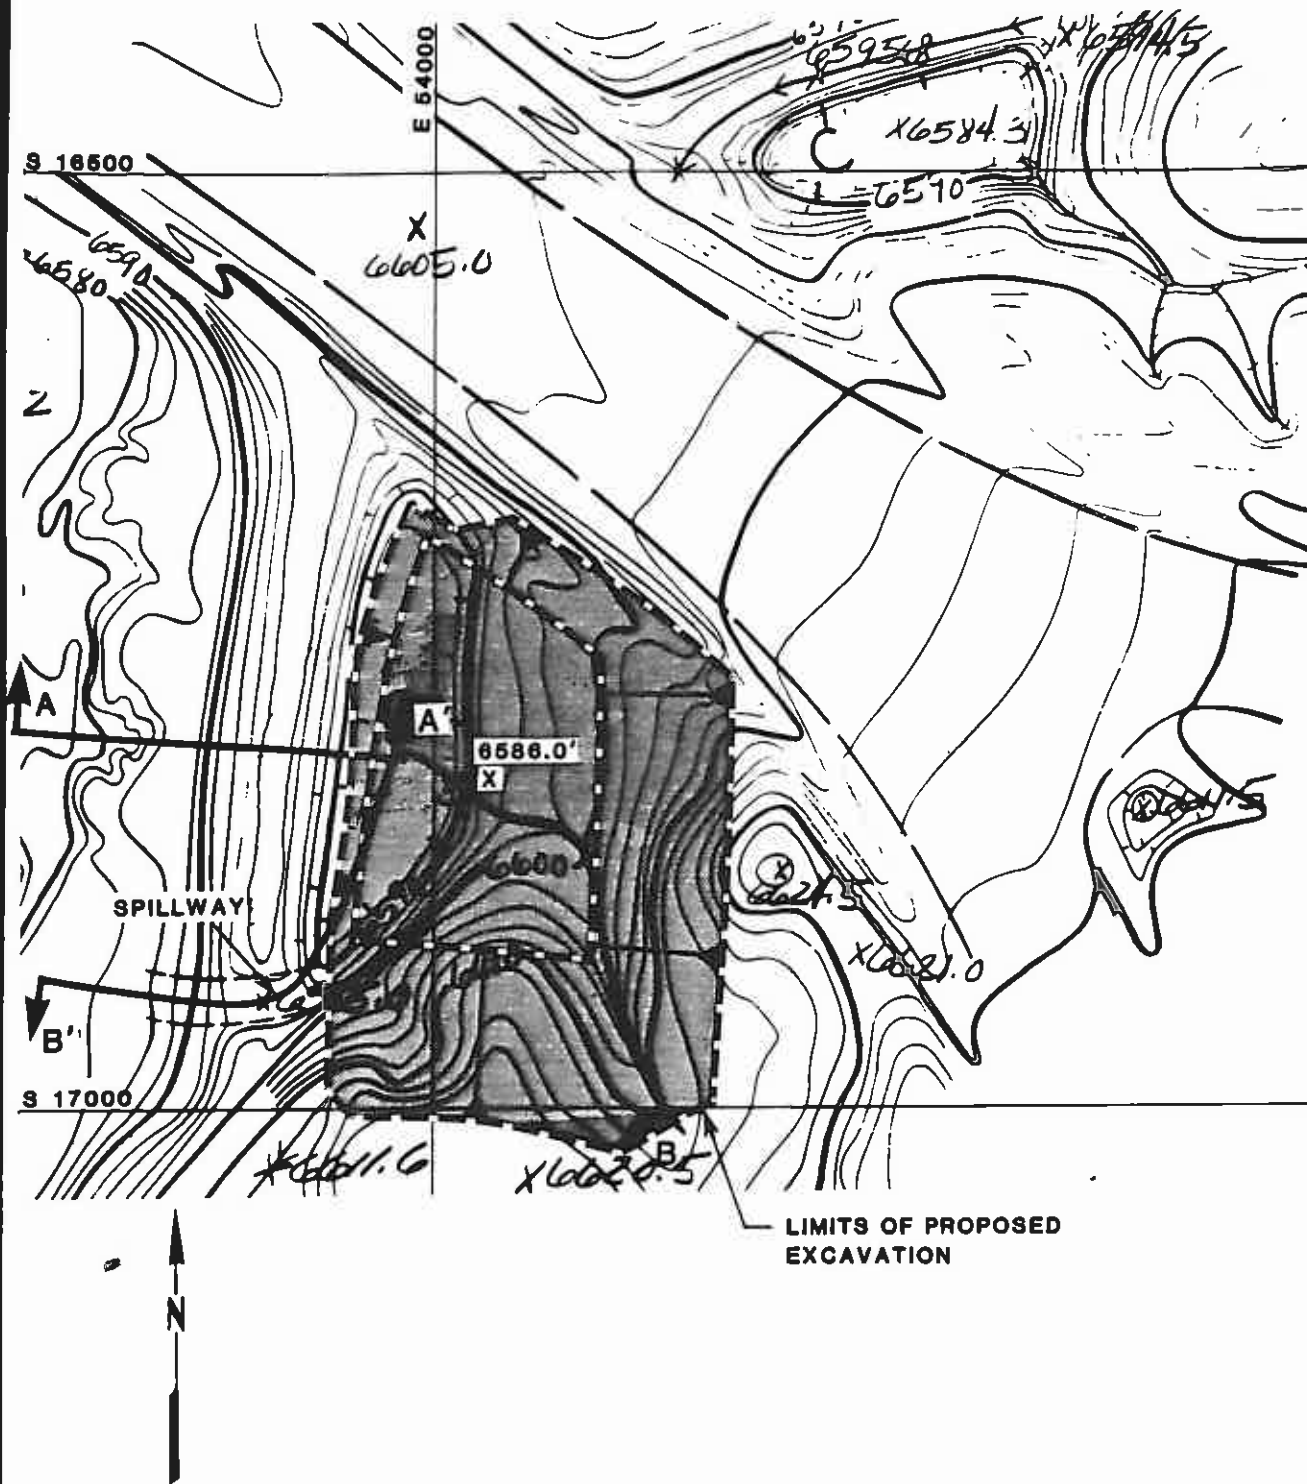
Plate 1

Sedimentation Structure J16-D is an earthen embankment, designed and constructed in 1982 by Peabody Coal Company as a temporary sedimentation structure to control runoff and sediment from the disturbed mining areas of the Kayenta Mine. The location of Structure J16-D is shown on Plate 1, Site Plan.

The spillway capacity of Structure J16-D is adequate but the storage capacity is inadequate. The storage capacity should be increased to 7.24 acre-feet by excavating the pond as shown on Plates 1 and 4. The trapezoidal outflow channel should be extended 20 feet along the alignment shown in Plate 1. The channel profile is shown in Plate 4 and the required dimensions are shown in Plate 5. Both the spillway and outflow channel extension should be protected against erosion using geotextile and riprap as shown in Plate 5.

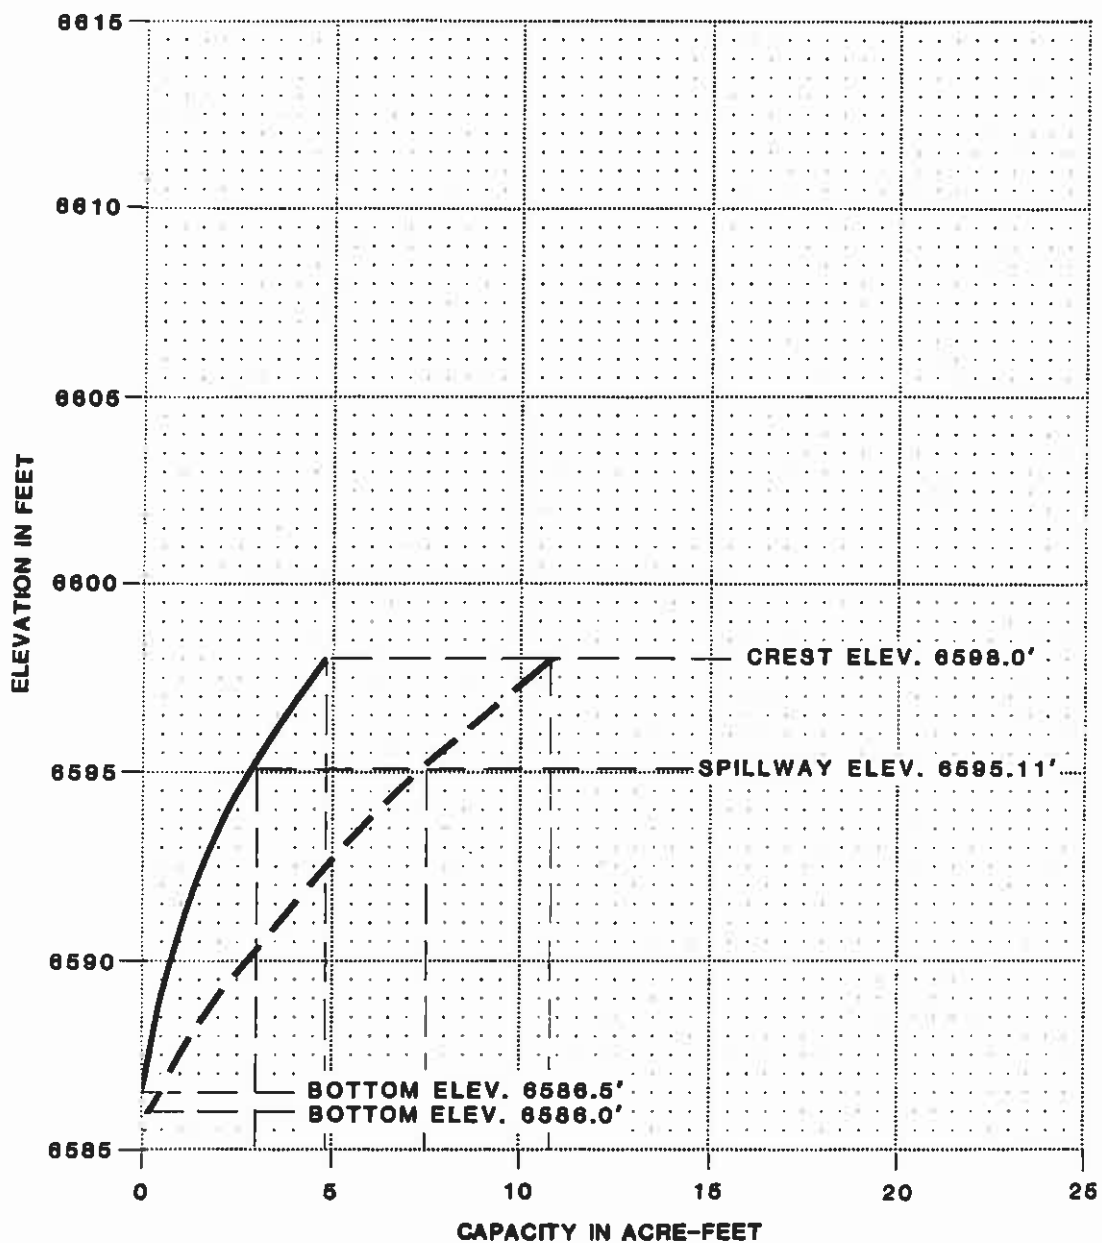
VOLUME-ELEVATION CURVE J16-D

The impoundment volume-elevation curve is based on site specific surveys conducted for Peabody Coal Company's August 1984 inspection, and 1985 resurveys, where available. Additionally, the most current topographic maps available were used in developing Plate 3, Volume-Elevation Curve, J16-D.

Enlarging the storage capacity to 7.24 acre-feet gives additional sediment storage. The analysis of these conditions is summarized in the following table.

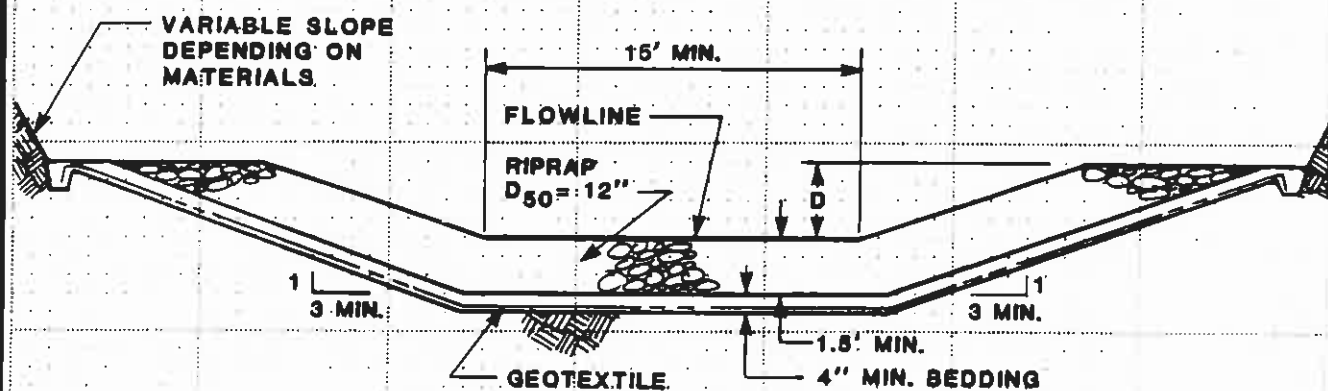
**SPILLWAY AND
OUTFLOW CHANNEL
CROSS SECTION
J16-D**

The existing outflow channel for J16-D has a trapezoidal channel with the following dimensions:

Channel width	16 ft
Channel length	50 ft
Side slopes (horizontal to vertical) . .	2:1
Average exit slope	15 percent

Rock provides adequate erosion protection within the channel.
