INSPECTION REPORT
Sedimentation Structure
J16-E
Kayenta Mine
Navajo County, Arizona
for
PEABODY COAL COMPANY

Dames & Moore
10139-011-22

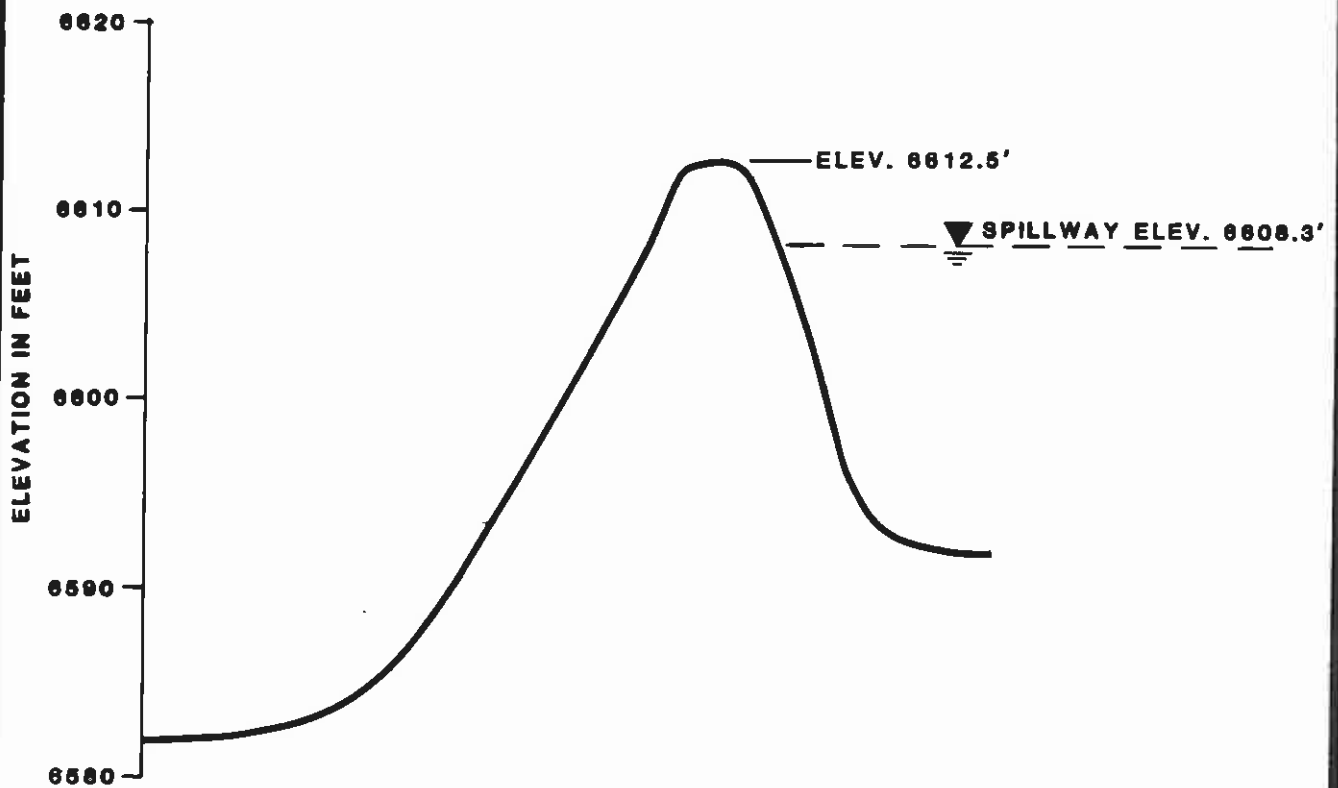
Plate 2

A cross-section of the embankment is shown on Plate 2, Existing Maximum Cross Section J16-E, A-A'. Grass provides erosion protection on the downstream slope of the embankment.

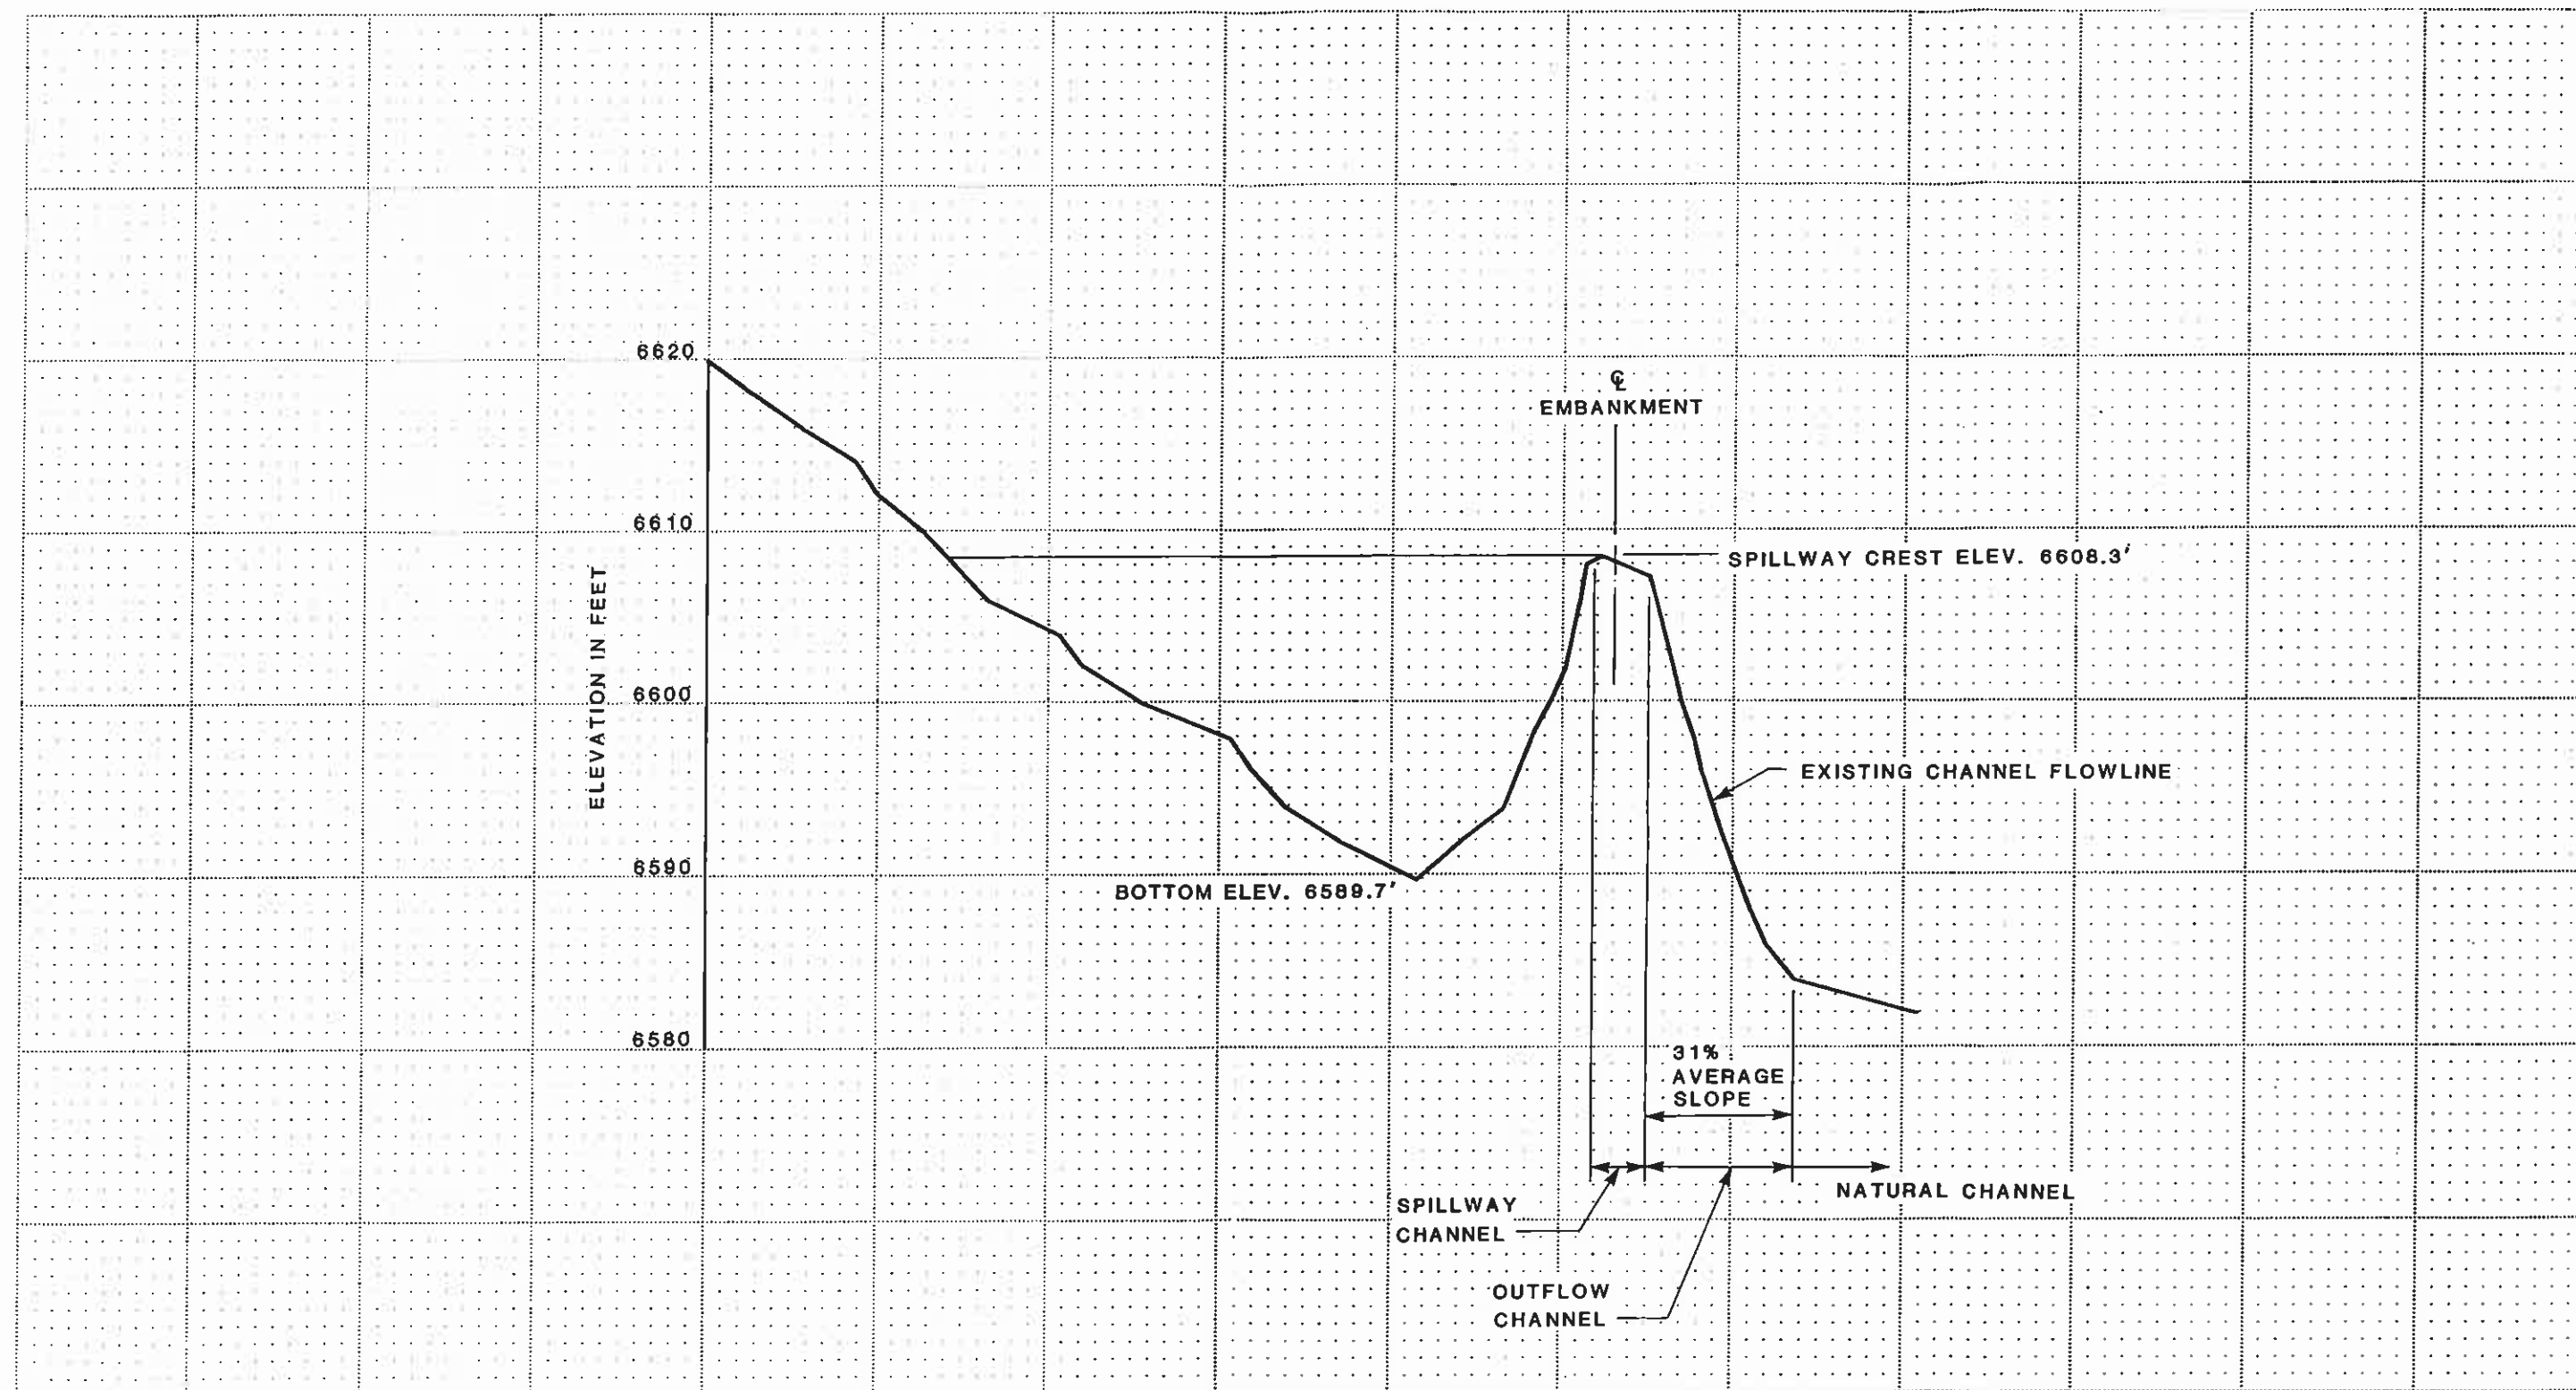
CHANNEL PROFILE B-B'
J16-E

There is presently no erosion protection within the channel.

The inspection of Structure J16-E indicated that the only geotechnical problem is rill erosion on the upstream and downstream slopes and the side slopes of the spillway channel. Correction of erosion is considered a periodic maintenance task and does not require remedial action.

The storage capacity and spillway capacity of Structure J16-E are adequate. The outflow channel is protected with riprap but the spillway channel is not. The spillway channel should be protected against erosion using geotextile and gravel as shown in Plate 5. Plate 4 shows the existing spillway and outflow channel profile and Plate 5 shows the channel dimensions.

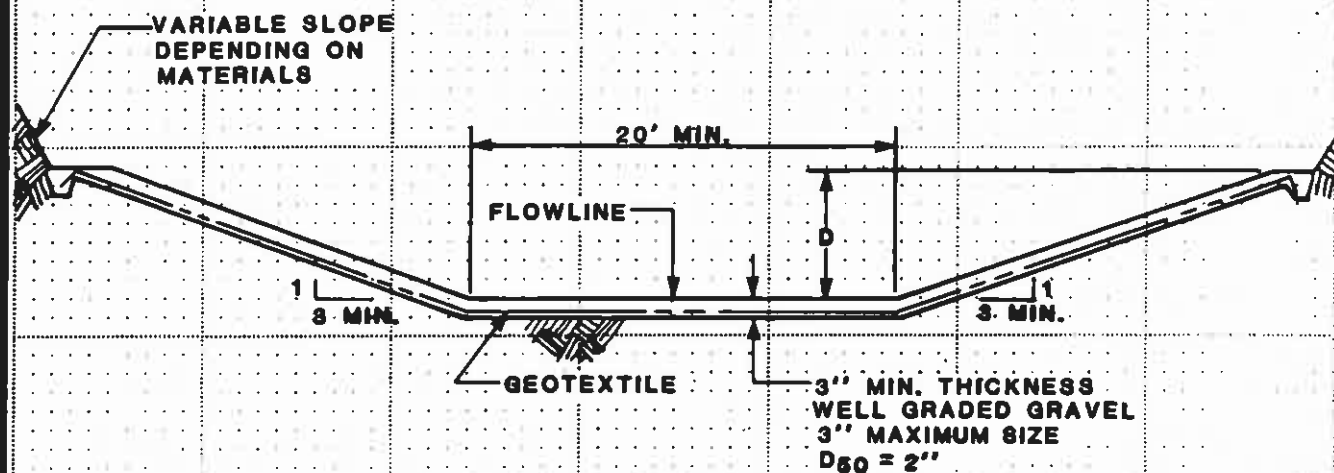
**SPILLWAY AND
 OUTFLOW CHANNEL
 CROSS SECTION
 J16-E**

Rock provides erosion protection within the channel.
