INSPECTION REPORT
Sedimentation Structure
J16-F
Kayenta Mine
Navajo County, Arizona
for
PEABODY COAL COMPANY

Dames & Moore
10139-011-22

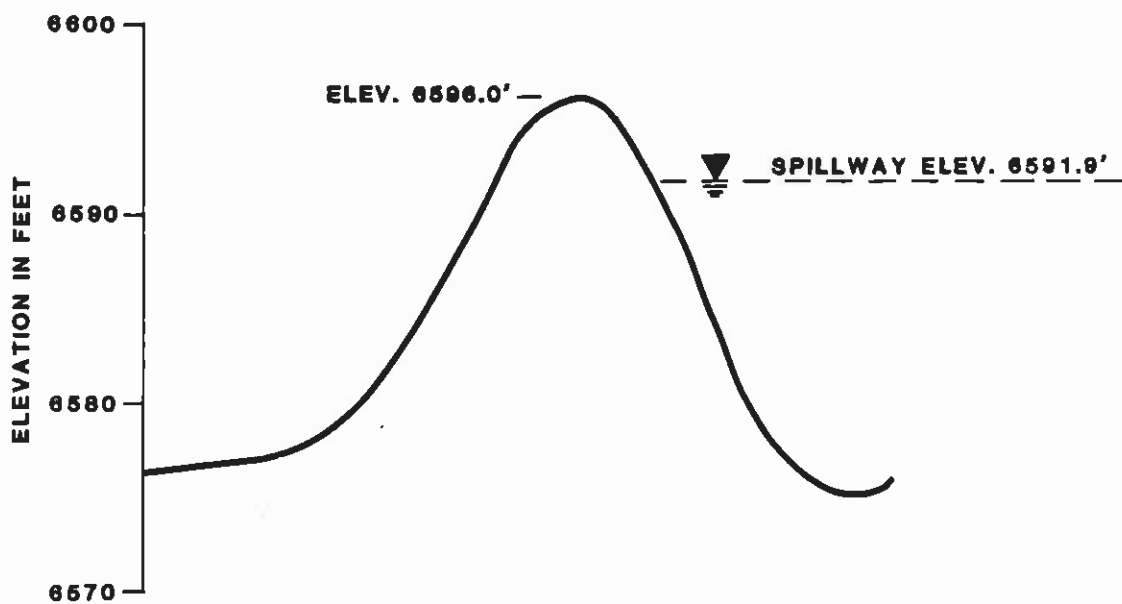
Plate 2

A cross-section of the embankment is shown on Plate 2, Existing Maximum Cross Section J16-F, A-A'. Grass provides erosion protection on the downstream slope of the embankment.

The J16-F embankment is lower in height and has flatter slopes than the category standard; therefore, the embankment has factors of safety greater than the design minimum.

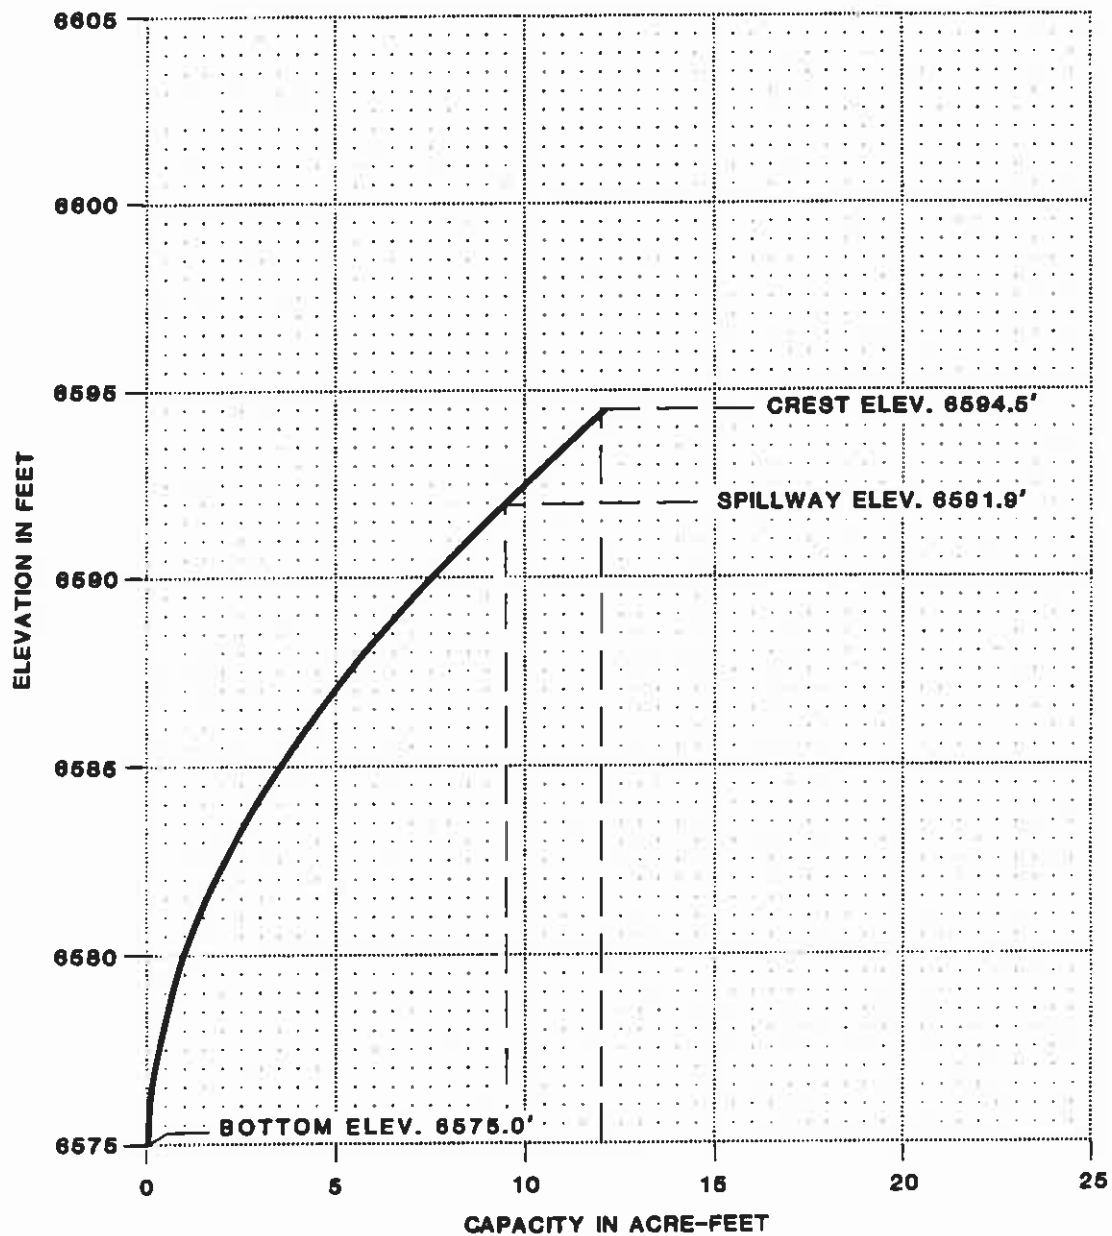
VOLUME-ELEVATION
CURVE
J16-F

The impoundment volume-elevation curve is based on site specific surveys conducted for Peabody Coal Company's August 1984 inspection, and 1985 resurveys, where available. Additionally, the most current topographic maps available were used in developing Plate 3, Volume-Elevation Curve, J16-F.

Total Storage Capacity	9.34	acre-ft
10-year, 24-hour Storm Inflow	2.04	acre-ft
Available Sediment Storage Capacity	7.3	acre-ft
Sediment Inflow Rate	0.167	acre-ft/yr
Sediment Storage Life	44	yrs

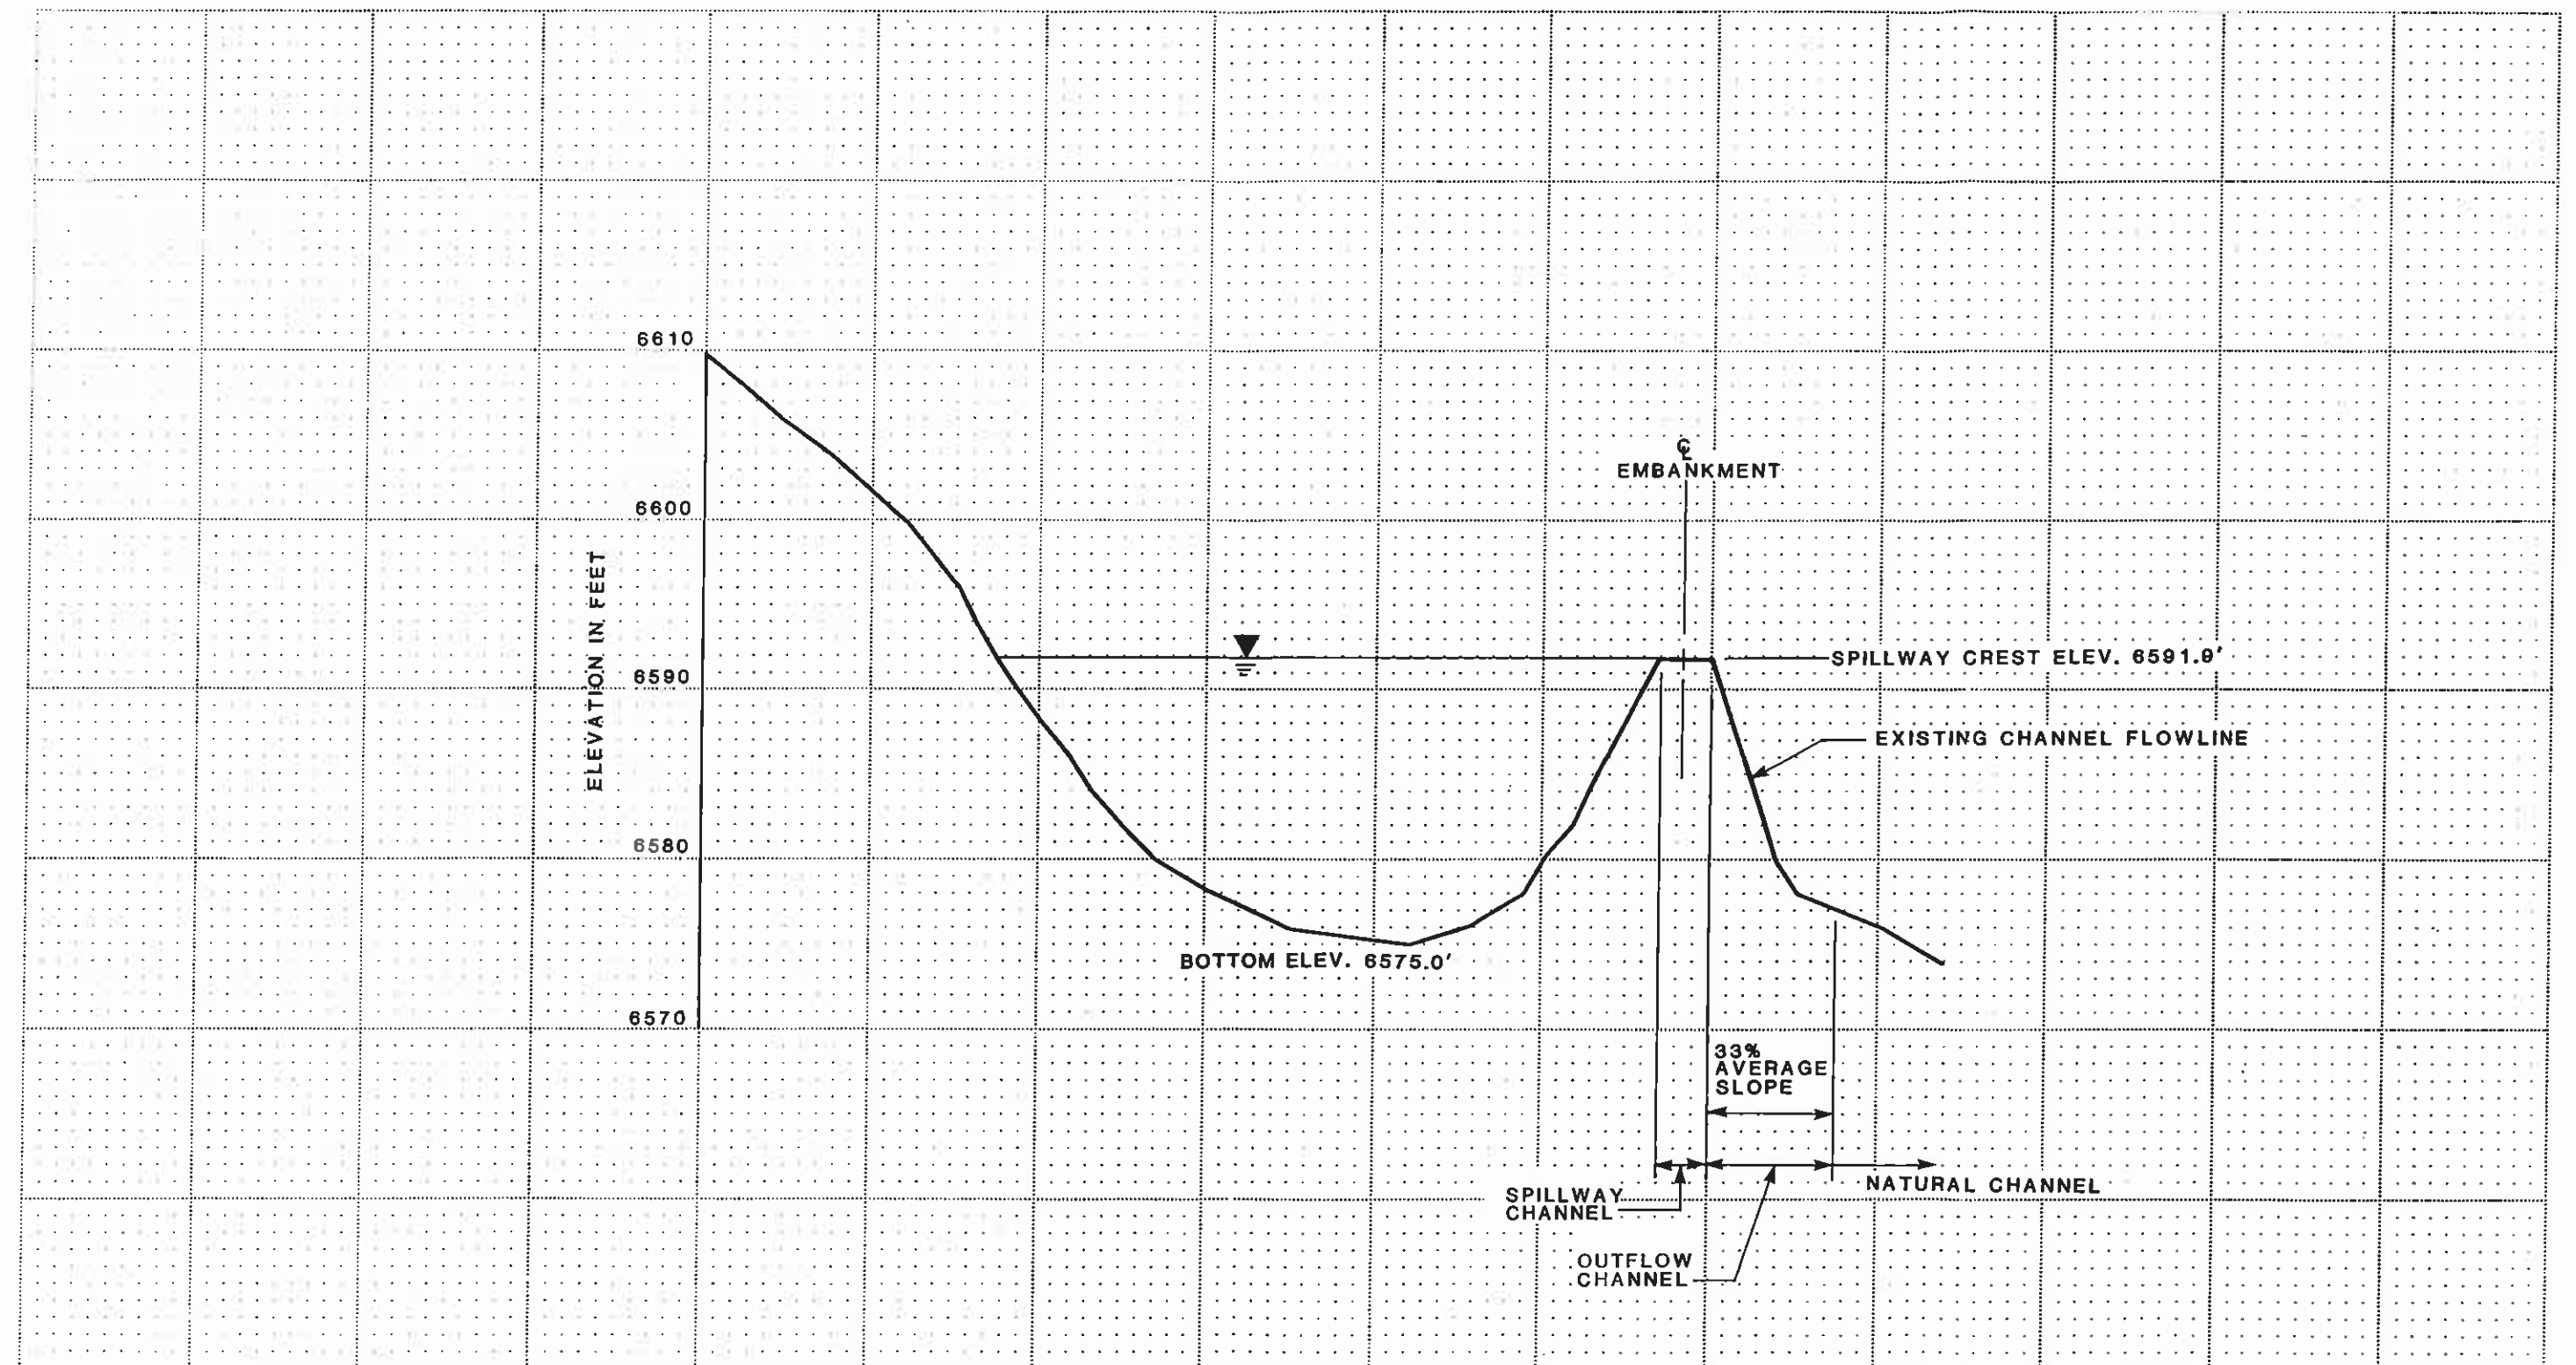
There is presently no erosion protection within the channel.

Rock provides no erosion protection within the channel.

The storage capacity and spillway capacity of Structure J16-F are adequate. The outflow channel is protected with riprap but the spillway channel is not. The spillway channel should be protected against erosion using geotextile and riprap as shown in Plate 5. Plate 4 shows the existing spillway and outflow channel profile and Plate 5 shows the channel dimensions.
