INSPECTION REPORT

Sedimentation Structure

J16-G

Kayenta Mine

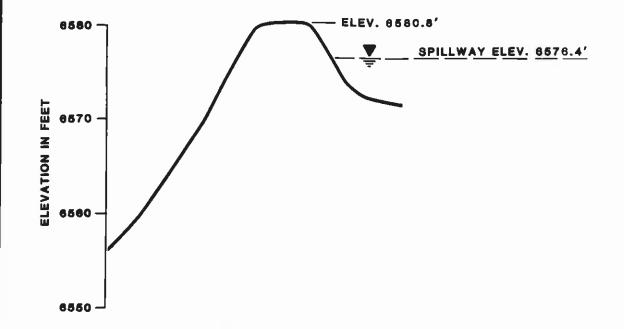
EXISTING
MAXIMUM CROSS-SECTION
A-A'
J16-G

The J16-G embankment is lower in height; however, the downstream slope is steeper than the category standard; therefore, the embankment has factors of safety less than the design minimum.

The inspection of Structure J16-G indicated that the geotechnical problems consist of rill and gully erosion on the upstream and downstream slopes and the side slopes and bottom of the spillway channel. Correction of erosion is considered a periodic maintenance task and does not require remedial action. The upstream and downstream slopes of the embankment are uneven and should be trimmed smooth to prevent masking of future potential problems. The downstream slope should be flattened to 4.0 horizontal to 1 vertical to meet stability requirements.

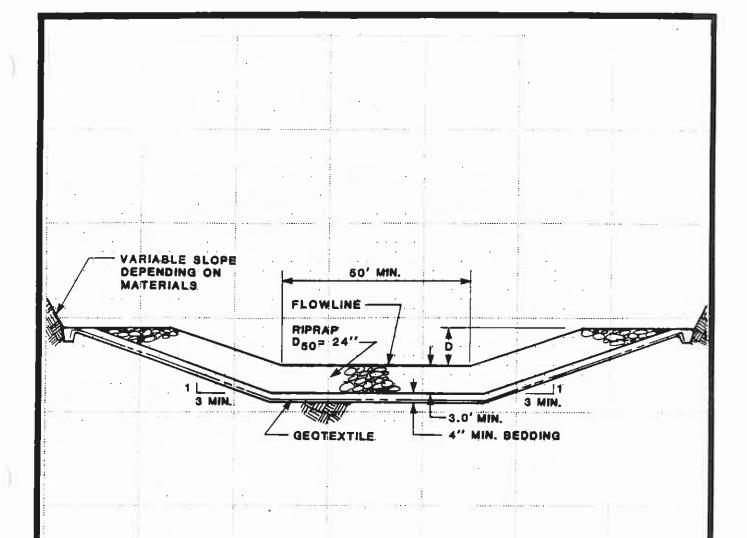
SPILLWAY AND OUTFLOW CHANNEL CROSS SECTION J16-G

Rock provides some but inadequate erosion protection within the channel.

The structure presently has no outflow channel.

The storage capacity and spillway capacity of Structure J16-G are adequate; however, the spillway does not have an adequate outflow channel. A trapezoidal outflow channel and a stilling basin should be constructed along the alignment B-B' shown in Plate 1. The channel and stilling basin profile is shown in Plate 4 and the required dimensions are shown in Plate 5 and Plate 6. The spillway channel, outflow channel and stilling basin should be protected against erosion using geotextile and riprap as shown in Plate 5.

The present storage capacity of Structure J16-G exceeds 20 acre-feet. The spillway should be lowered to elevation 6576.00 feet to reduce the storage capacity to 19.65 acre-feet. The analysis of these conditions is summarized in the following table.
