INSPECTION REPORT
Sedimentation Structure
J16-I
Kayenta Mine
Navajo County, Arizona

for
PEABODY COAL COMPANY

Dames & Moore
10139-011-22

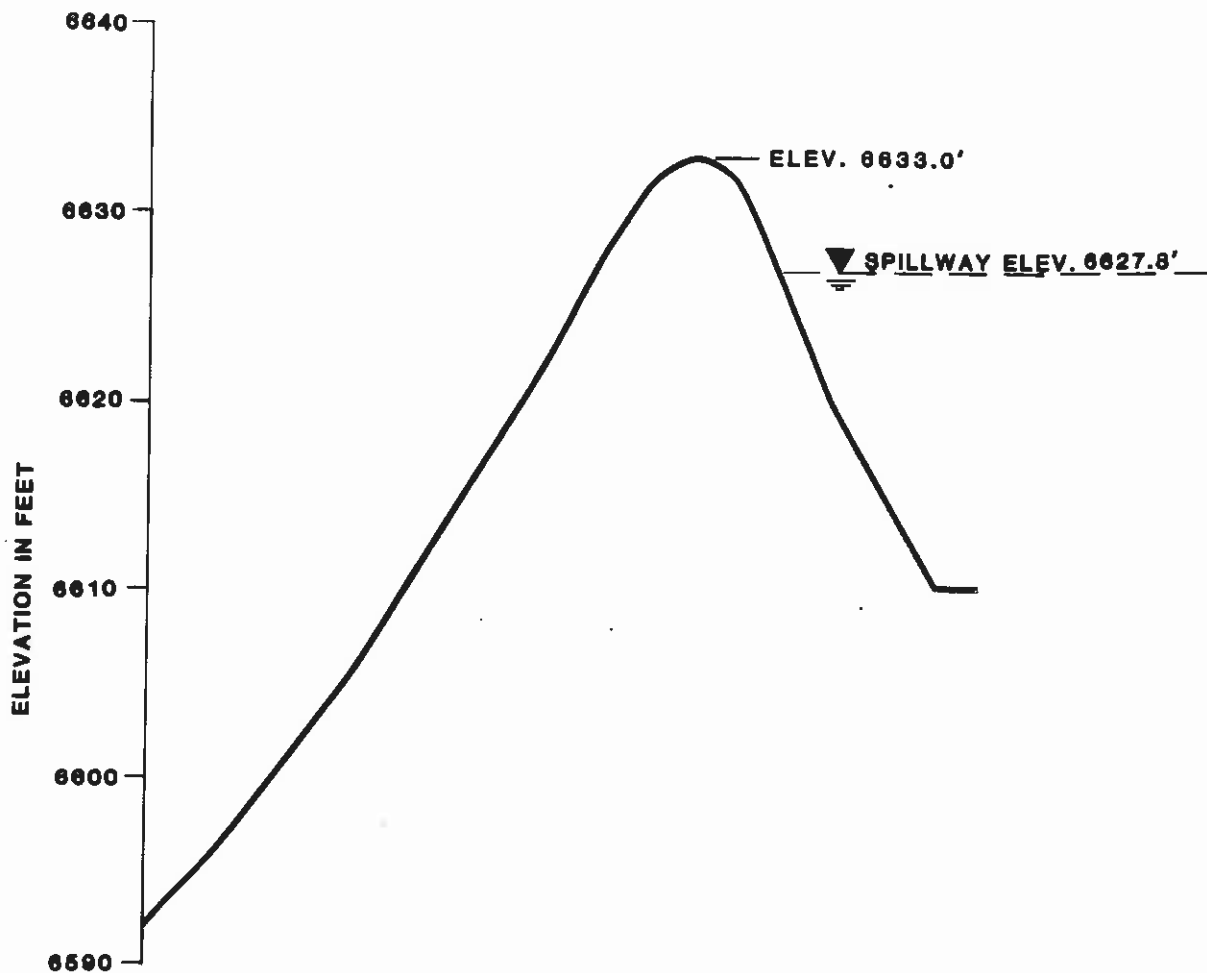
EXISTING
MAXIMUM CROSS-SECTION
A-A'
J16-1

Structure J16-I is a homogeneous earthen embankment classified as a cross-valley embankment. Physical characteristics of the embankment are listed in the following table:

<u>Structure J16-I</u>	
Embankment	Residual Shale Soils
Foundation	Residual Shale Soils
Right Abutment	Residual Shale Soils
Left Abutment	Residual Shale Soils
Height	7.8 ft
Crest Width	20 ft
Upstream Slope	2.2 H : 1 V
Downstream Slope	2.6 H : 1 V

The J16-I embankment is lower in height and has flatter slopes than the category standard; therefore, the embankment has factors of safety greater than the design minimum.

The inspection of Structure J16-I indicated that the only geotechnical problem is rill and gully erosion on the upstream and downstream slopes, the side slopes of the spillway channel and the left abutment. Correction of erosion is considered a periodic maintenance task and does not require remedial action. The crest and downstream slope of the

embankment are uneven and should be trimmed level and smooth, respectively, to prevent masking of future potential problems.

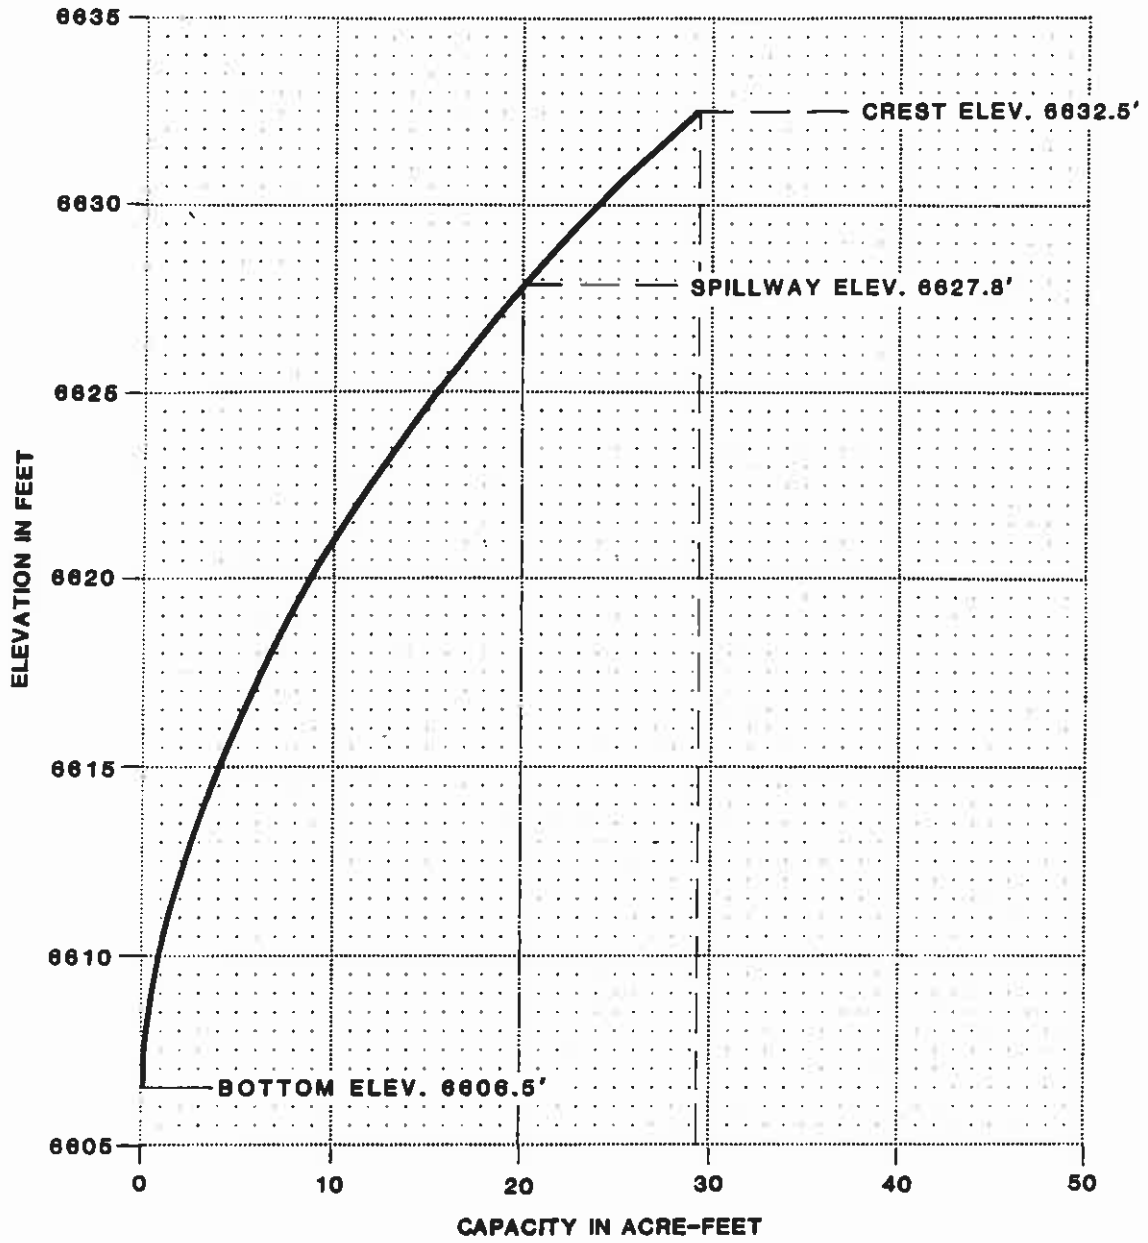
VOLUME-ELEVATION
CURVE

The impoundment volume-elevation curve is based on site specific surveys conducted for Peabody Coal Company's August 1984 inspection, and 1985 resurveys, where available. Additionally, the most current topographic maps available were used in developing Plate 3, Volume-Elevation Curve, J16-I.

Total Storage Capacity	20.0	acre-ft
10-year, 24-hour Storm Inflow	4.10	acre-ft
Available Sediment Storage Capacity	15.9	acre-ft
Sediment Inflow Rate	0.341	acre-ft/yr
Sediment Storage Life	47	yrs

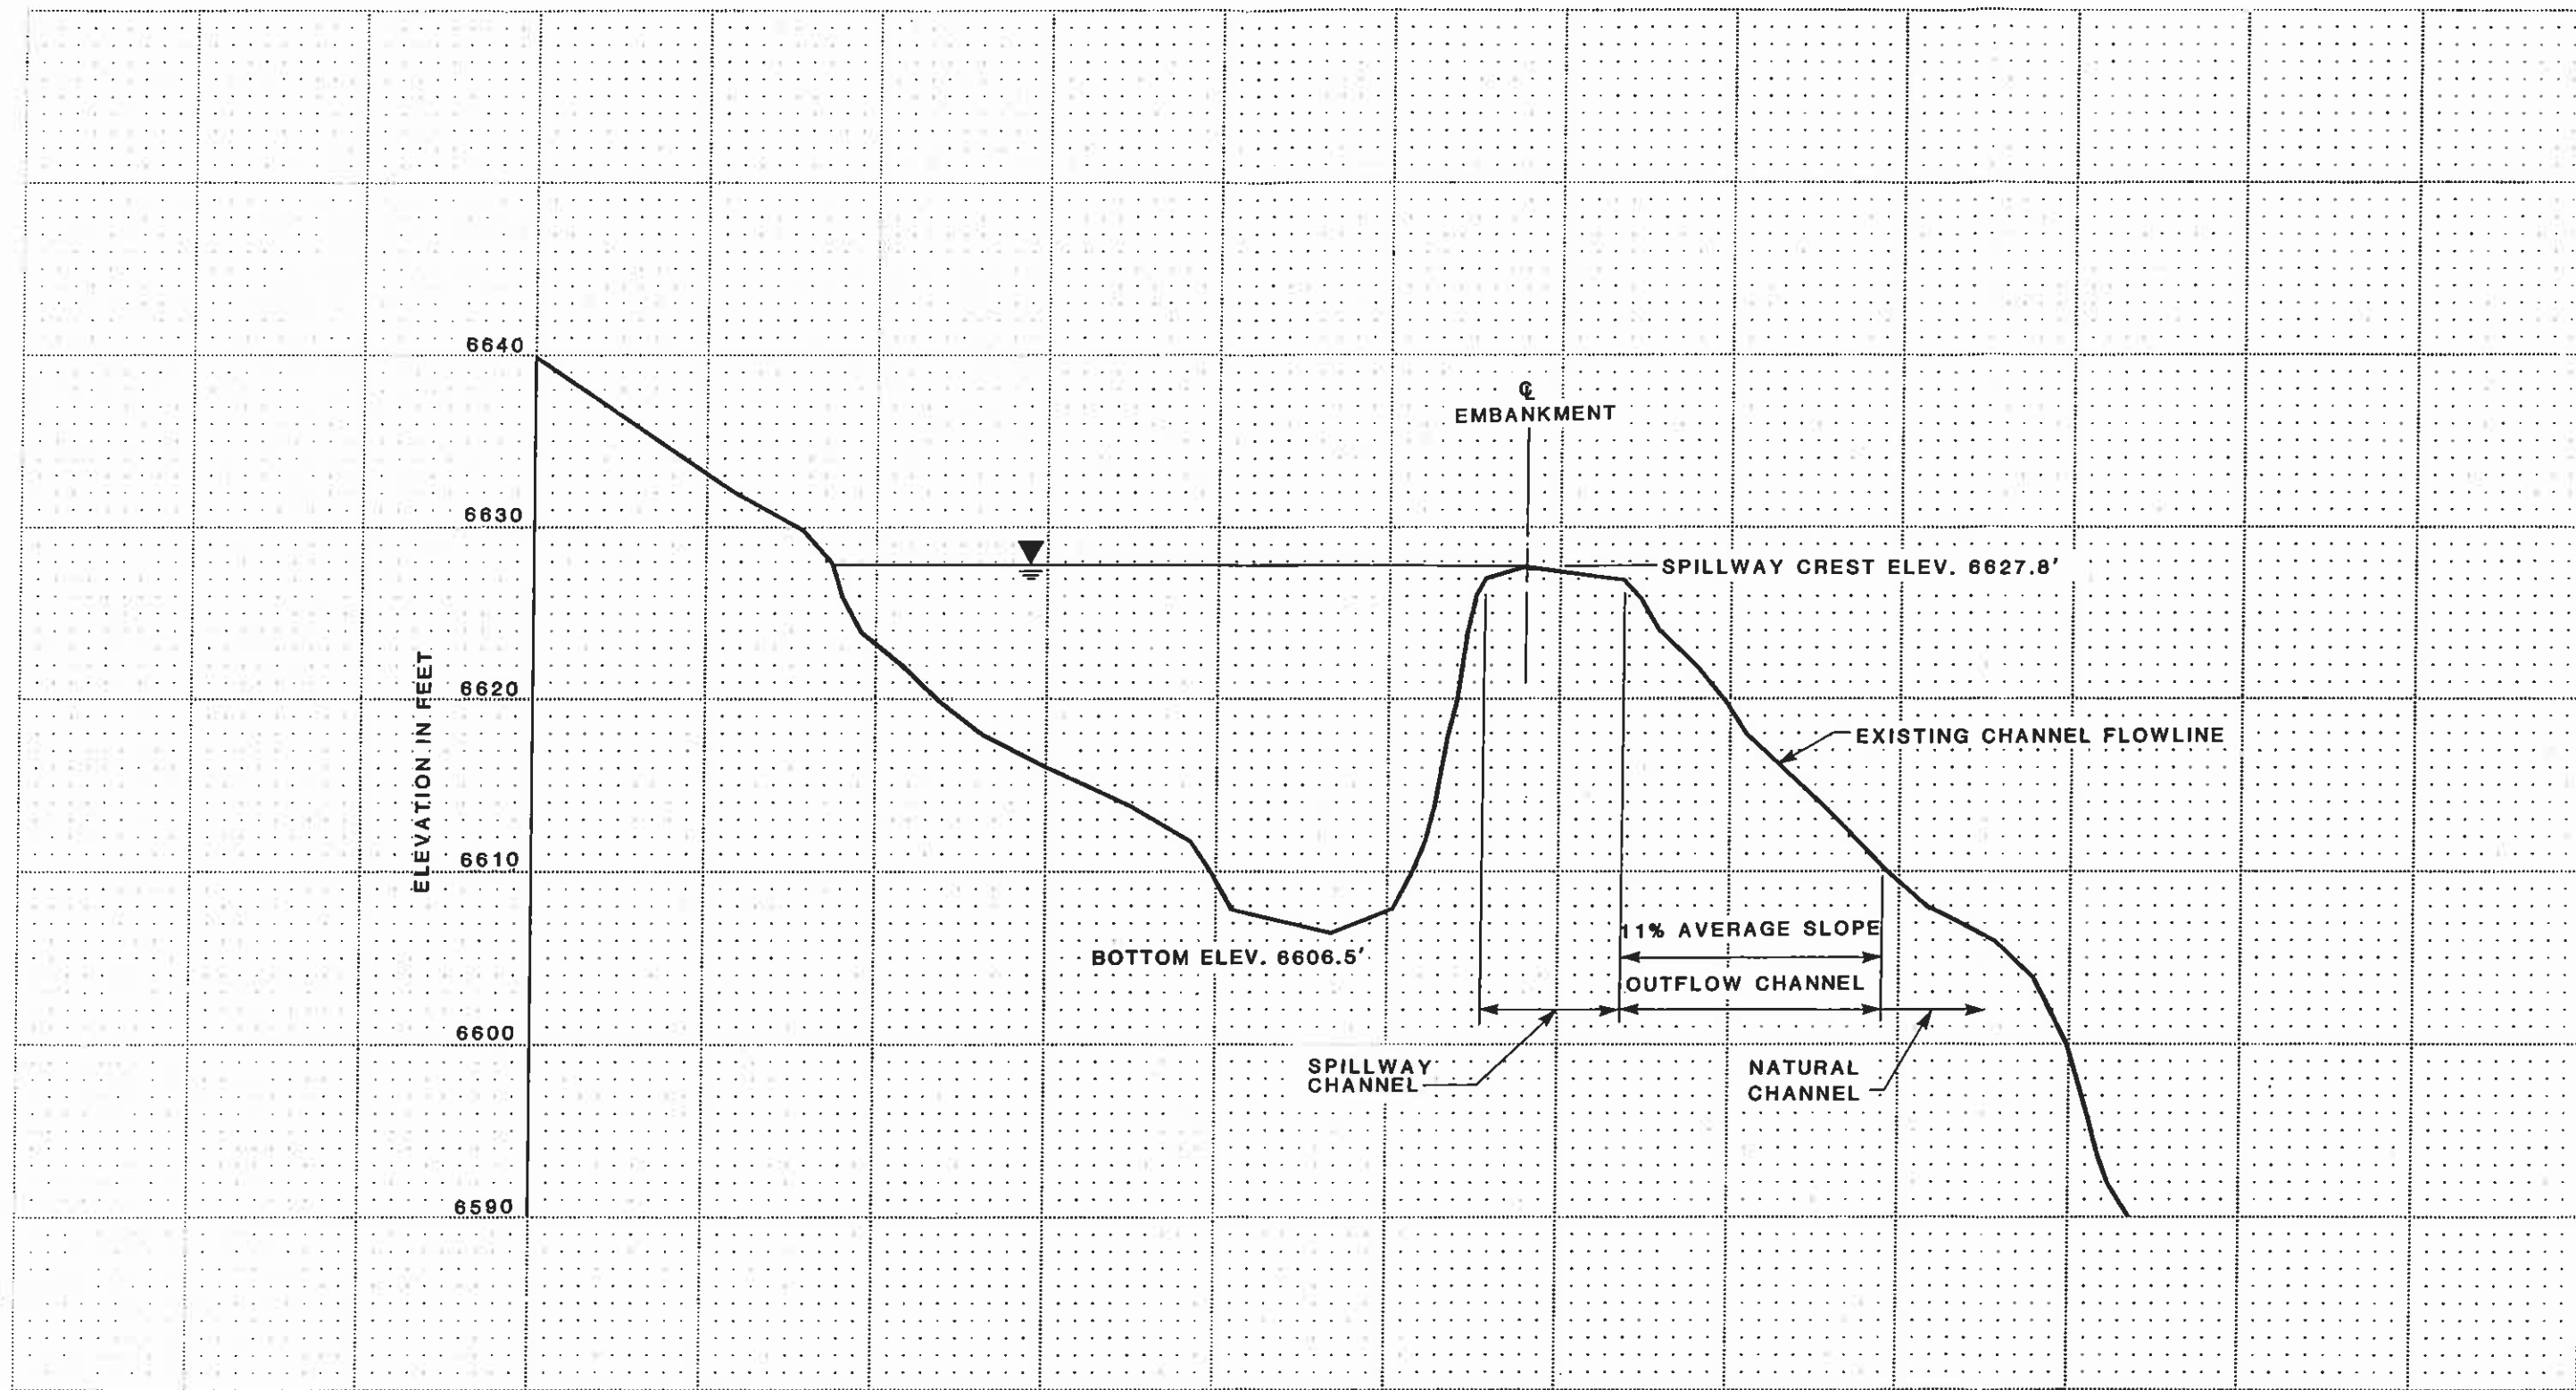
CHANNEL PROFILE B-B'
J16-1

There is presently no erosion protection within the channel.

Rock provides adequate erosion protection within the channel.

The storage capacity and spillway capacity of Structure J16-I are adequate. The outflow channel is protected with riprap but the spillway channel is not. The spillway channel should be protected against erosion using geotextile and gravel as shown in Plate 5. Plate 4 shows the existing spillway and outflow channel profile.

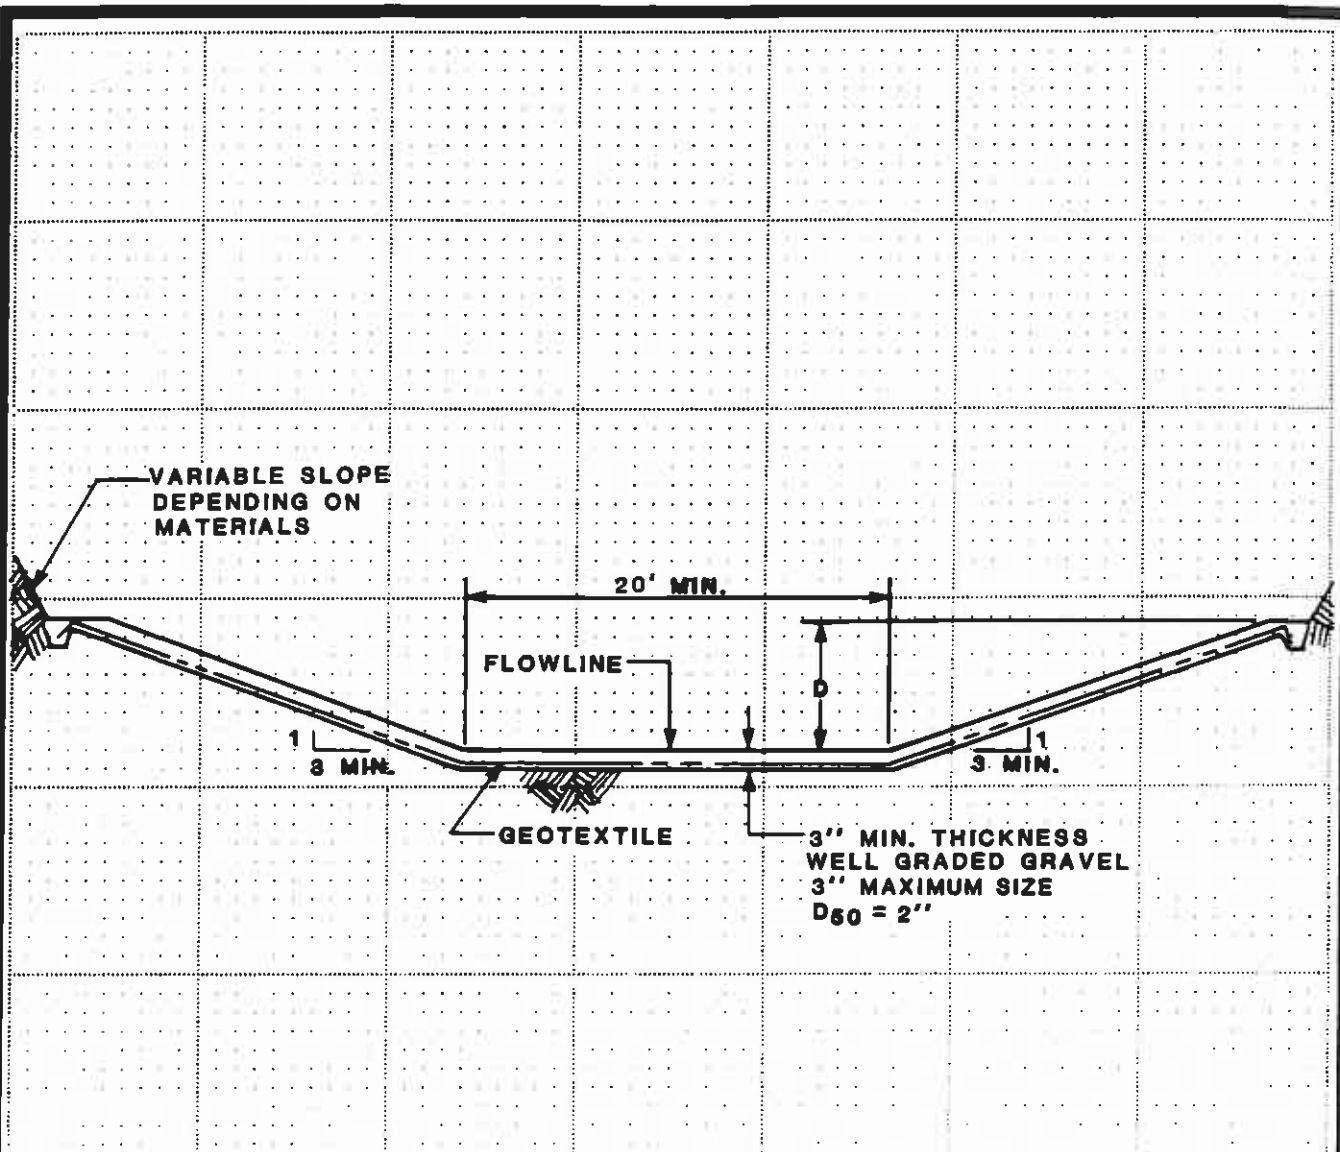
**SPILLWAY CHANNEL
 CROSS SECTION
 J16-1**

Channel depth	5.7 ft
Channel width	25 ft
Channel length	75 ft
Side slopes (horizontal to vertical).	2:1
Average exit slope	0 percent
