INSPECTION REPORT
Sedimentation Structure
J16-J
Kayenta Mine
Navajo County, Arizona
for
PEABODY COAL COMPANY

Dames & Moore
10139-011-22

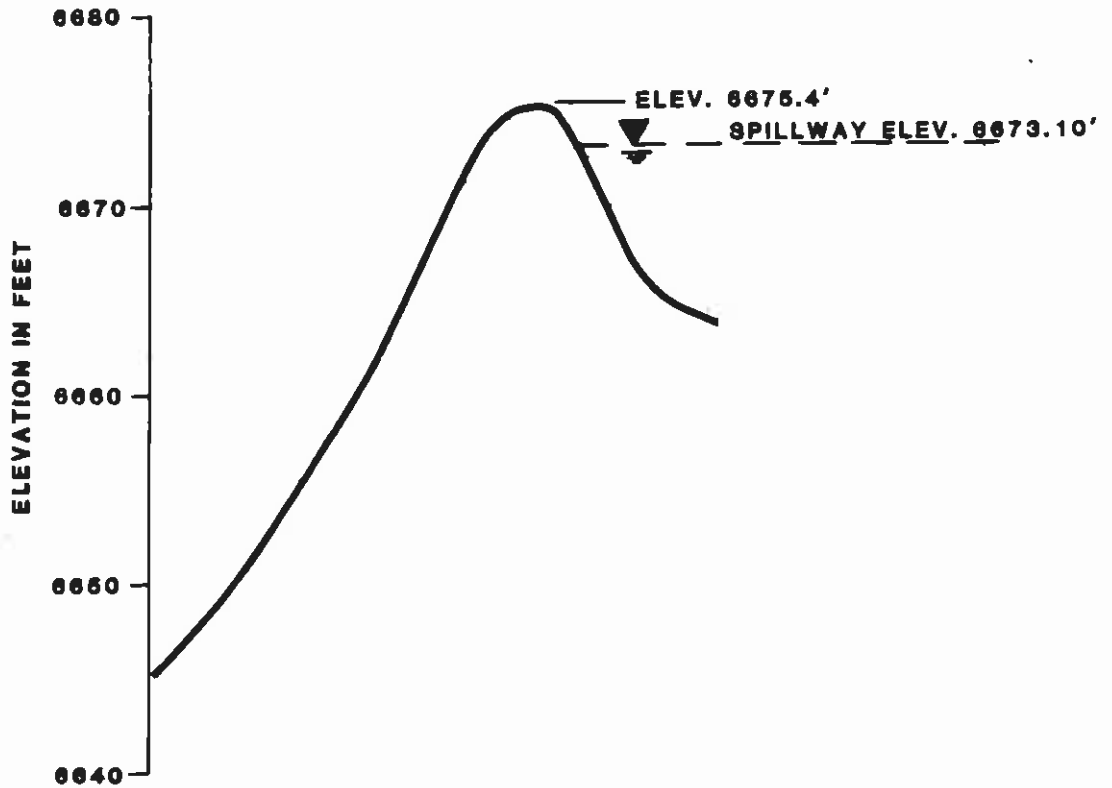
Plate 2

A cross-section of the embankment is shown on Plate 2, Existing Maximum Cross Section J16-J, A-A'.

The J16-J embankment is lower in height; however, the foundation slope is greater than 5 percent and the downstream slope is steeper than the category standard; therefore, the embankment has factors of safety less than the design minimum.

The downstream slope should be flattened to 3.25 horizontal to 1 vertical to meet stability requirements. This flatter slope was selected due to a foundation slope greater than 5 percent.

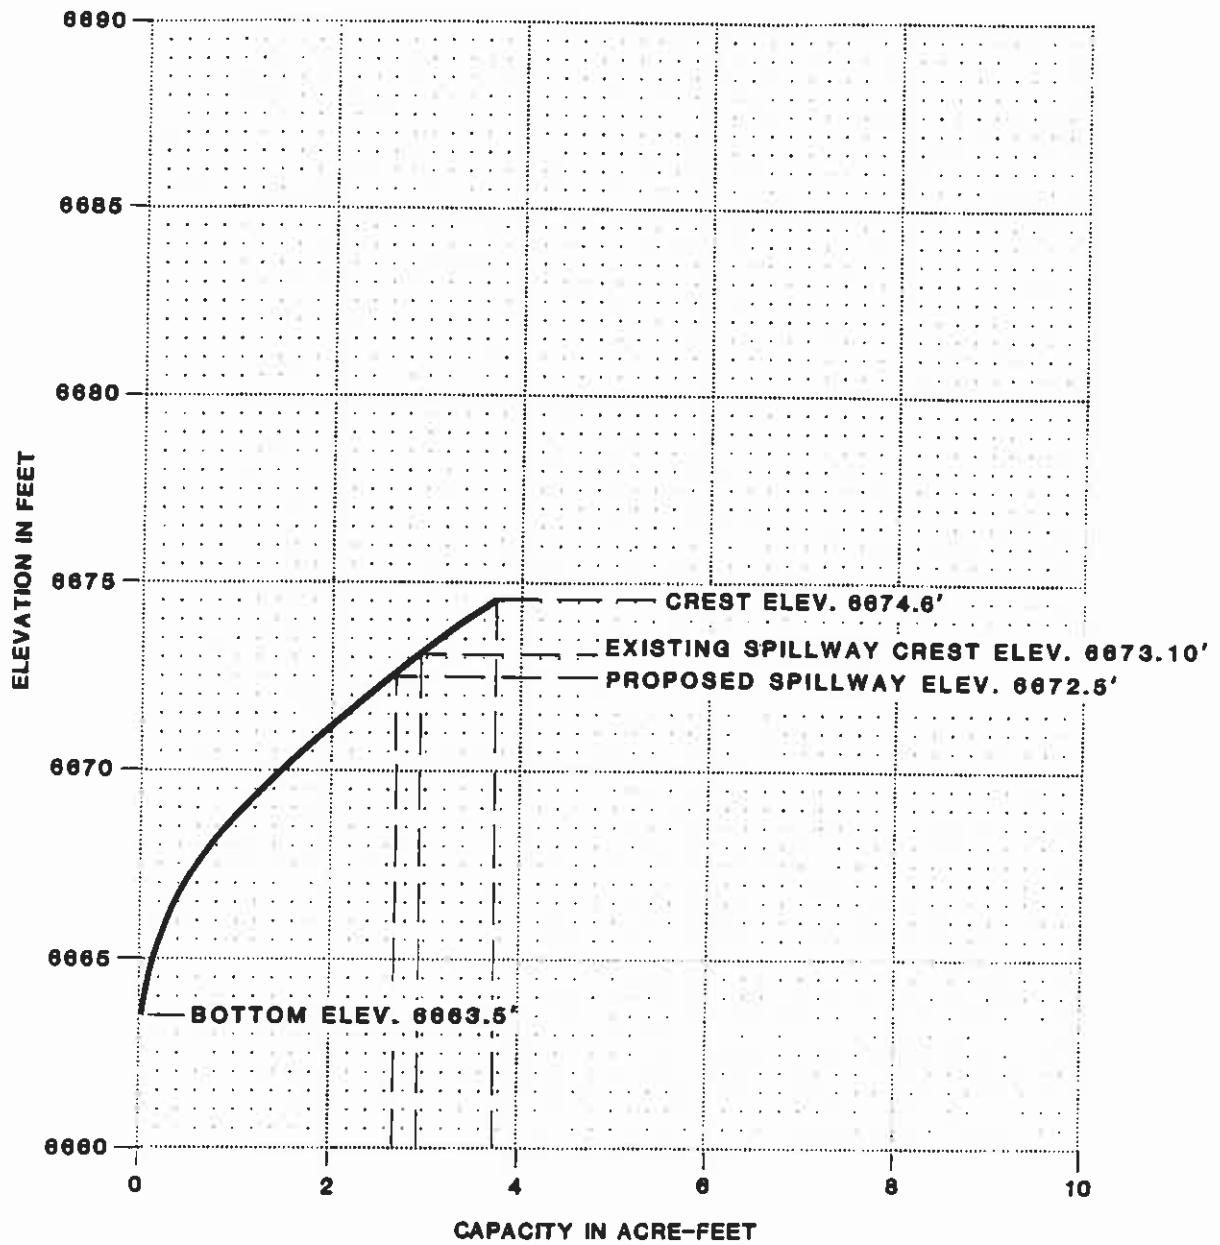
VOLUME-ELEVATION
CURVE

The impoundment volume-elevation curve is based on site specific surveys conducted for Peabody Coal Company's August 1984 inspection, and 1985 resurveys, where available. Additionally, the most current topographic maps available were used in developing Plate 3, Volume-Elevation Curve, J16-J.

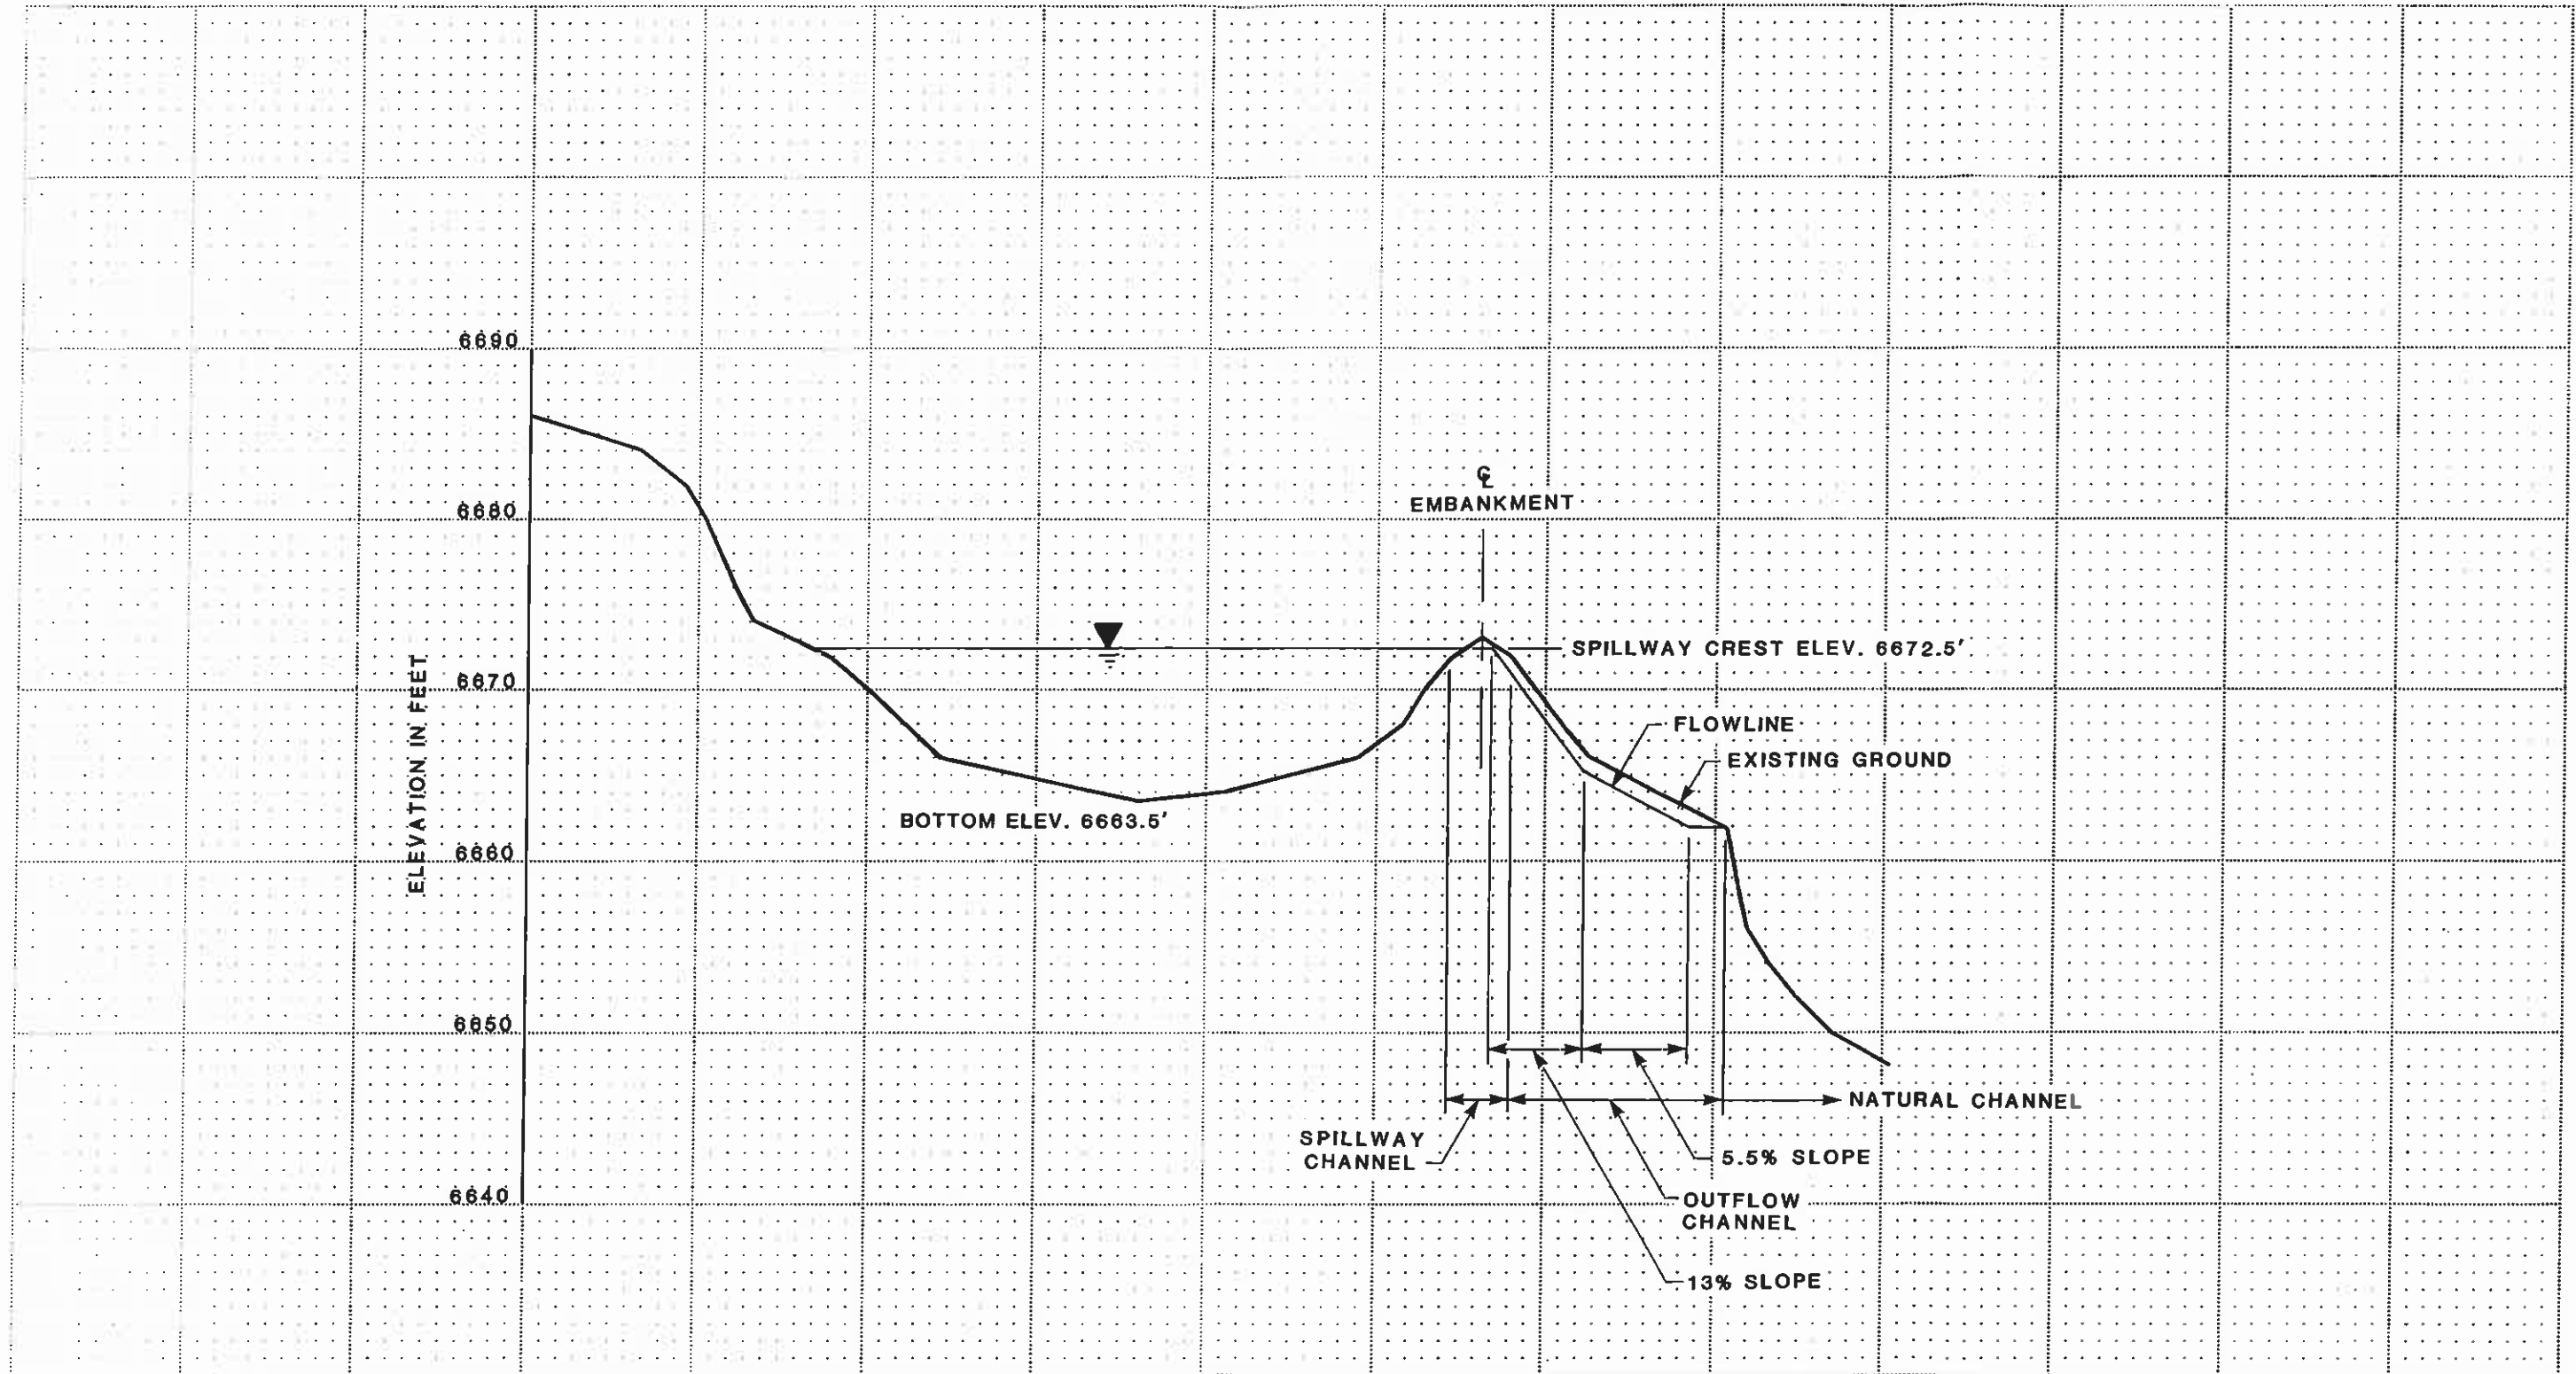
CHANNEL PROFILE B-B'
J16-J

There is presently no erosion protection within the channel.

The structure presently has no outflow channel.

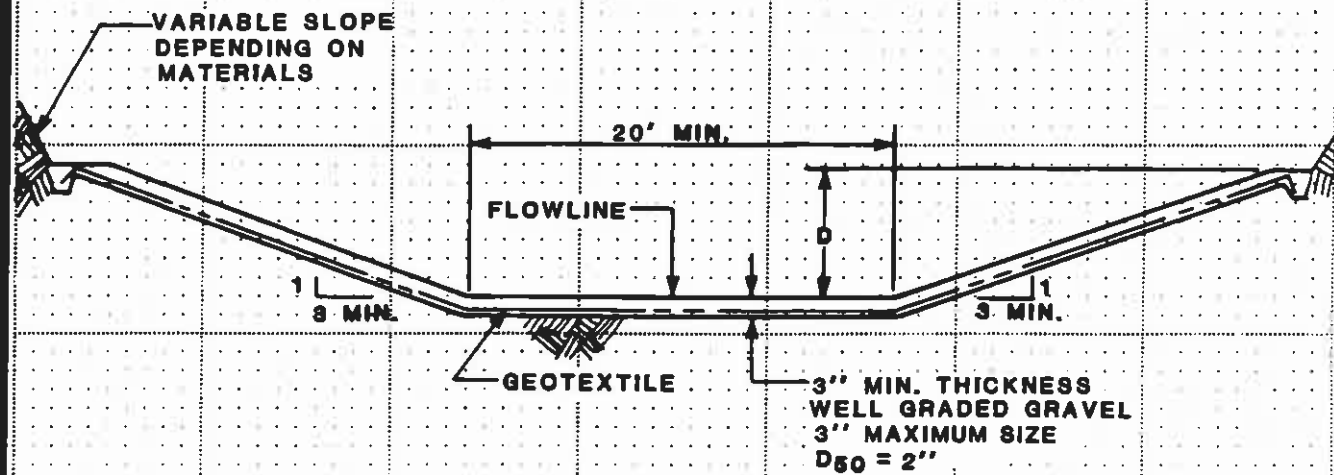
**SPILLWAY AND
 OUTFLOW CHANNEL
 CROSS SECTION
 J16-J**

D = 1.7'
 LENGTH = 40'
 FLOWLINE ELEV. = 6672.50'

D = 1'

The storage capacity of Structure J16-J is adequate but the spillway capacity is inadequate. The structure does not have an adequate outflow channel. The bottom elevation of the existing spillway channel should be lowered to elevation 6672.5 while maintaining the bottom width of 20 feet as shown on Plate 5. A trapezoidal outflow channel with the same bottom width as the spillway should be constructed along the alignment shown in Plate 1. The channel profile is shown in Plate 4 and required dimensions are shown in Plate 5. Both the spillway and outflow channel should be protected against erosion using geotextile and gravel as shown in Plate 5.
