INSPECTION REPORT  
Sedimentation Structure  
J16-K  
Kayenta Mine  
Navajo County, Arizona  
for  
PEABODY COAL COMPANY

Dames & Moore  
10139-011-22

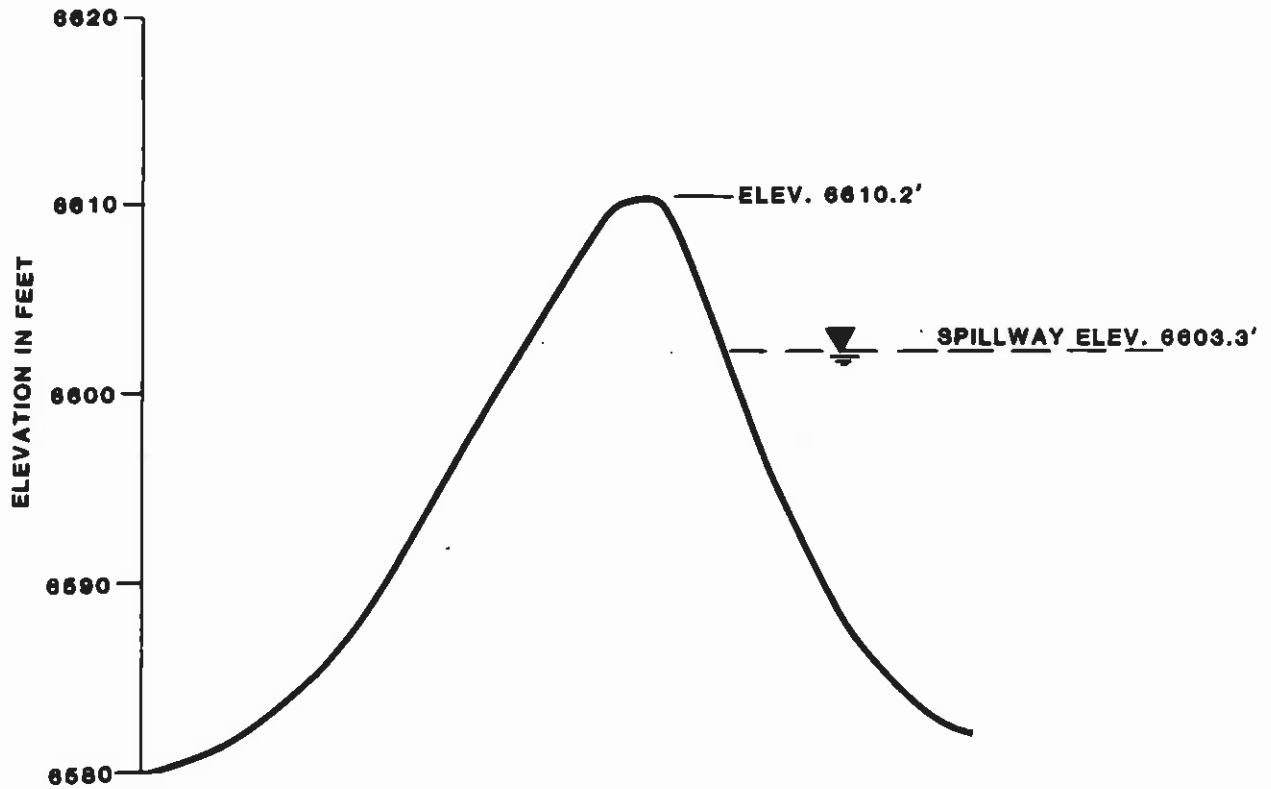
Plate 2

The J16-K embankment is lower in height; however, the downstream slope is steeper than the category standard; therefore, the embankment has factors of safety less than the design minimum.

EXISTING  
 MAXIMUM CROSS-SECTION  
 A-A'  
 J16-K

and does not require remedial action. The downstream slope should be flattened to 4.25 horizontal to 1 vertical to meet stability requirements.

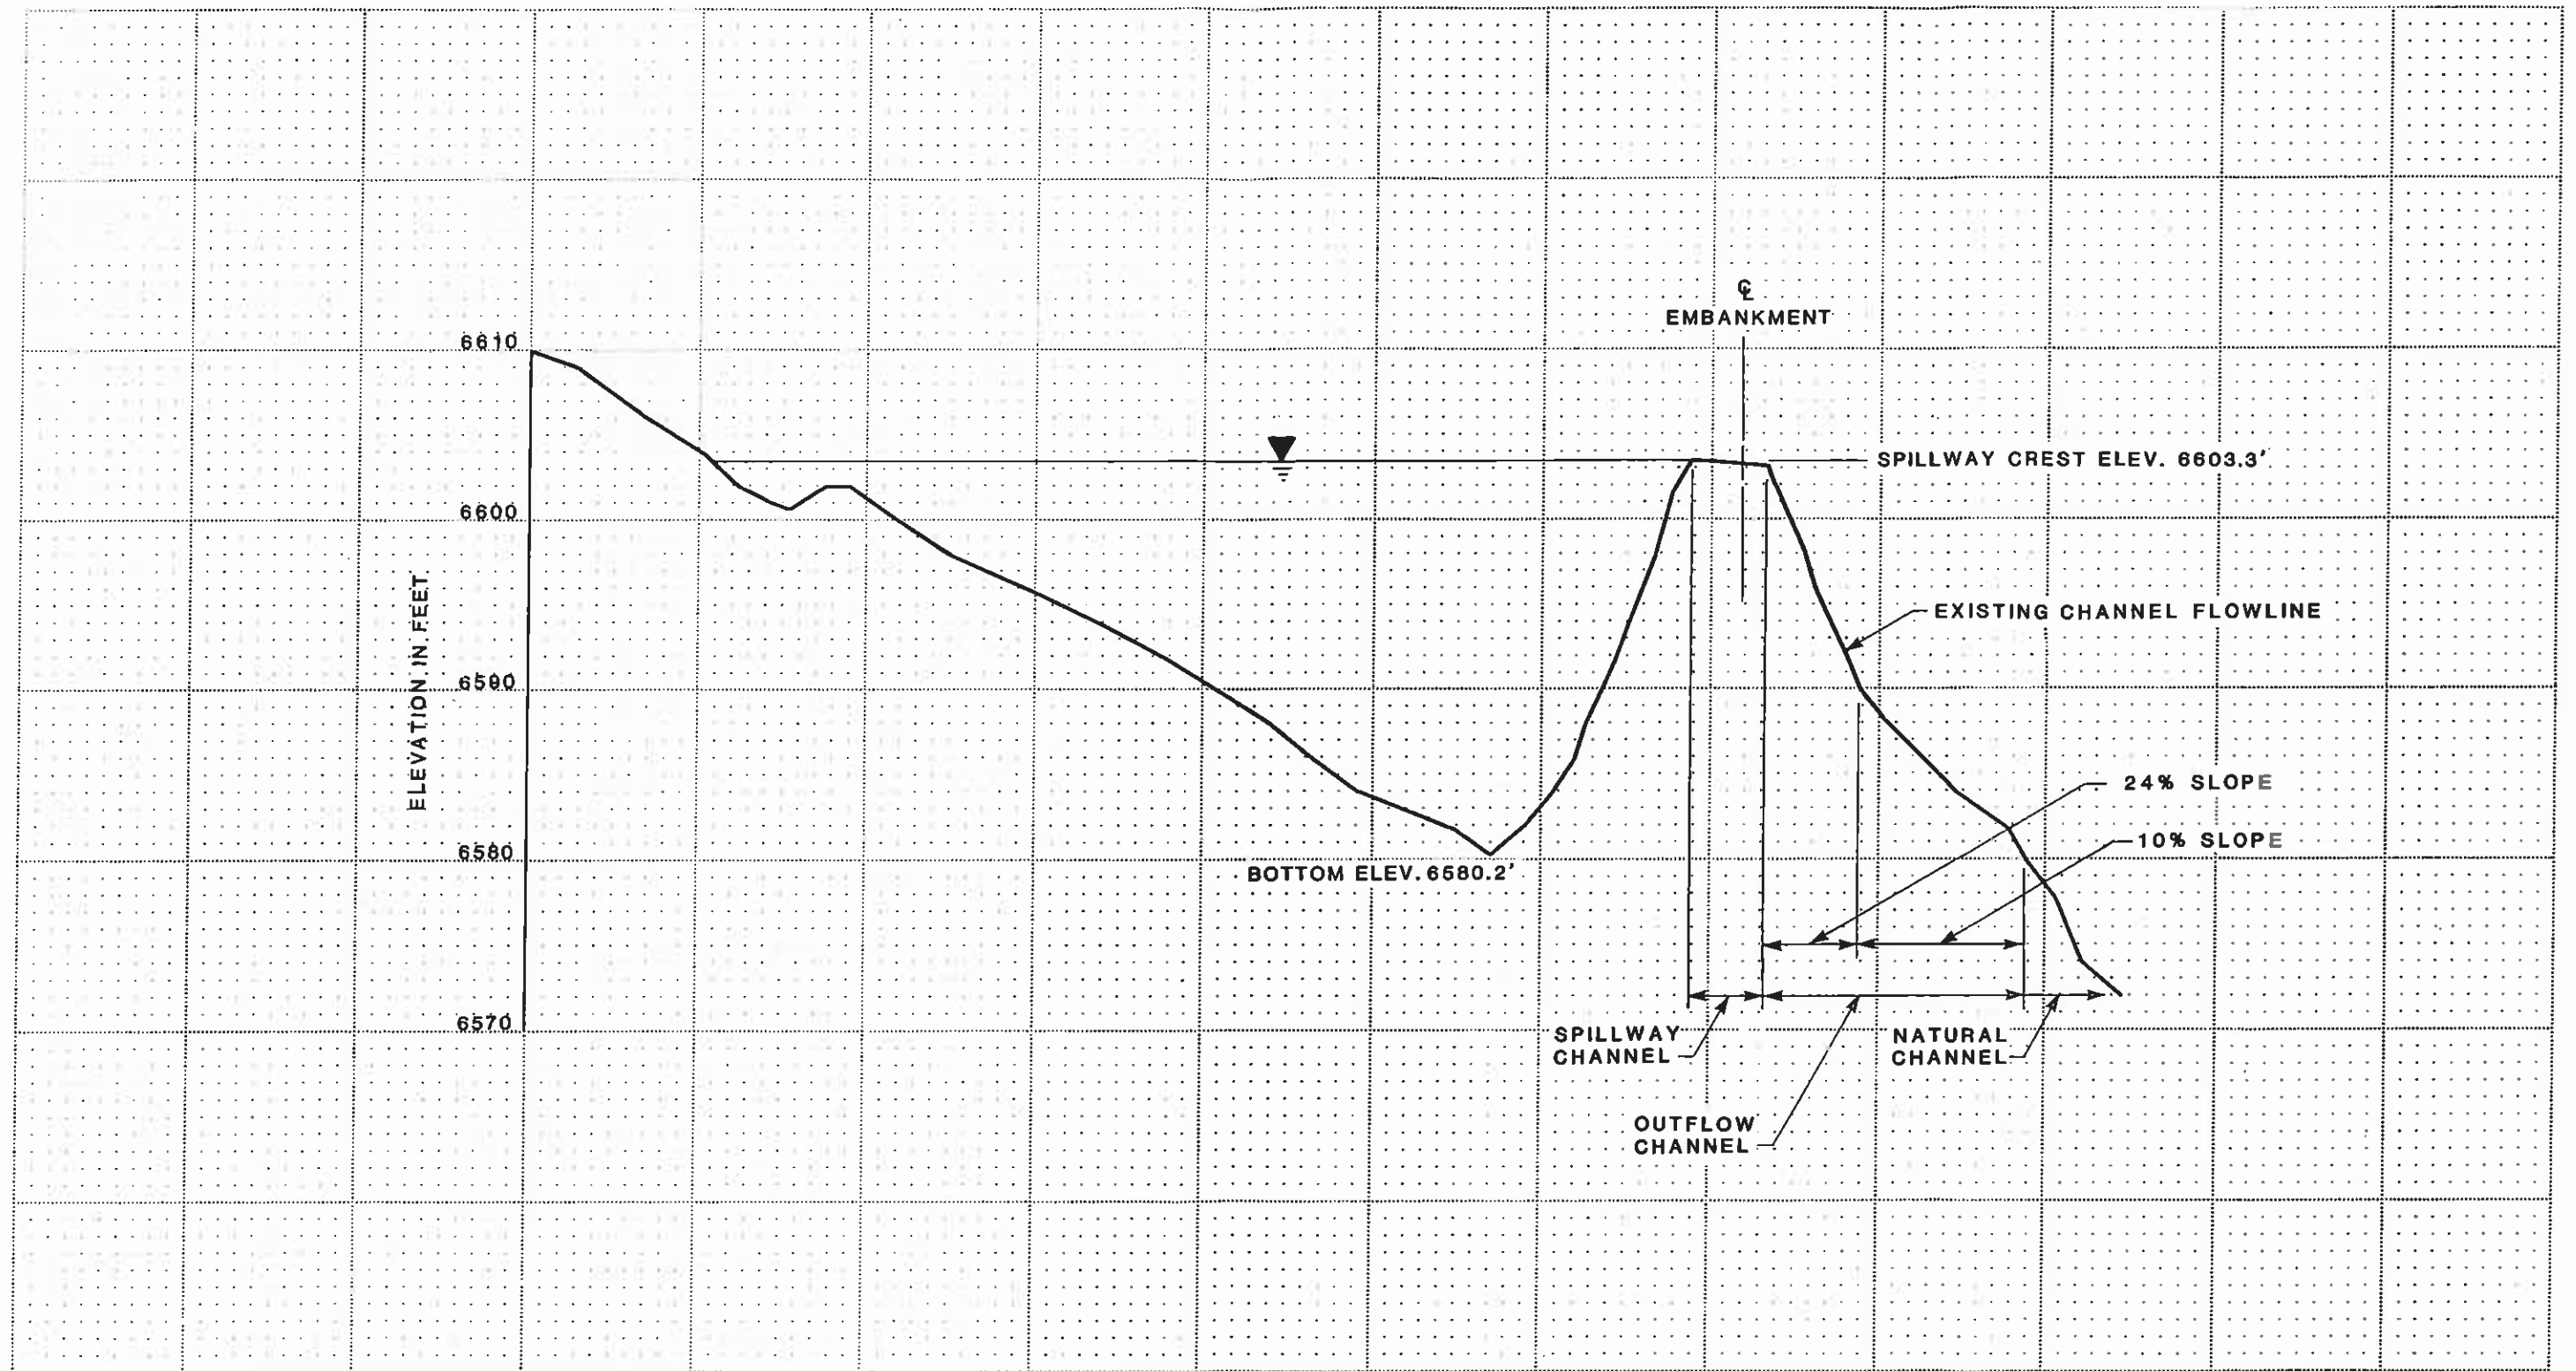
BY **Dames & Moore** Plate 4

There is presently no erosion protection within the channel.

CHANNEL PROFILE B-B'  
J16-K

The storage capacity and spillway capacity of Structure J16-K are adequate. The outflow channel is protected with riprap but the spillway channel is not. The spillway channel should be protected against erosion using geotextile and riprap as shown in Plate 5. Plate 4 shows the existing spillway and outflow channel profile and Plate 5 shows the channel dimensions.

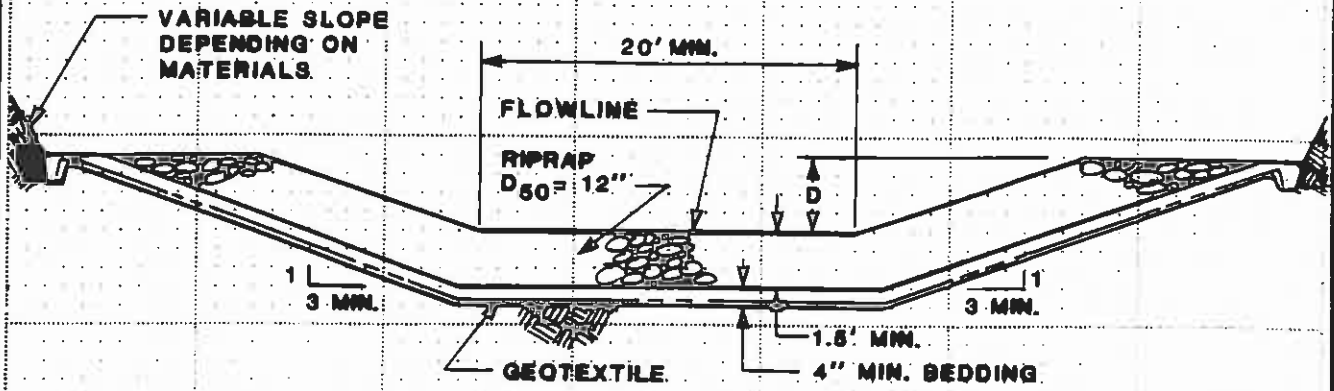
**SPILLWAY CHANNEL  
 CROSS SECTION  
 J16-K**

**SPILLWAY CHANNEL**  
 D = 2.7'  
 LENGTH = 60'  
 FLOWLINE ELEV. = 6603.30'
