PEABODY COAL COMPANY

Black Mesa Mine

Sedimentation Structure

INSPECTION REPORT

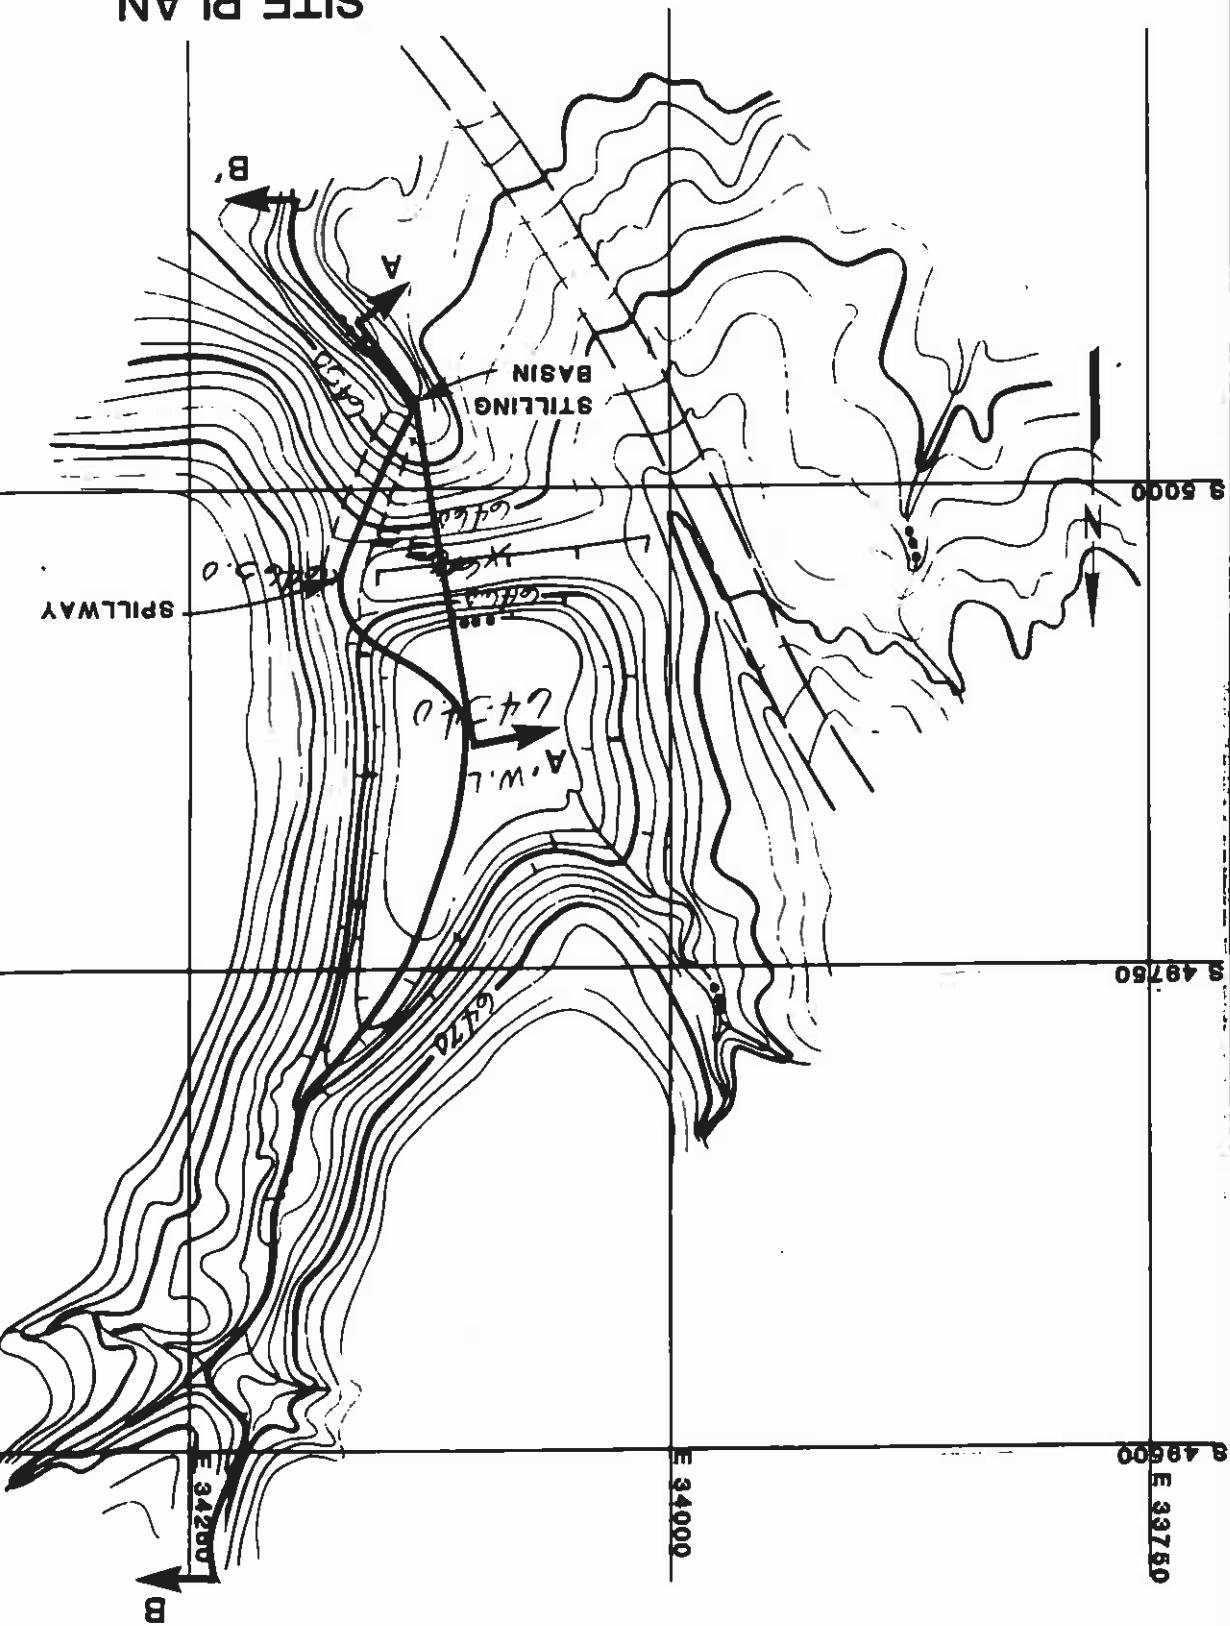
SITE PLAN
J7-F

Sedimentation Structure J7-F is shown on Plate I, Site Plan. This inspection report contains information specific to Structure J7-F. Regional site information is presented in the "General Report, Company" as a temporary sedimentation structure to control runoff and sediment from the disturbed mining areas of the Black Mesa Mine. The location of Structure J7-F is shown on Plate I, Site Plan.

and spilling basin should be protected against erosion using geotextile and
dimensions are shown in Plate 5 and Plate 6. The spillway, outflow channel
channel and spilling basin profile is shown in Plate 4 and the required
basin should be constructed along the alignment B-B', shown in Plate 1. The
adequate erosion protection. A trapezoidal outflow channel and a spilling
adequate; however, the spillway does not have an adequate outflow channel or
The storage capacity and spillway capacity of Structure J7-F are

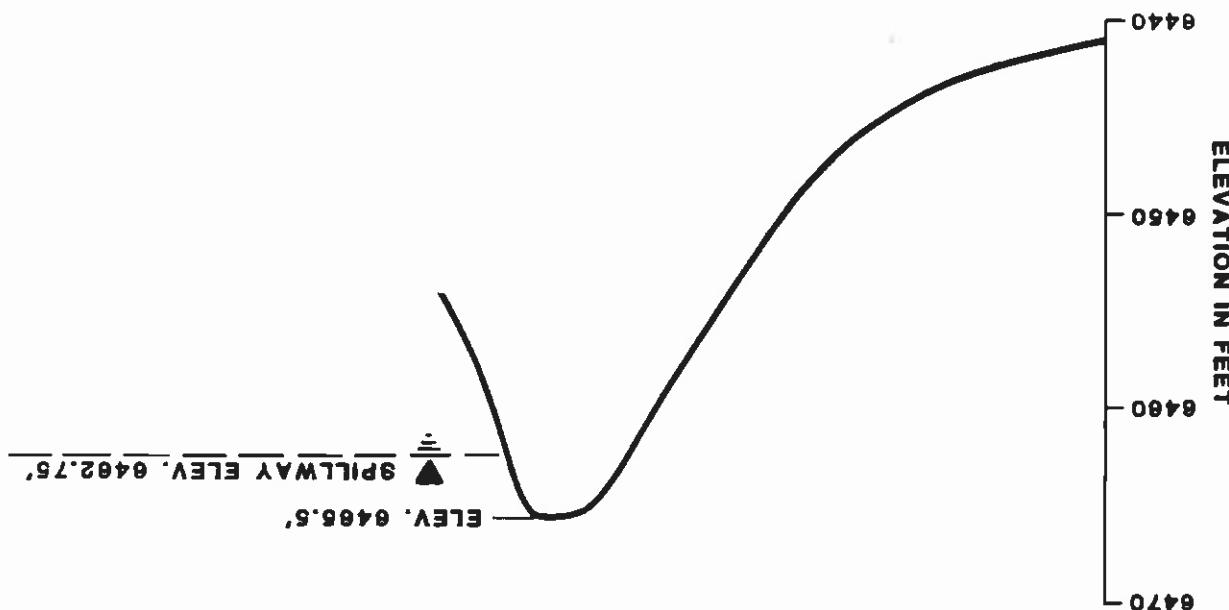
MAXIMUM CROSS-SECTION
EXISTING

Embankment	Residual Shale/Sandstone Soils
Foundation	Residual Sandstone Soils
Right Abutment	Residual Sandstone Soils
Left Abutment	Residual Sandstone Soils
Height	5.4 ft
Creep Width	12.5 ft
Upstream Slope	1.75 H : 1 V
Downstream Slope	2.9 H : 1 V

Cross-valley embankment. Physical characteristics of the embankment are structure J7-F is a homogeneous earthen embankment classified as a

The J7-F embankment is lower in height and has flatter slopes than the category standard; therefore, the embankment has factors of safety greater than the design minimum.

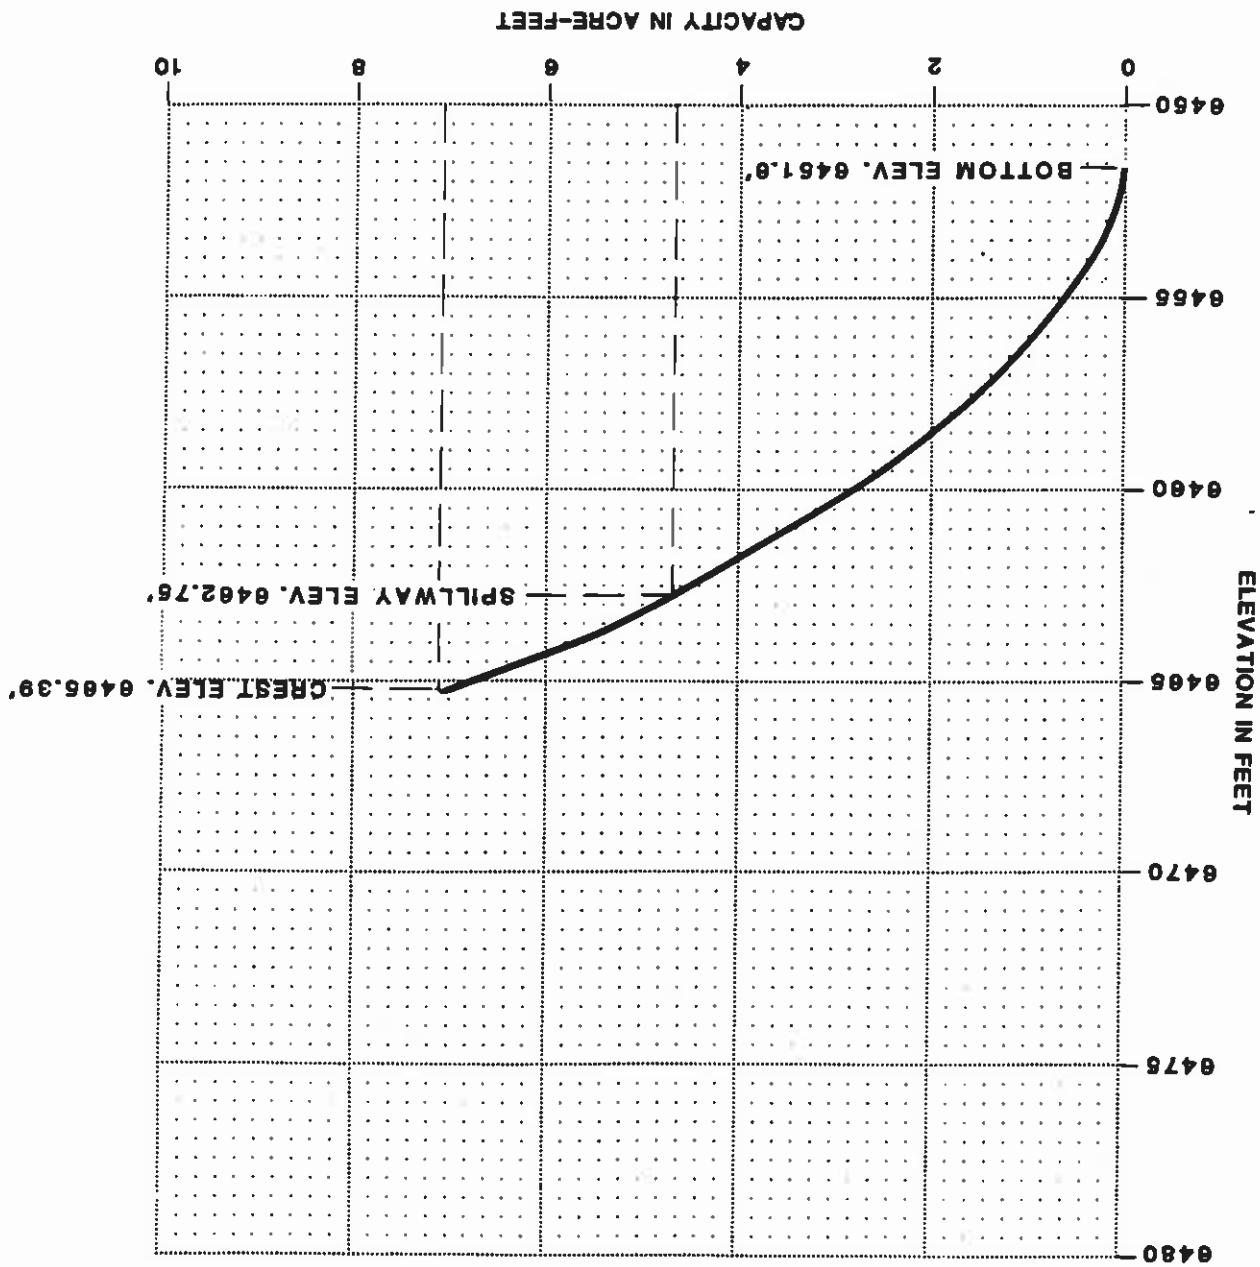
J7-F
CURVE
VOLUME-ELEVATION

Total Storage Capacity	4.65 acre-ft	10-year, 24-hour Storm Inflow	3.35 acre-ft	Available Sediment Storage Capacity	1.31 acre-ft	Sediment Inflow Rate	0.218 acre-ft/yr	Sediment Storage Life	6 yrs
----------------------------------	--------------	---	--------------	---	--------------	--------------------------------	------------------	---------------------------------	-------

The hydrologic analysis gives the storage volume required to contain the 10-year, 24-hour storm, and the remaining storage volume available for storing sediment. The existing storage capacity of J7-F is shown on Plate 3, Volume-Elevation Curve, J7-F, and the results of the analysis are summarized in the following table.

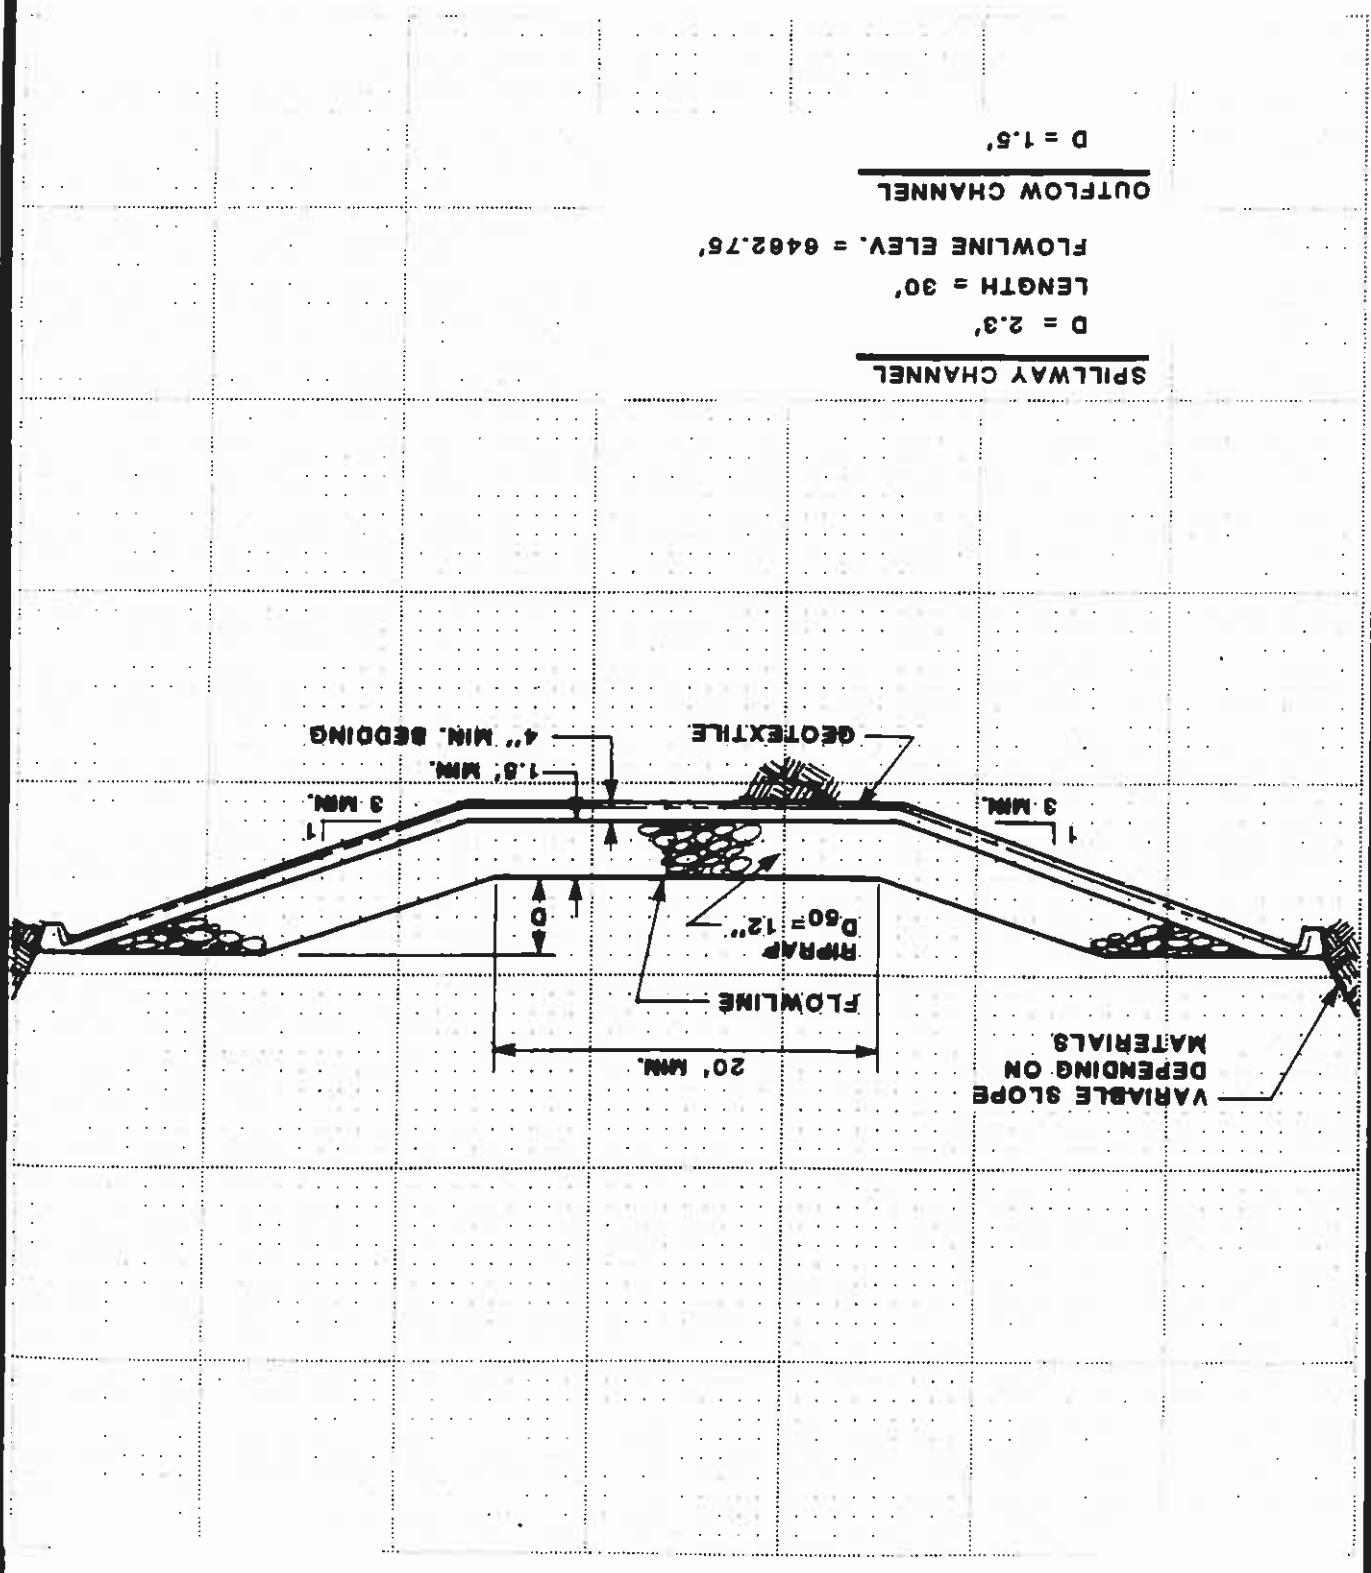
J7-F
CROSS SECTION
OUTFLOW CHANNEL
SPILLWAY AND

The structure presently has no outflow channel.

There is presently no erosion protection within the channel.

Channel depth	3.5 ft	Channel width	20 ft	Channel length	24 ft	Slide slopes (horizontal to vertical)	2:1	Average exit slope	3 percent
-------------------------	--------	-------------------------	-------	--------------------------	-------	---	-----	------------------------------	-----------

The existing spillway for J7-F has a trapezoidal channel with the

TRAP as shown in Plate 5.

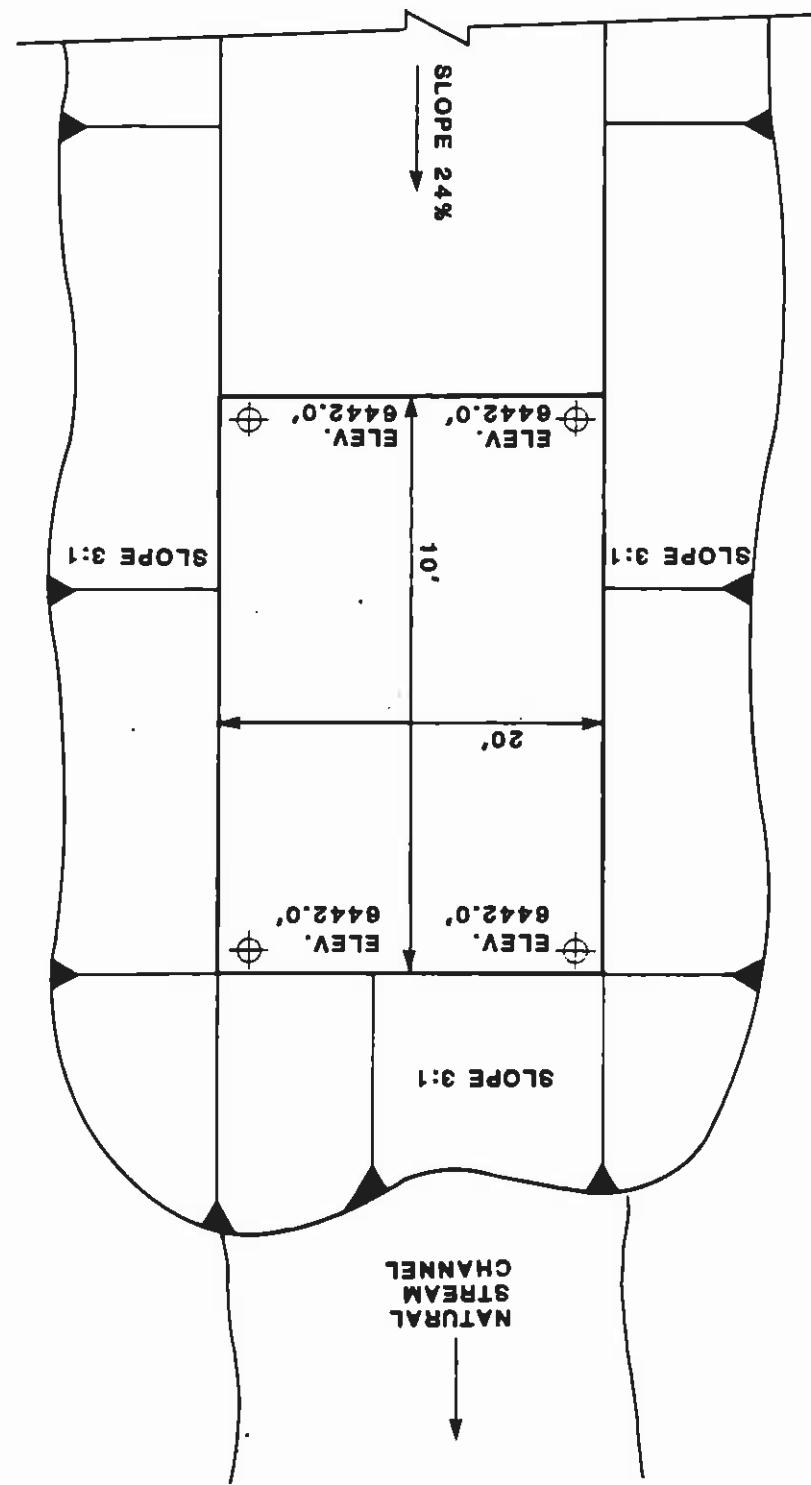
SPILLWAY STYLING

MINIMUM DEPTH OF BASIN FLOOR = 1.6'

MINIMUM HEIGHT OF RIPRAP
ALONG SIDEWALLS ABOVE
THE BASIN FLOOR = 2.8'
