INSPECTION REPORT
Sedimentation Structure
J7-G
Black Mesa Mine
Navajo County, Arizona

for
PEABODY COAL COMPANY

Dames & Moore
10139-011-22

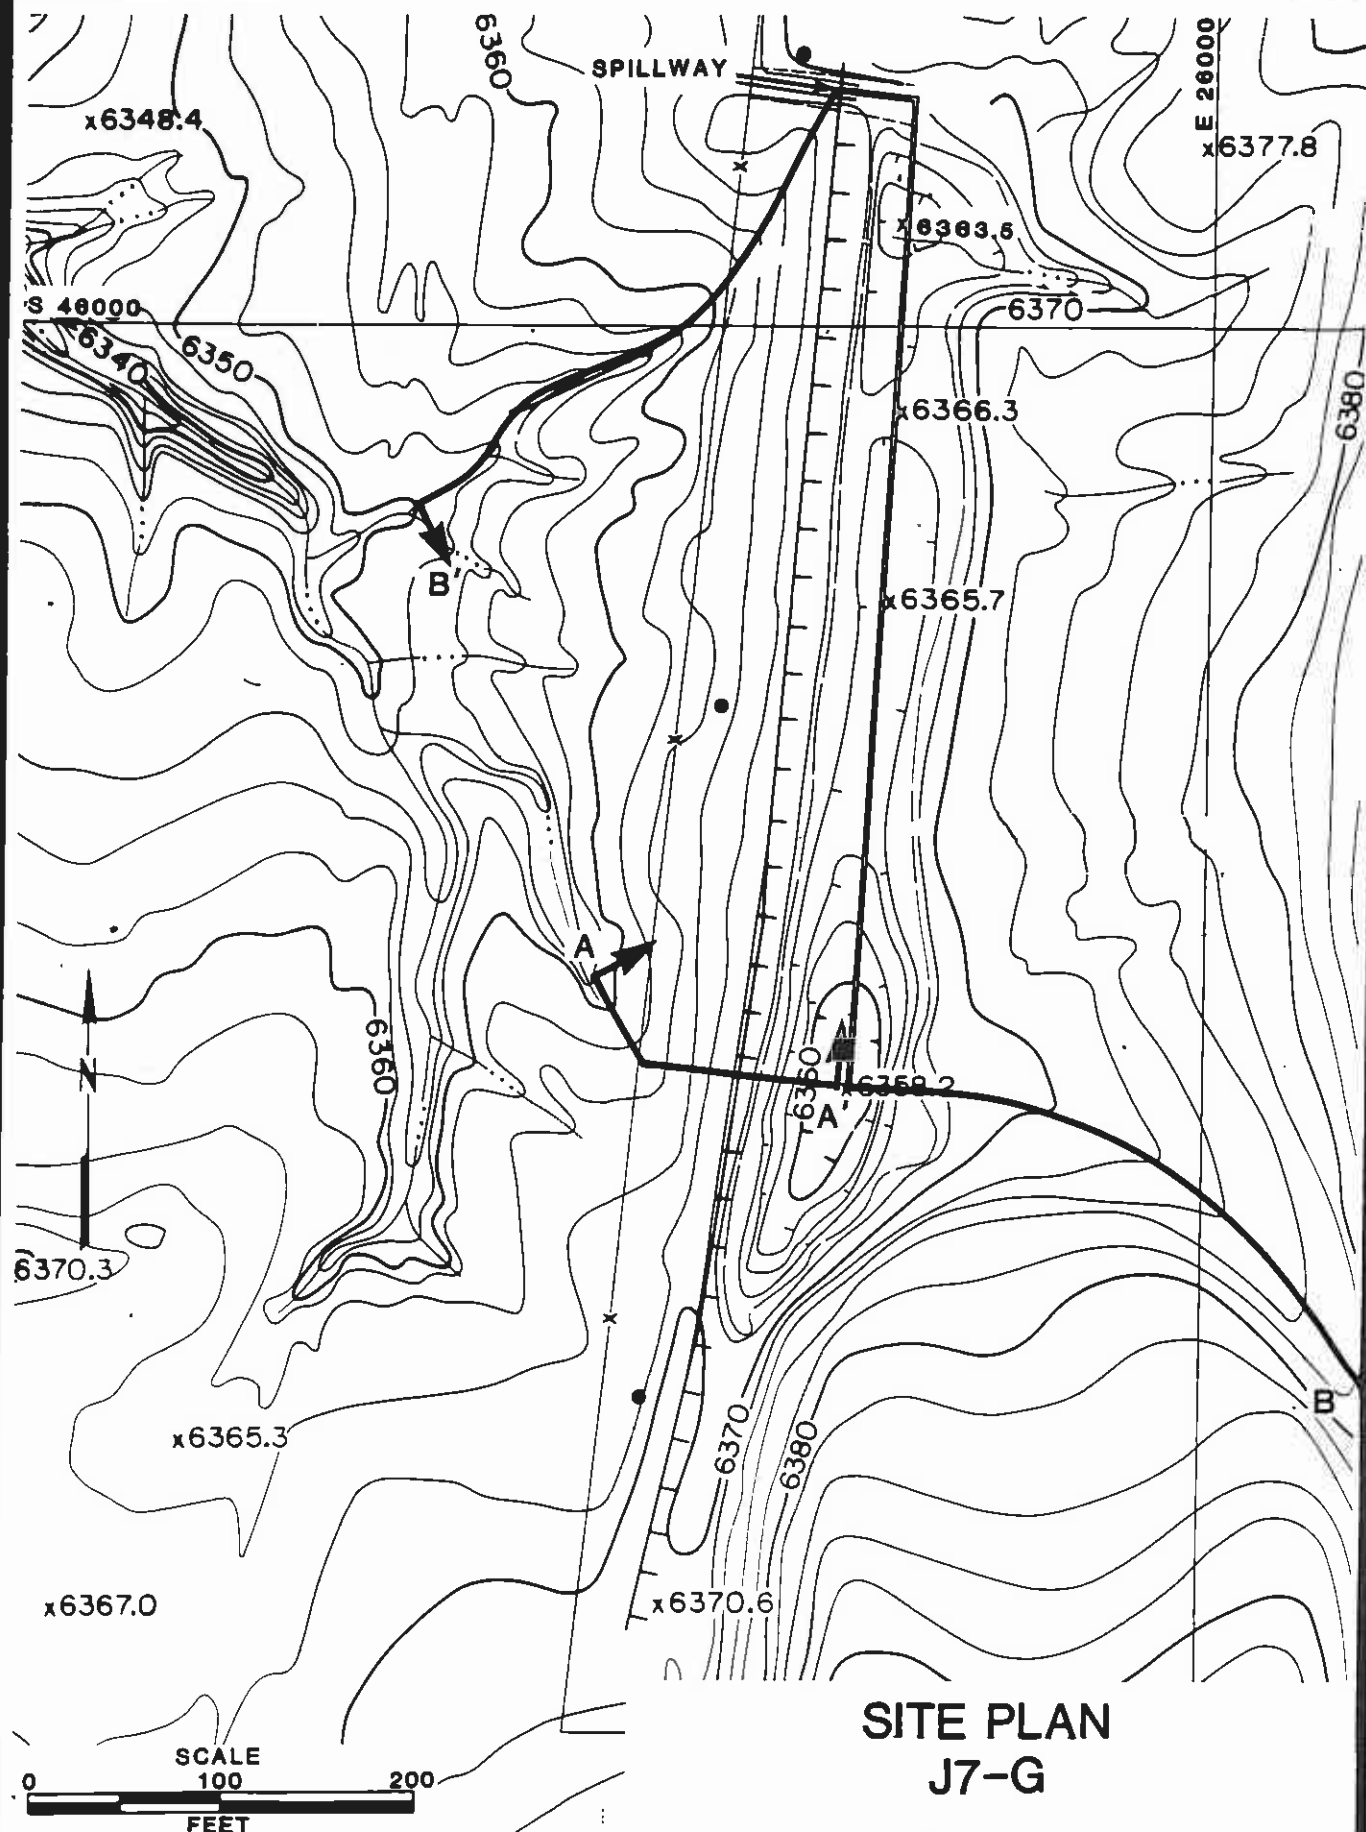
Sedimentation Structure J7-G is an earthen embankment, designed and constructed in 1981 by Peabody Coal Company as a temporary sedimentation structure to control runoff and sediment from the disturbed mining areas of the Black Mesa Mine. The location of Structure J7-G is shown on Plate 1, Site Plan.

Dames & Moore's evaluation indicates that the storage and spillway capacity of Structure J7-G are adequate; however, the spillway does not have an outflow channel nor adequate erosion protection. A trapezoidal outflow channel should be constructed along the alignment B-B' shown on Plate 1. The channel profile is shown on Plate 4 and the required dimensions are shown on Plate 5. Both the spillway and outflow channel should be protected against erosion using geotextile and gravel as shown on Plate 5.

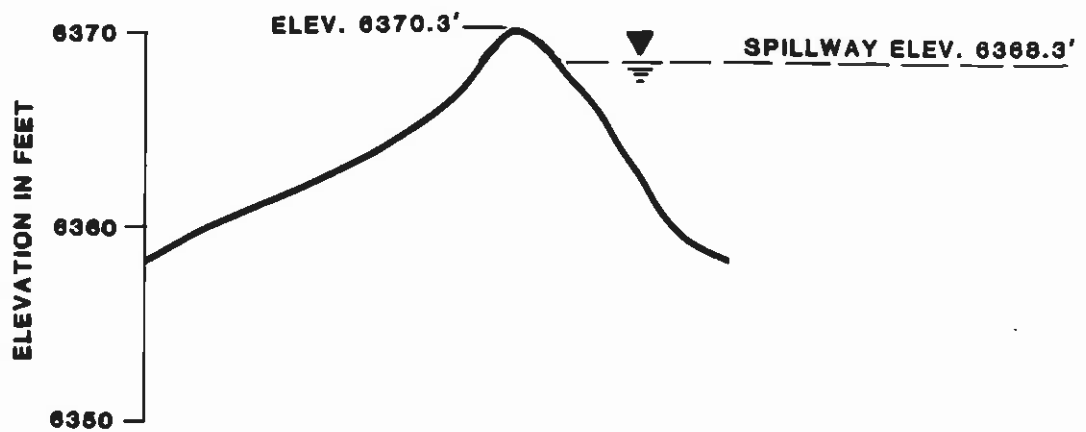
Plate 2

A cross-section of the embankment is shown on Plate 2, Existing Maximum Cross Section J7-G, A-A'. Grass provides erosion protection on the upstream and downstream slopes of the embankment.

EXISTING
MAXIMUM CROSS-SECTION
J7-G
A-A'

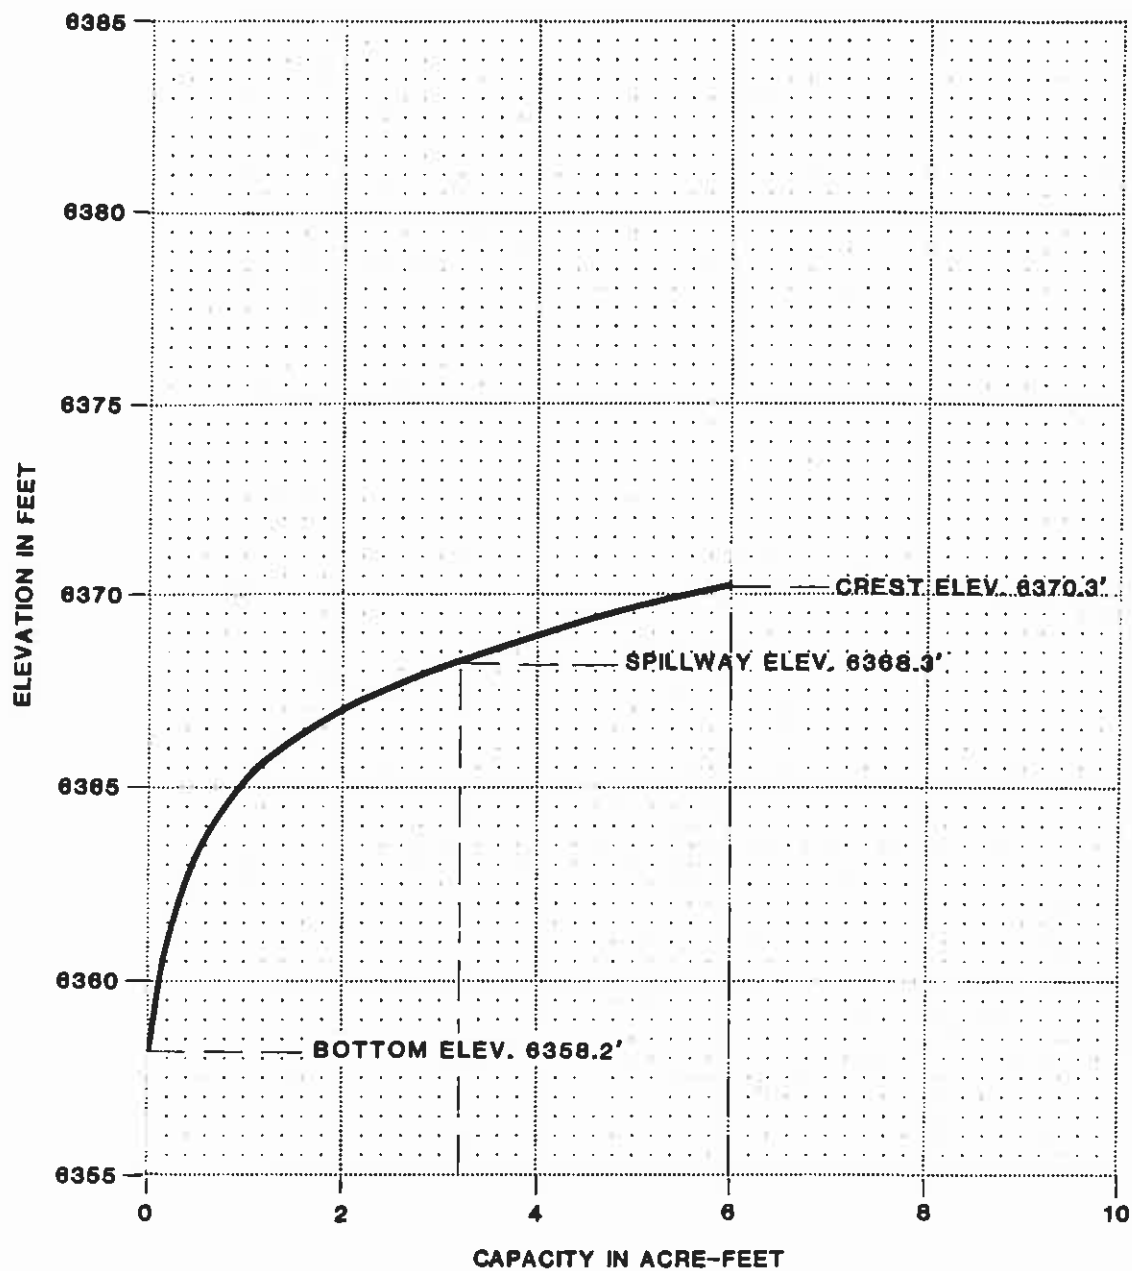
VOLUME-ELEVATION
CURVE
J7-G

The hydrologic analysis gives the storage volume required to contain the 10-year, 24-hour storm, and the remaining storage volume available for storing sediment. The existing storage capacity of J7-G is shown on Plate 3, Volume-Elevation Curve, J7-G, and the results of the analysis are summarized in the following table.

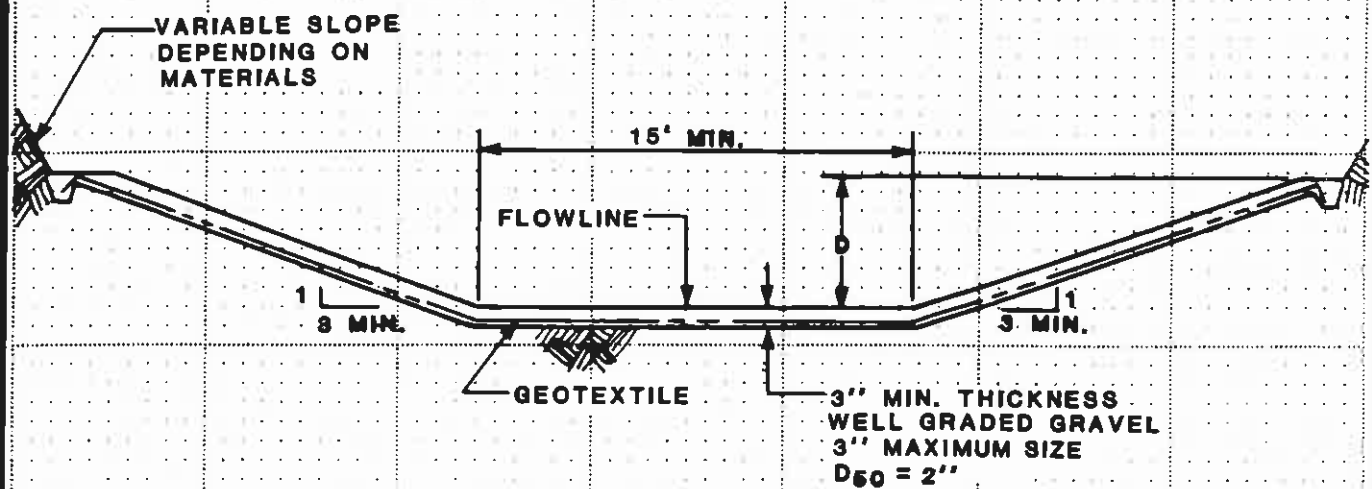
**SPILLWAY AND
 OUTFLOW CHANNEL
 CROSS SECTION
 J7-G**

There is presently no erosion protection within the channel.

The structure presently has no outflow channel.
