INSPECTION REPORT  
Sedimentation Structure

J7-H

Black Mesa Mine  
Navajo County, Arizona

PEABODY COAL COMPANY

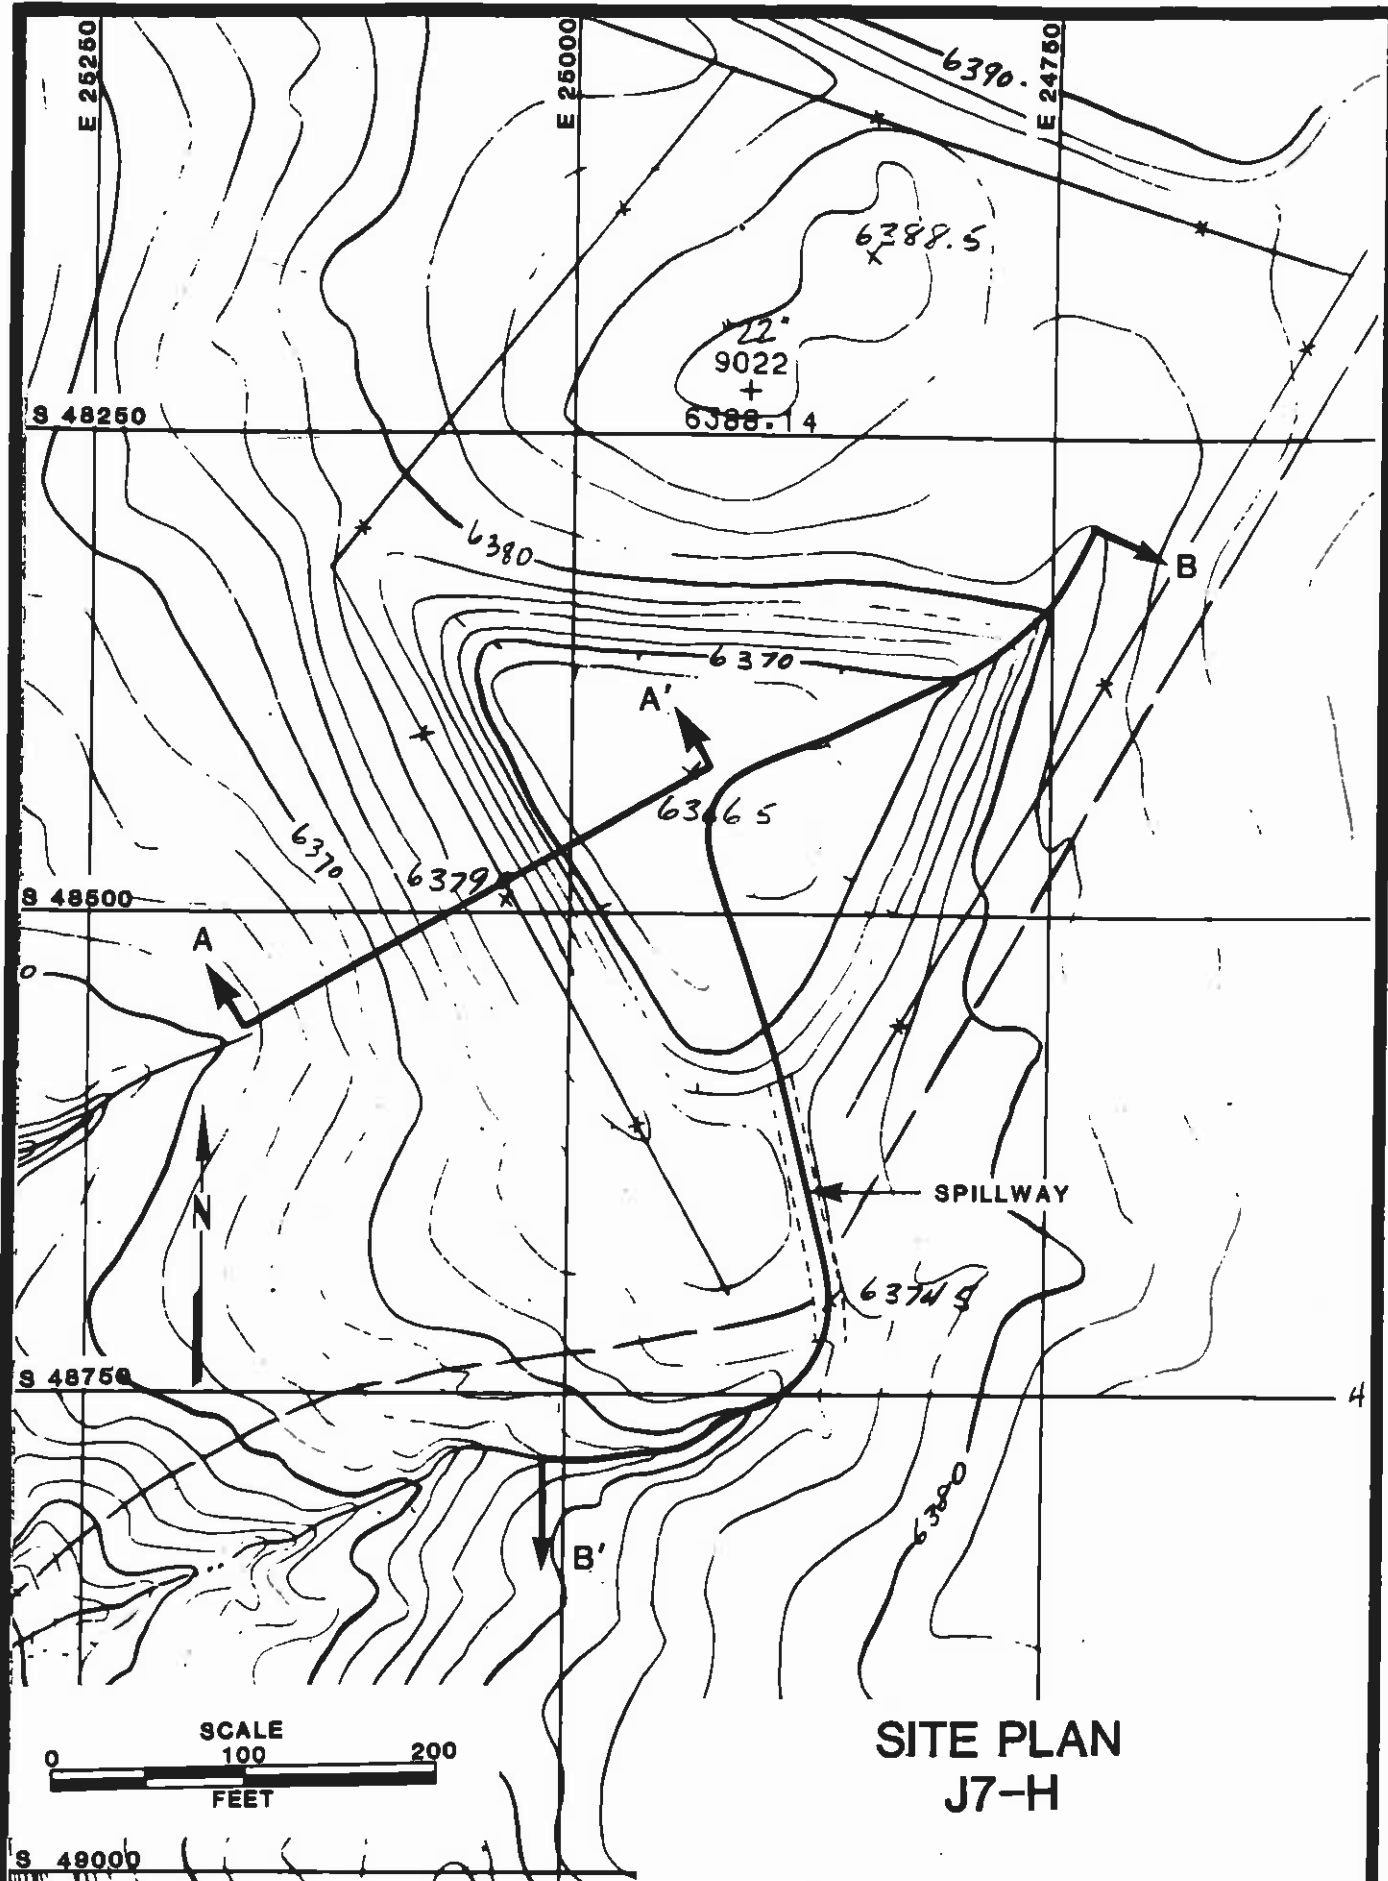
**SITE PLAN  
J7-H**

Sedimentation Structure J7-H is an earthen embankment, designed and constructed in 1980 by Peabody Coal Company as a temporary sedimentation structure to control runoff and sediment from the disturbed mining areas of the Black Mesa Mine. The location of Structure J7-H is shown on Plate 1, Site Plan.

The storage capacity and spillway capacity of Structure J7-H are adequate; however, the spillway does not have an outflow channel or adequate erosion protection. A trapezoidal outflow channel should be constructed along the alignment B-B' shown in Plate 1. The channel profile is shown in Plate 4 and the required dimensions are shown in Plate 5. Both the spillway and outflow channel should be protected against erosion using geotextile and gravel as shown in Plate 5.

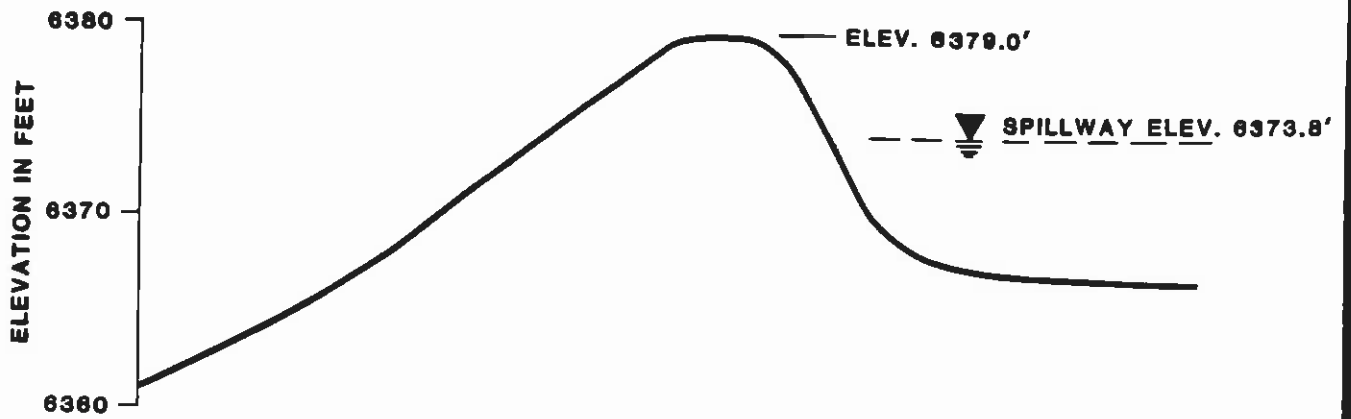
EXISTING  
MAXIMUM CROSS-SECTION  
A-A'  
J7-H

Embankment . . . . .	Residual Shale/Sandstone Soils
Foundation . . . . .	Residual Shale Soils
Right Abutment . . . . .	Residual Shale Soils
Left Abutment . . . . .	Residual Shale Soils
Height . . . . .	7.3 ft
Crest Width . . . . .	22 ft
Upstream Slope . . . . .	2.5 H : 1 V
Downstream Slope . . . . .	7.5 H : 1 V

A cross-section of the embankment is shown on Plate 2, Existing Maximum Cross Section J7-H, A-A'.

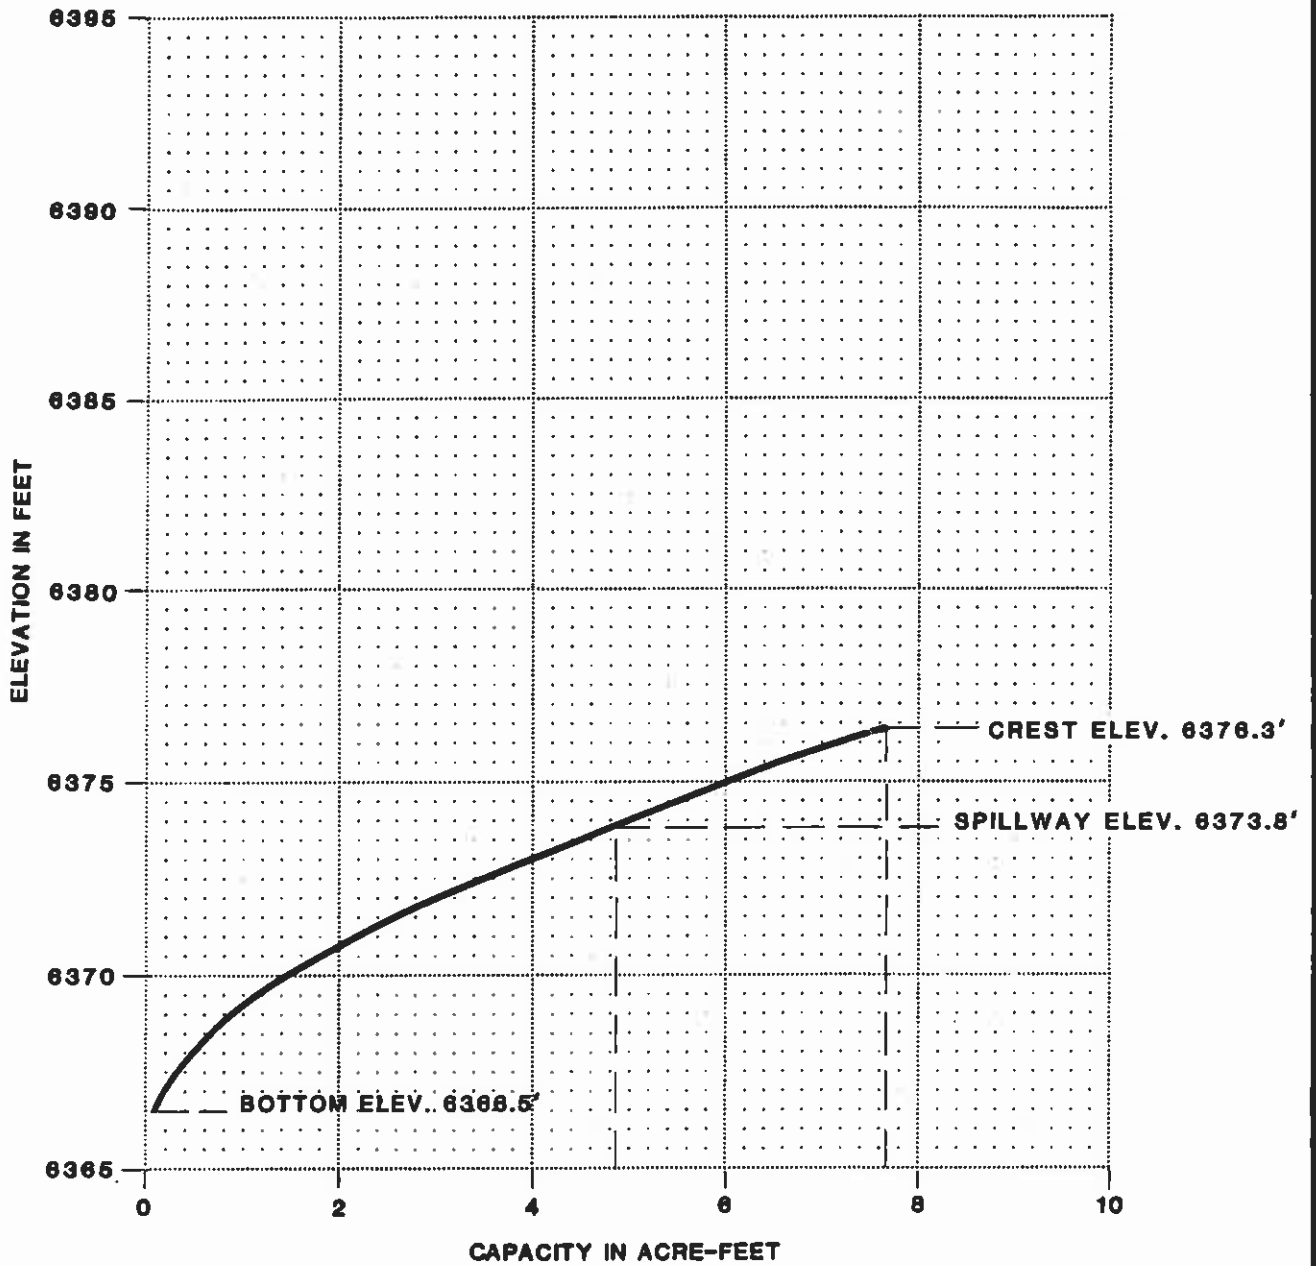
VOLUME-ELEVATION  
CURVE  
J7-H

The hydrologic analysis gives the storage volume required to contain the 10-year, 24-hour storm, and the remaining storage volume available for storing sediment. The storage capacity of J7-H is shown on Plate 3, Volume-Elevation Curve, J7-H, and the results of the analysis are summarized in the following table.

Total Storage Capacity . . . . .	4.82	acre-ft
10-year, 24-hour Storm Inflow . . . . .	2.45	acre-ft
Available Sediment Storage Capacity . . . . .	2.35	acre-ft
Sediment Inflow Rate . . . . .	0.095	acre-ft/yr
Sediment Storage Life . . . . .	25	yrs

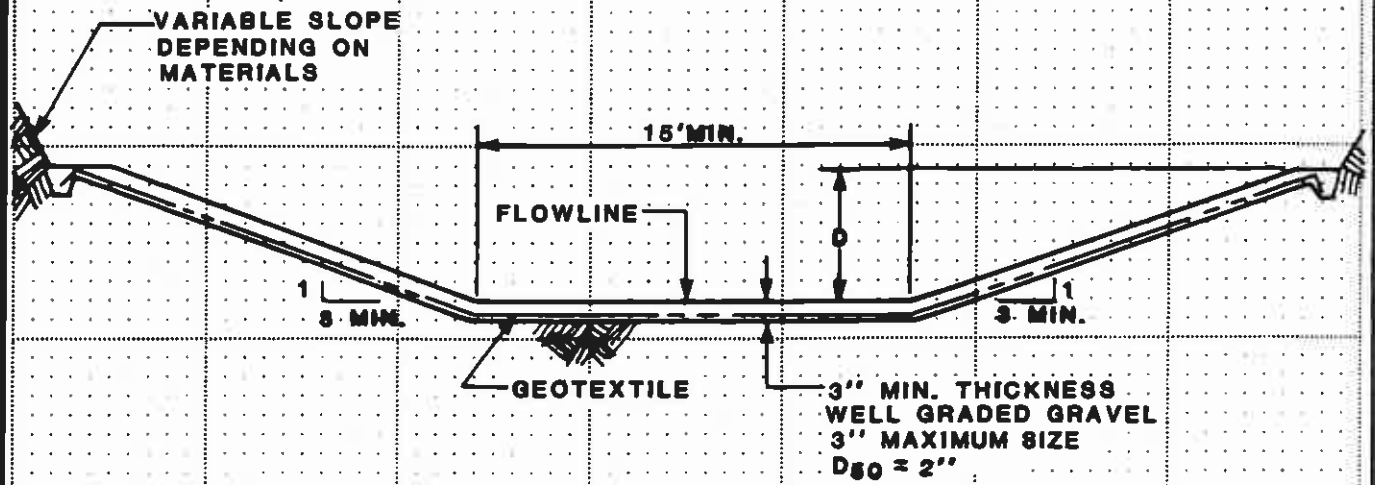
**SPILLWAY AND  
 OUTFLOW CHANNEL  
 CROSS SECTION  
 J7-H**

There is presently only grass for erosion protection within the channel.

The inspection of Structure J7-H indicated that the only geotechnical problem is rill erosion on the upstream slope and the side slopes and bottom of the spillway channel. Correction of erosion is considered a periodic maintenance task and does not require remedial action.
