INSPECTION REPORT
Sedimentation Structure
J7-I
Black Mesa Mine
Navajo County, Arizona
for
PEABODY COAL COMPANY

Dames & Moore
10139-011-22

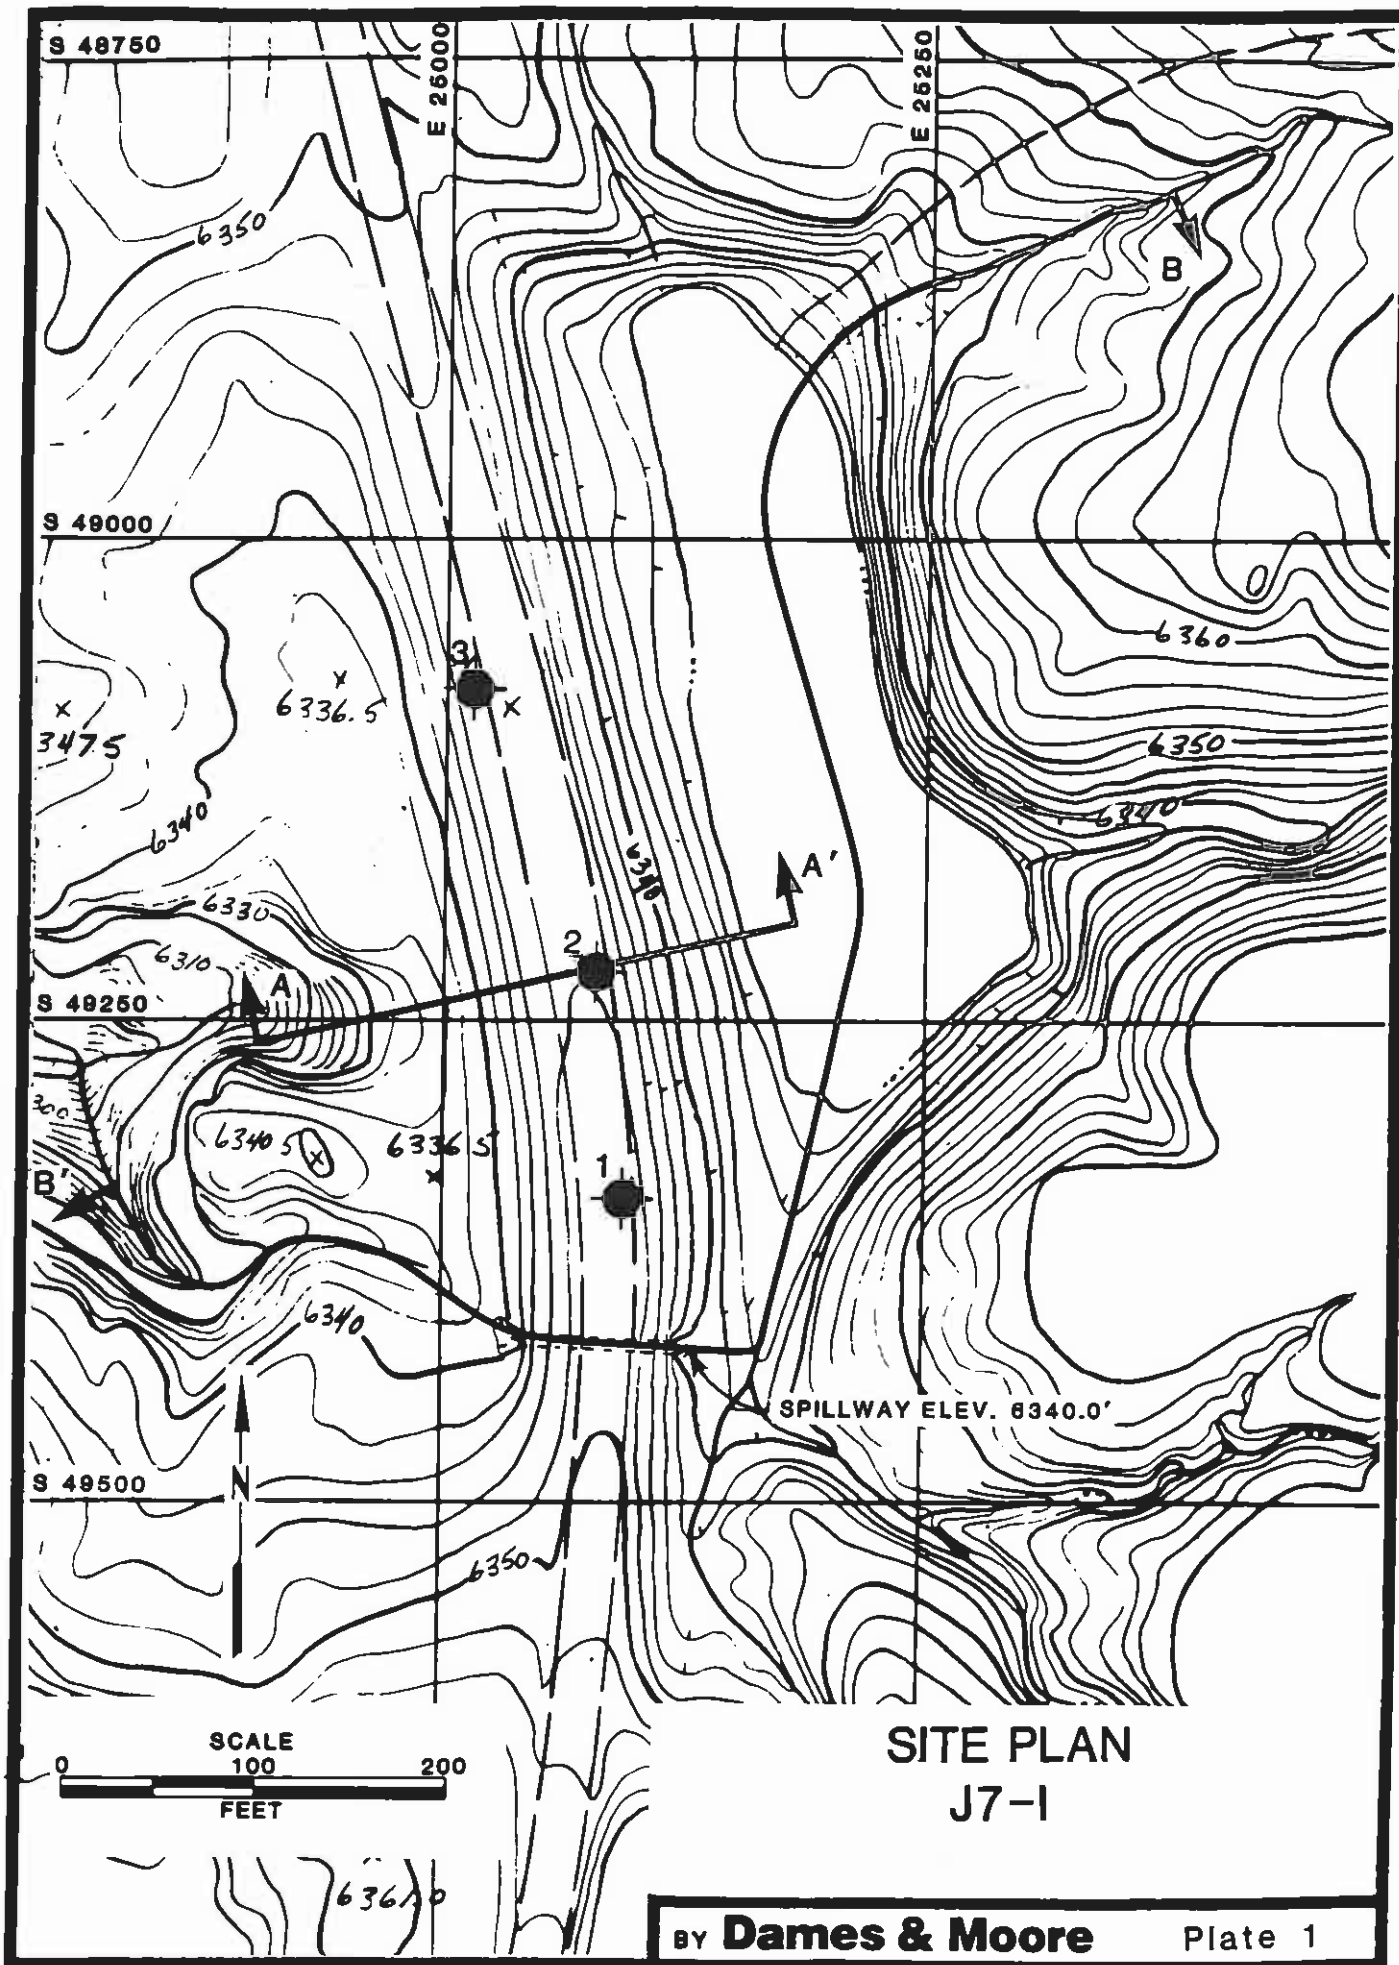
The storage capacity and spillway capacity of Structure J7-I are adequate; however, the spillway does not have an adequate outflow channel or adequate erosion protection. A trapezoidal outflow channel and a stilling basin should be constructed along the alignment B-B' shown in Plate 1. The channel and stilling basin profile is shown in Plate 4 and the required dimensions are shown in Plate 5 and Plate 6. The outflow channel, and stilling basin should be protected against erosion using geotextile and riprap as shown in Plate 5. A trashrack should be installed on the inlet of the CMP to prevent clogging of the spillway.

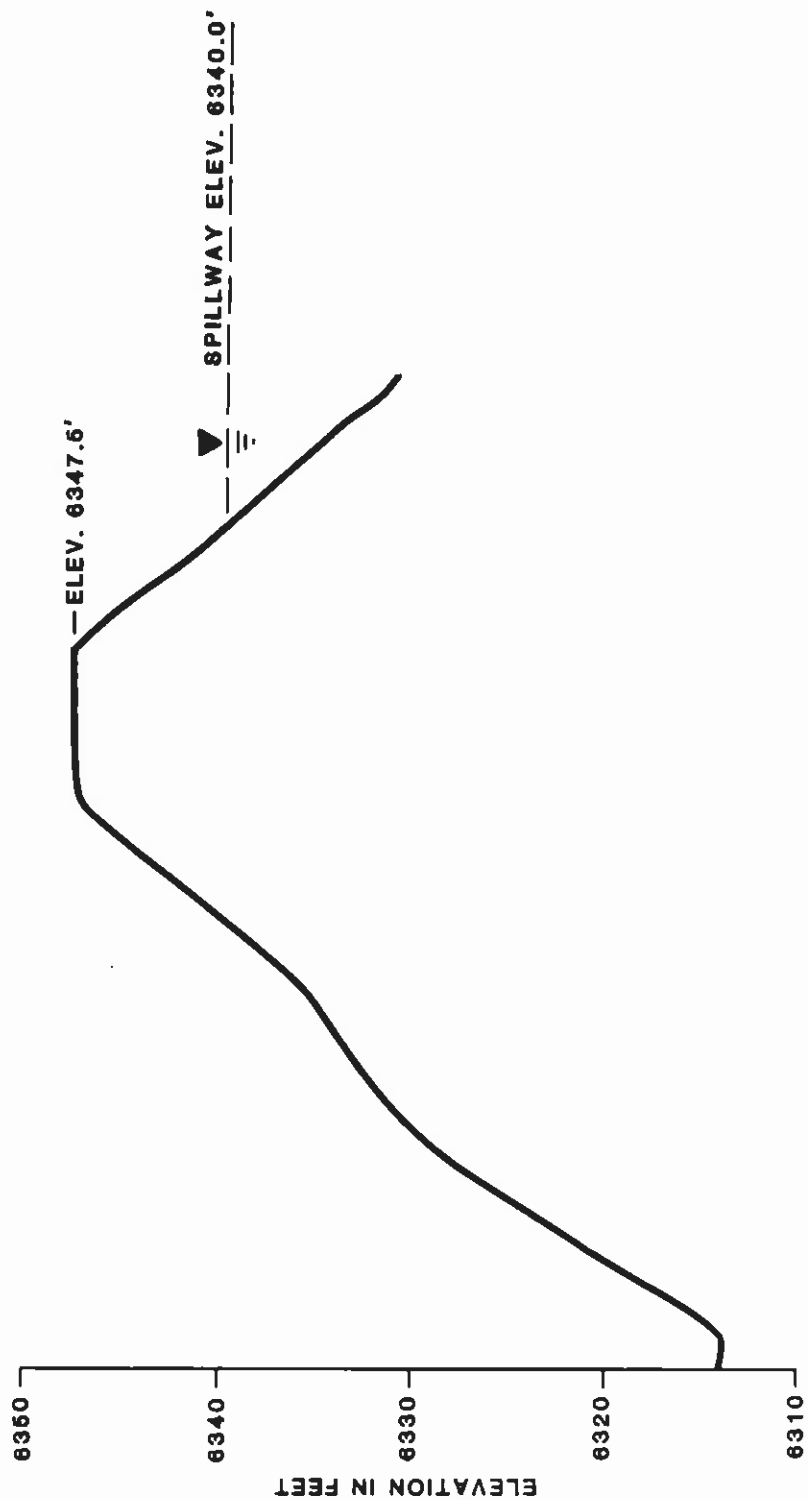
EXISTING
MAXIMUM CROSS-SECTION
A-A'
J7-1

A cross-section of the embankment is shown on Plate 2, Existing Maximum Cross Section J7-I, A-A'. Grass provides erosion protection on the upstream and downstream slopes of the embankment.

The upstream slope is lower in height and has a flatter slope than the category standard. The downstream slope is steeper than the category standard; therefore, the embankment has factors of safety less than the design minimum.

remedial action. The downstream slope should be flattened to 4.25 horizontal to 1 vertical to meet stability requirements. Evidence of seepage was noted below the downstream toe of embankment through the sandstone bedrock. Remedial action for this condition is not required at the present time, however, future inspections should check for changes.

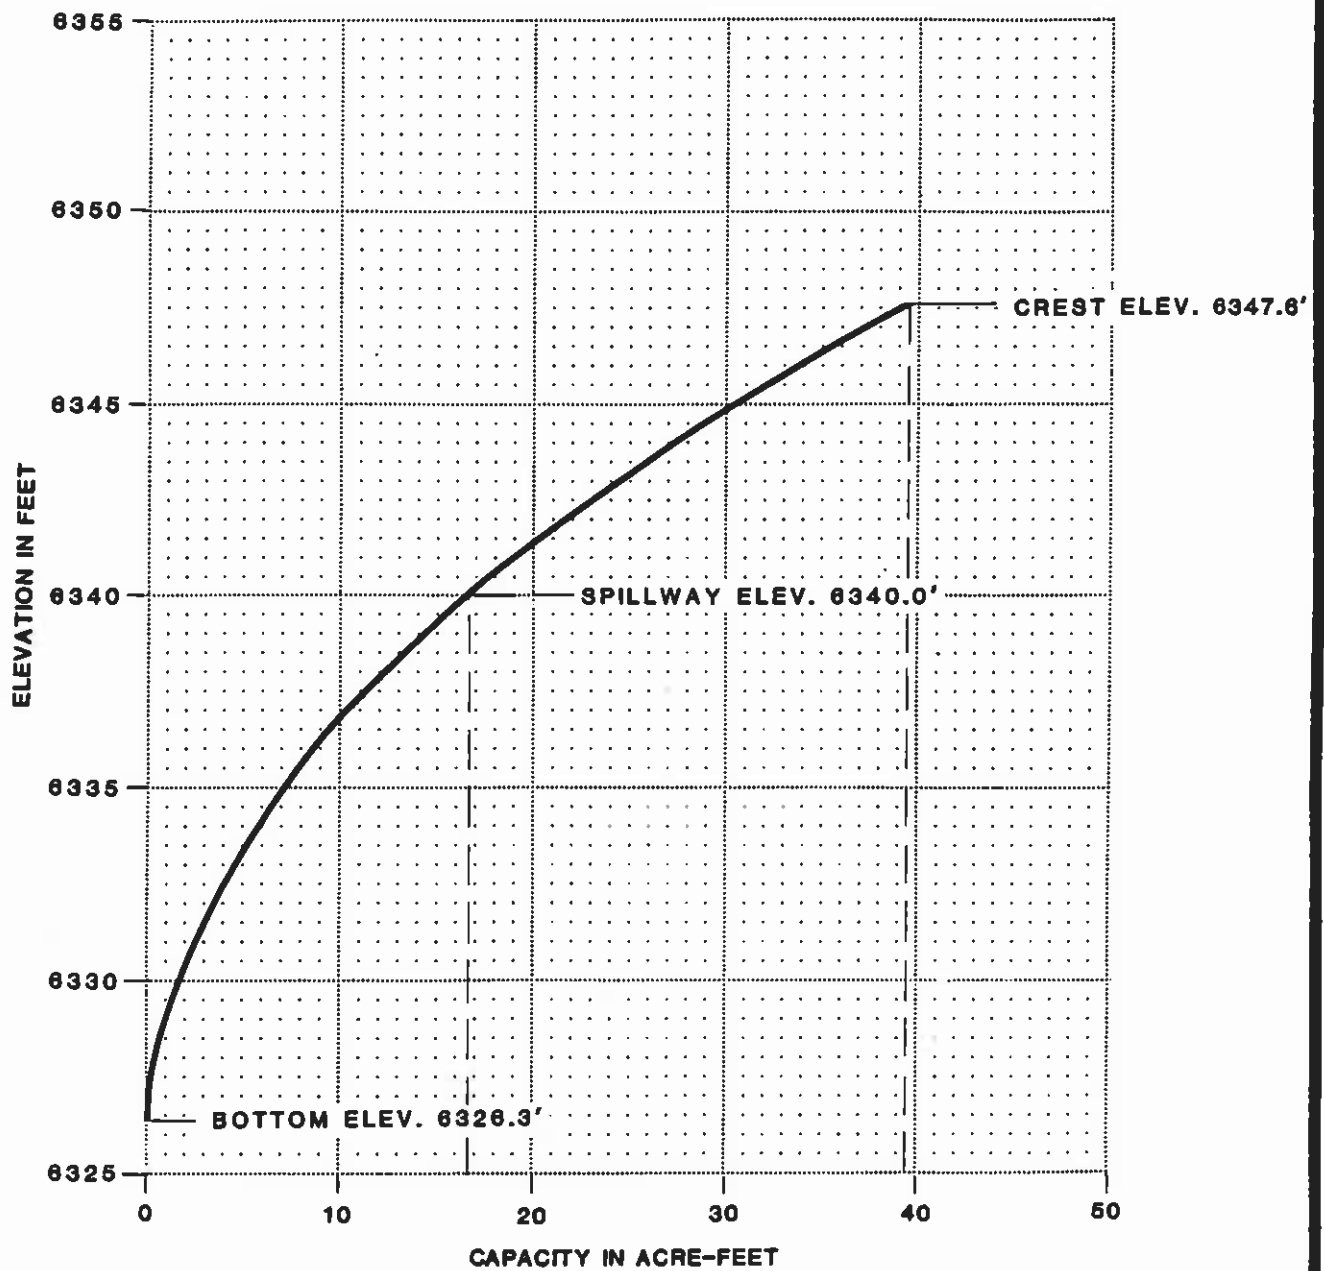
VOLUME-ELEVATION
CURVE
J7-1

The hydrologic analysis gives the storage volume required to contain the 10-year, 24-hour storm, and the remaining storage volume available for storing sediment. The existing storage capacity of J7-I is shown on Plate 3, Volume-Elevation Curve, J7-I, and the results of the analysis are summarized in the following table.

Total Storage Capacity	16.8	acre-ft
10-year, 24-hour Storm Inflow	8.59	acre-ft
Available Sediment Storage Capacity	8.23	acre-ft
Sediment Inflow Rate	0.27	acre-ft/yr
Sediment Storage Life	30	yrs

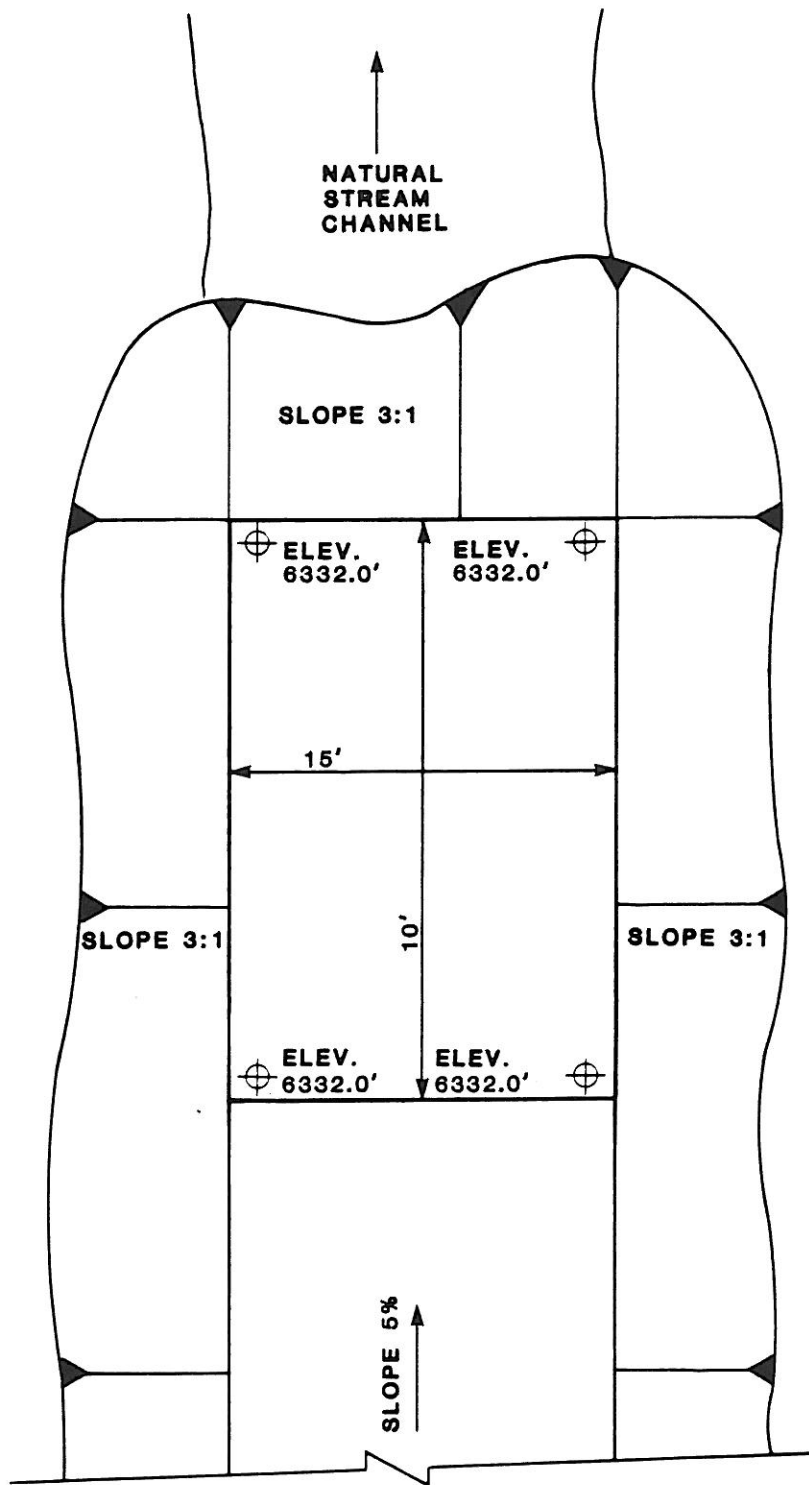
SPILLWAY STILLING BASIN PLAN J7-1

MINIMUM HEIGHT OF RIPRAP
ALONG SIDEWALLS ABOVE
THE BASIN FLOOR = 3.0'

MINIMUM DEPTH OF BASIN FLOOR
BELOW NATURAL STREAMBED = 1.3'
