INSPECTION REPORT
Sedimentation Structure
J7-J
Black Mesa Mine
Navajo County, Arizona
for
PEABODY COAL COMPANY

Dames & Moore
10139-011-22

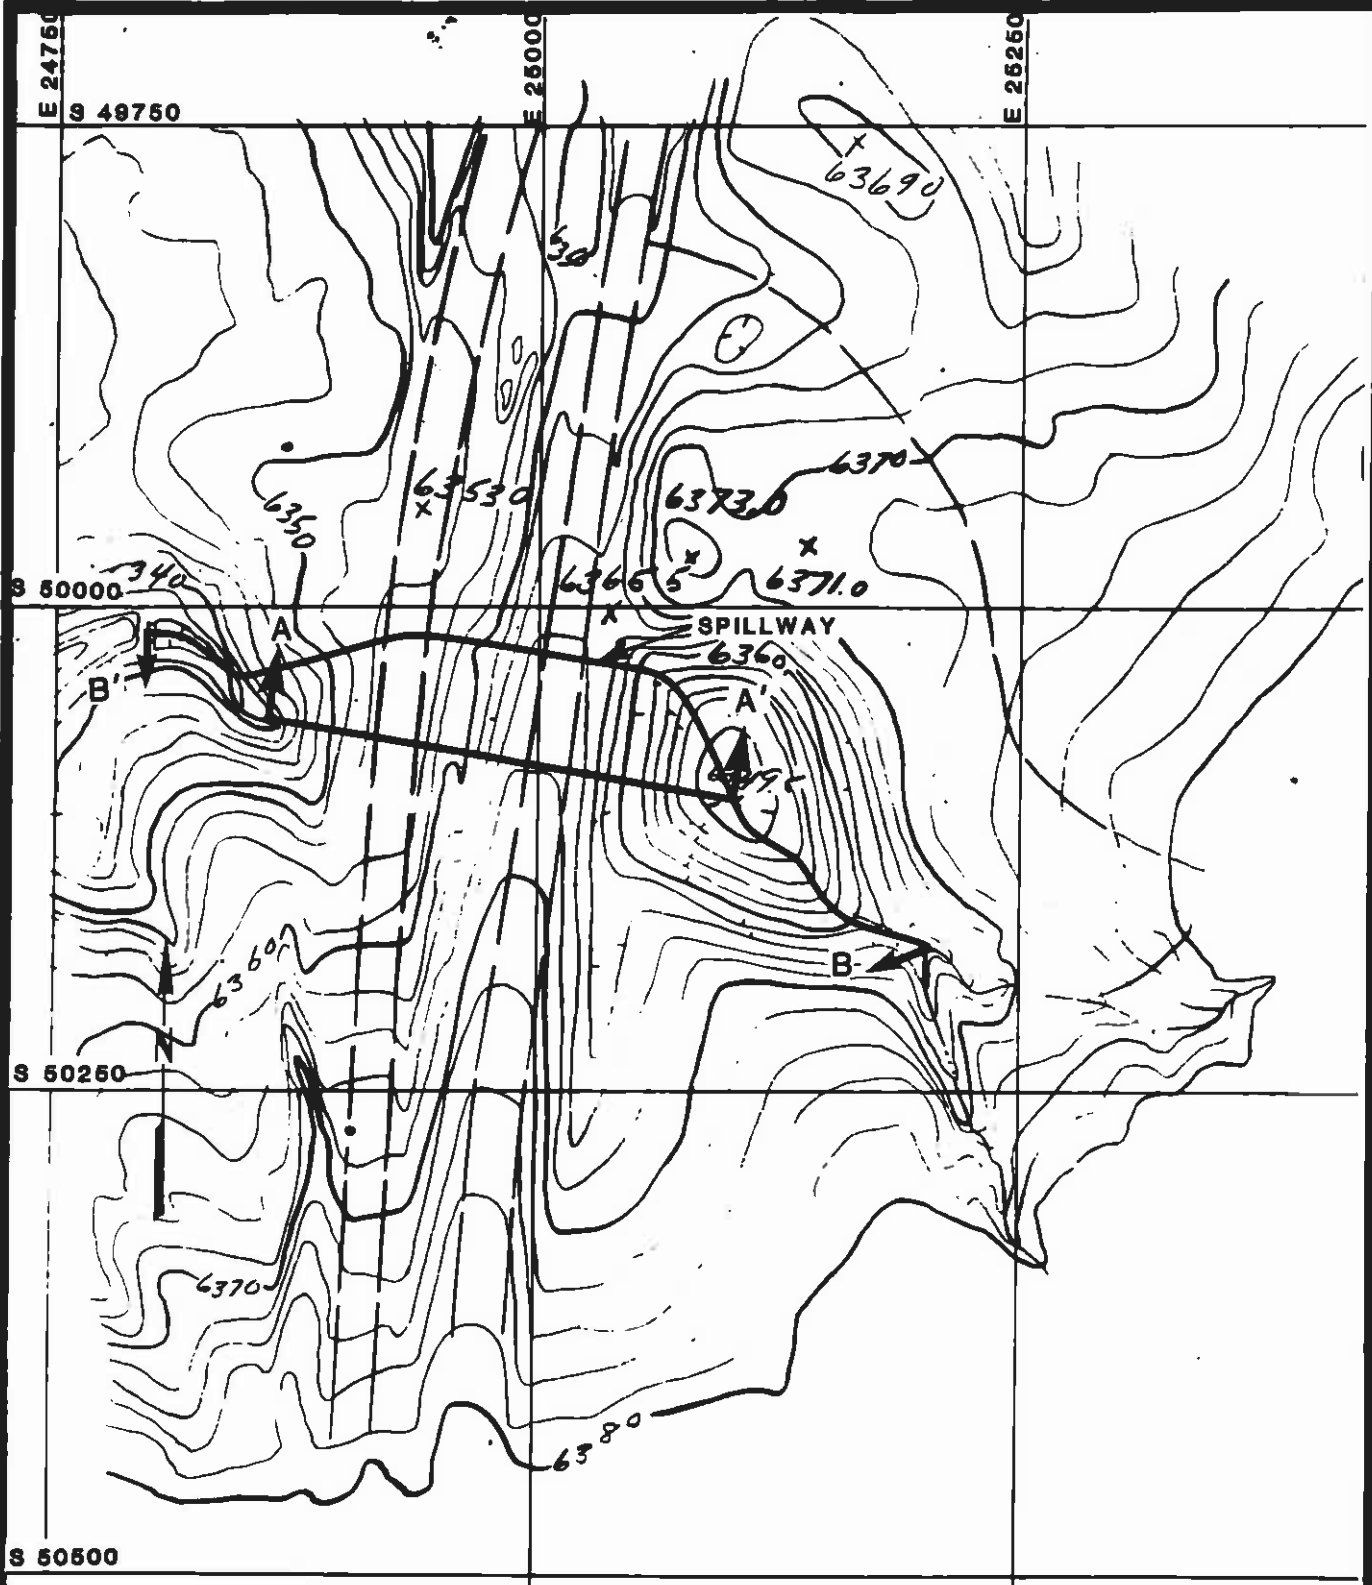
**SITE PLAN
J7-J**

The storage capacity and spillway capacity of Structure J7-J are adequate; however, the spillway does not have an outflow channel. A trapezoidal outflow channel should be constructed along the alignment B-B' shown in Plate 1. The channel profile is shown in Plate 4 and the required dimensions are shown in Plate 5. The outflow channel should be protected against erosion using geotextile and riprap as shown in Plate 5. A trash-rack should be installed on the inlet of the CMP to prevent clogging of the spillway.

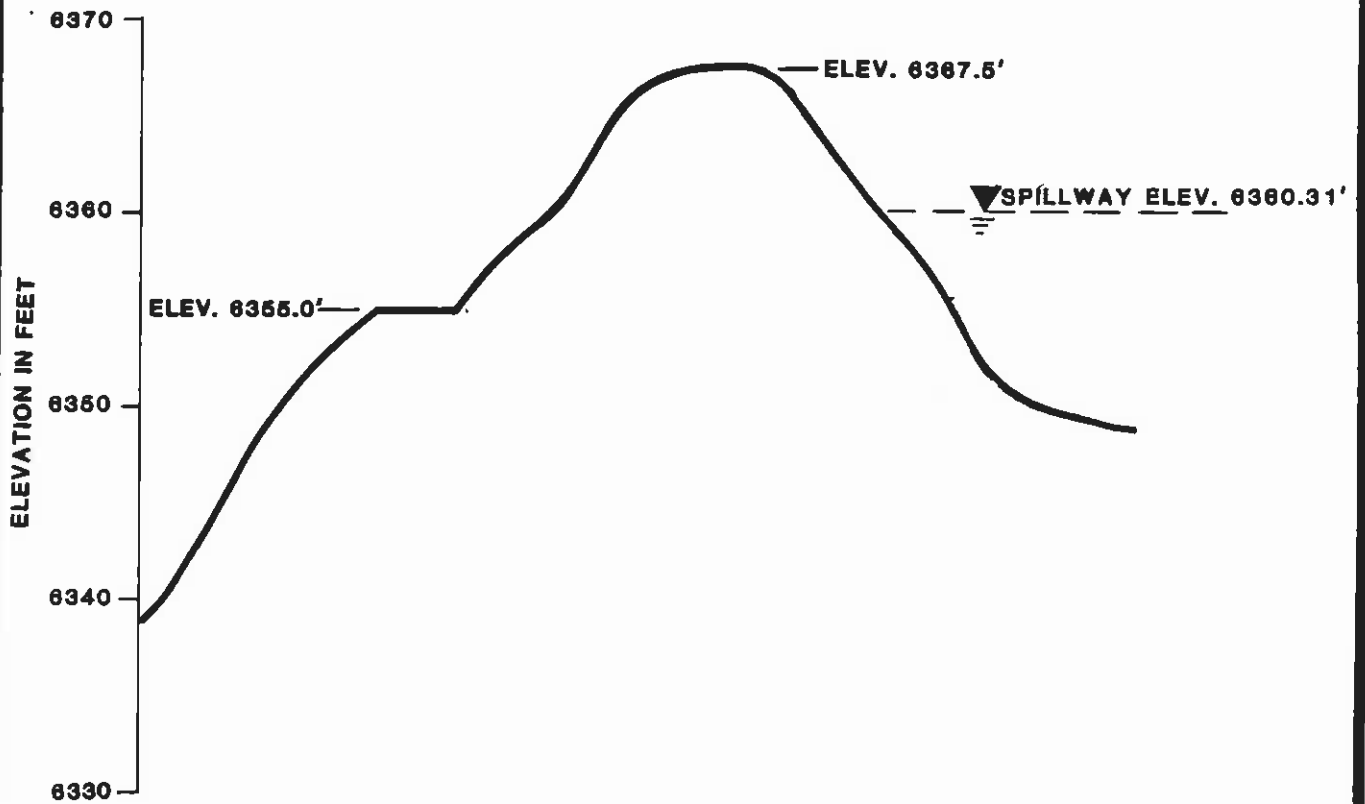
EXISTING
MAXIMUM CROSS-SECTION
A-A'
J7-J

A cross-section of the embankment is shown on Plate 2, Existing Maximum Cross Section J7-J, A-A'. Grass provides erosion protection on the upstream and downstream slopes of the embankment.

The J7-J embankment is lower in height and has flatter slopes than the category standard; therefore, the embankment has factors of safety greater than the design minimum.

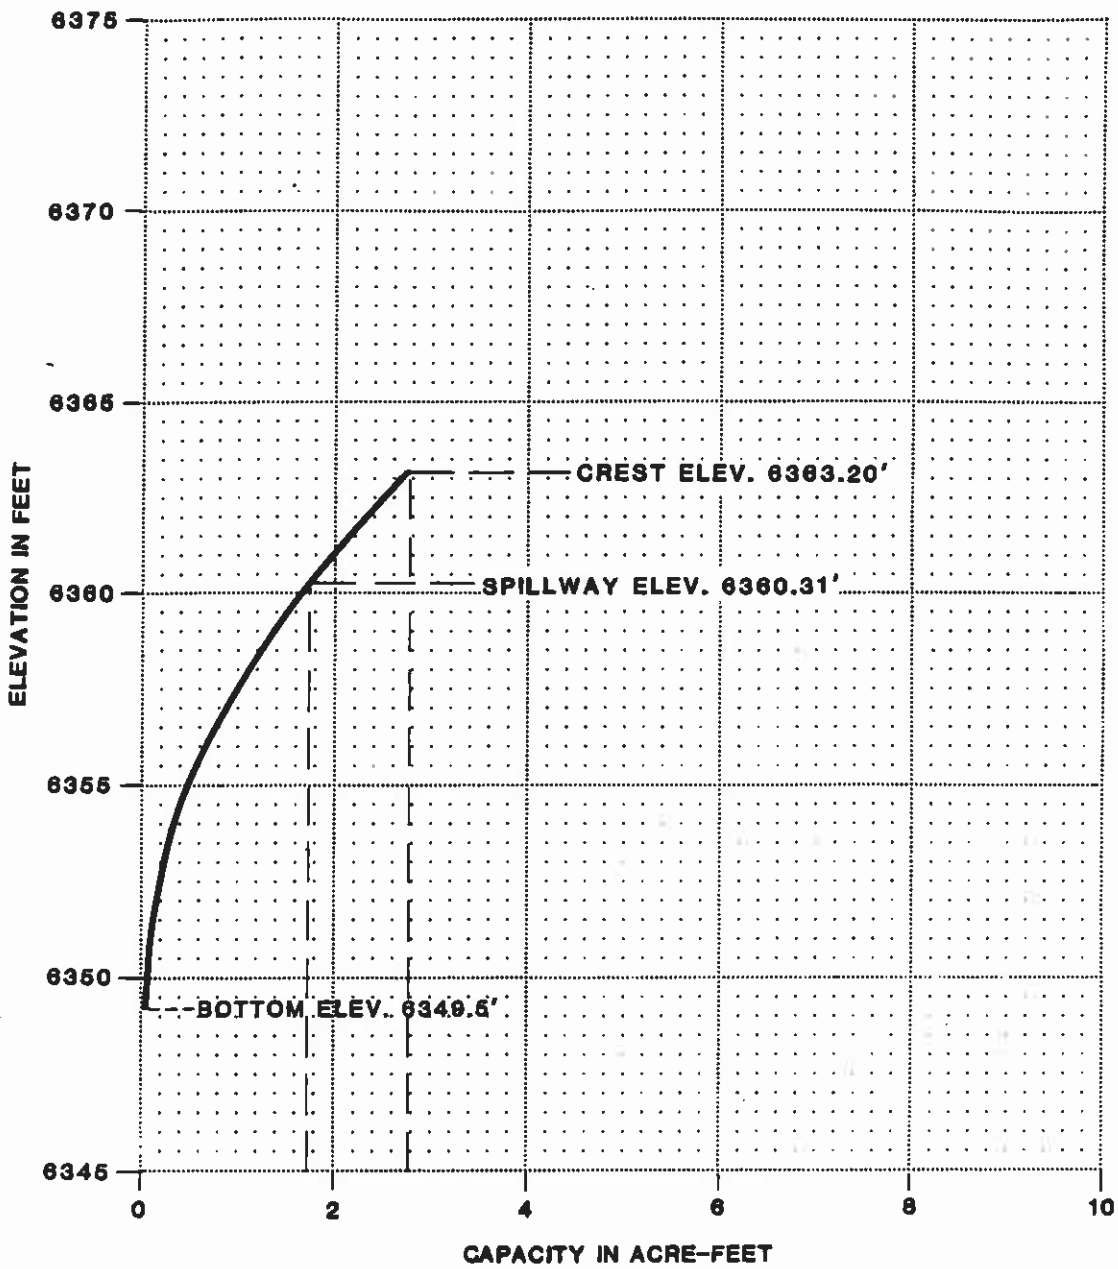
VOLUME-ELEVATION
CURVE
J7-J

The hydrologic analysis gives the storage volume required to contain the 10-year, 24-hour storm, and the remaining storage volume available for storing sediment. The existing storage capacity of J7-J is shown on Plate 3, Volume-Elevation Curve, J7-J, and the results of the analysis are summarized in the following table.

Total Storage Capacity	1.72	acre-ft
10-year, 24-hour Storm Inflow	0.96	acre-ft
Available Sediment Storage Capacity	0.78	acre-ft
Sediment Inflow Rate	0.099	acre-ft/yr
Sediment Storage Life	8	yrs
