INSPECTION REPORT
Sedimentation Structure
J7-K
Black Mesa Mine
Navajo County, Arizona

for
PEABODY COAL COMPANY

Dames & Moore
10139-011-22

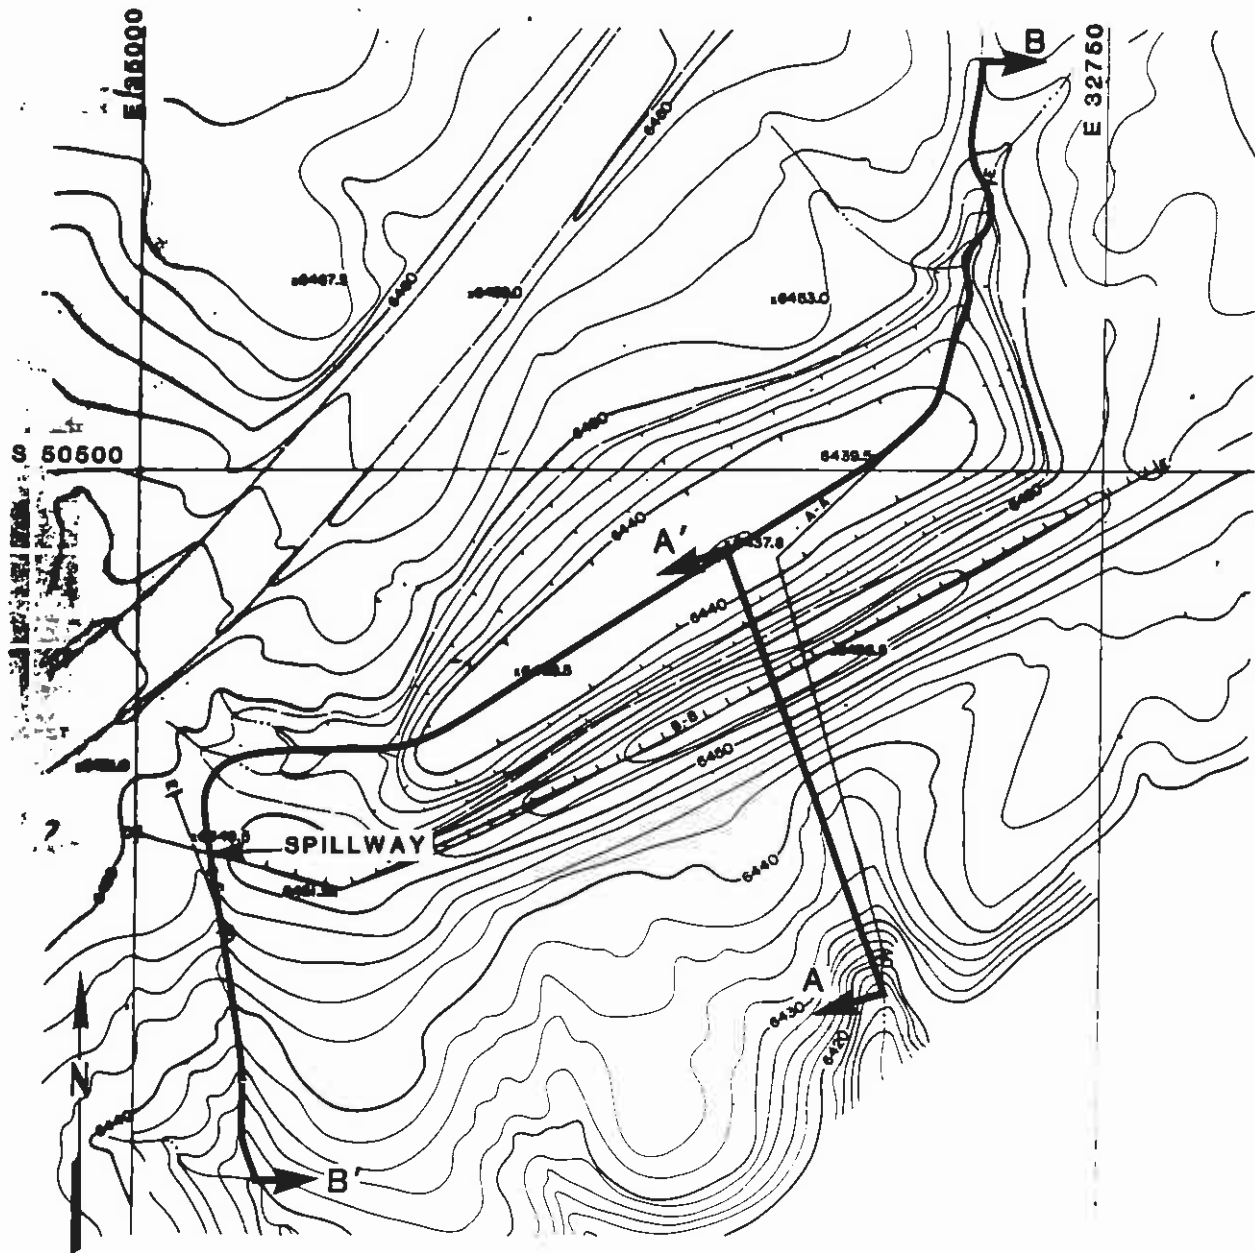
SITE PLAN J7-K

Sedimentation Structure J7-K is an earthen embankment, designed and constructed in 1981 by Peabody Coal Company as a temporary sedimentation structure to control runoff and sediment from the disturbed mining areas of the Black Mesa Mine. The location of Structure J7-K is shown on Plate 1, Site Plan.

The storage capacity and spillway capacity of Structure J7-K are adequate; however, the spillway does not have an adequate outflow channel or adequate erosion protection. A trapezoidal outflow channel should be constructed along the alignment B-B' shown in Plate 1. The channel profile is shown in Plate 4 and the required dimensions are shown in Plate 5. Both the spillway and outflow channel should be protected against erosion using geotextile and riprap as shown in Plate 5.

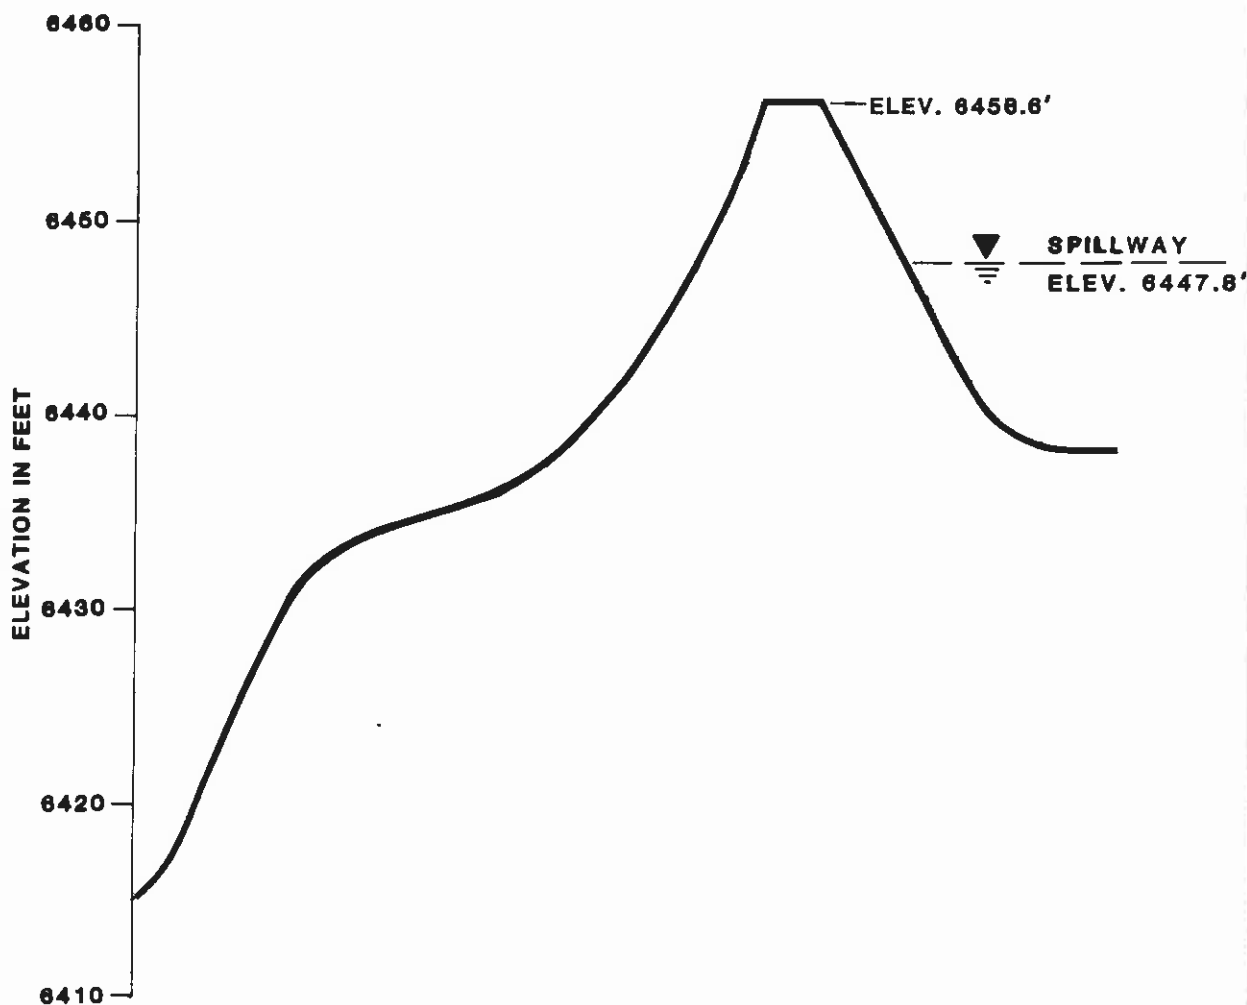
EXISTING
MAXIMUM CROSS-SECTION
A-A'
J7-K

Structure J7-K is a homogeneous earthen embankment classified as a sidehill embankment. Physical characteristics of the embankment are listed in the following table:

Embankment	Residual Shale Soils
Foundation	Residual Shale Soils
Right Abutment	Residual Shale Soils
Left Abutment	Residual Shale Soils/ Residual Sandstone Soils
Height	10.0 ft
Crest Width	15 ft
Upstream Slope	2.0 H : 1 V
Downstream Slope	2.6 H : 1 V

The J7-K embankment is lower in height and has flatter slopes than the category standard; therefore, the embankment has factors of safety greater than the design minimum.

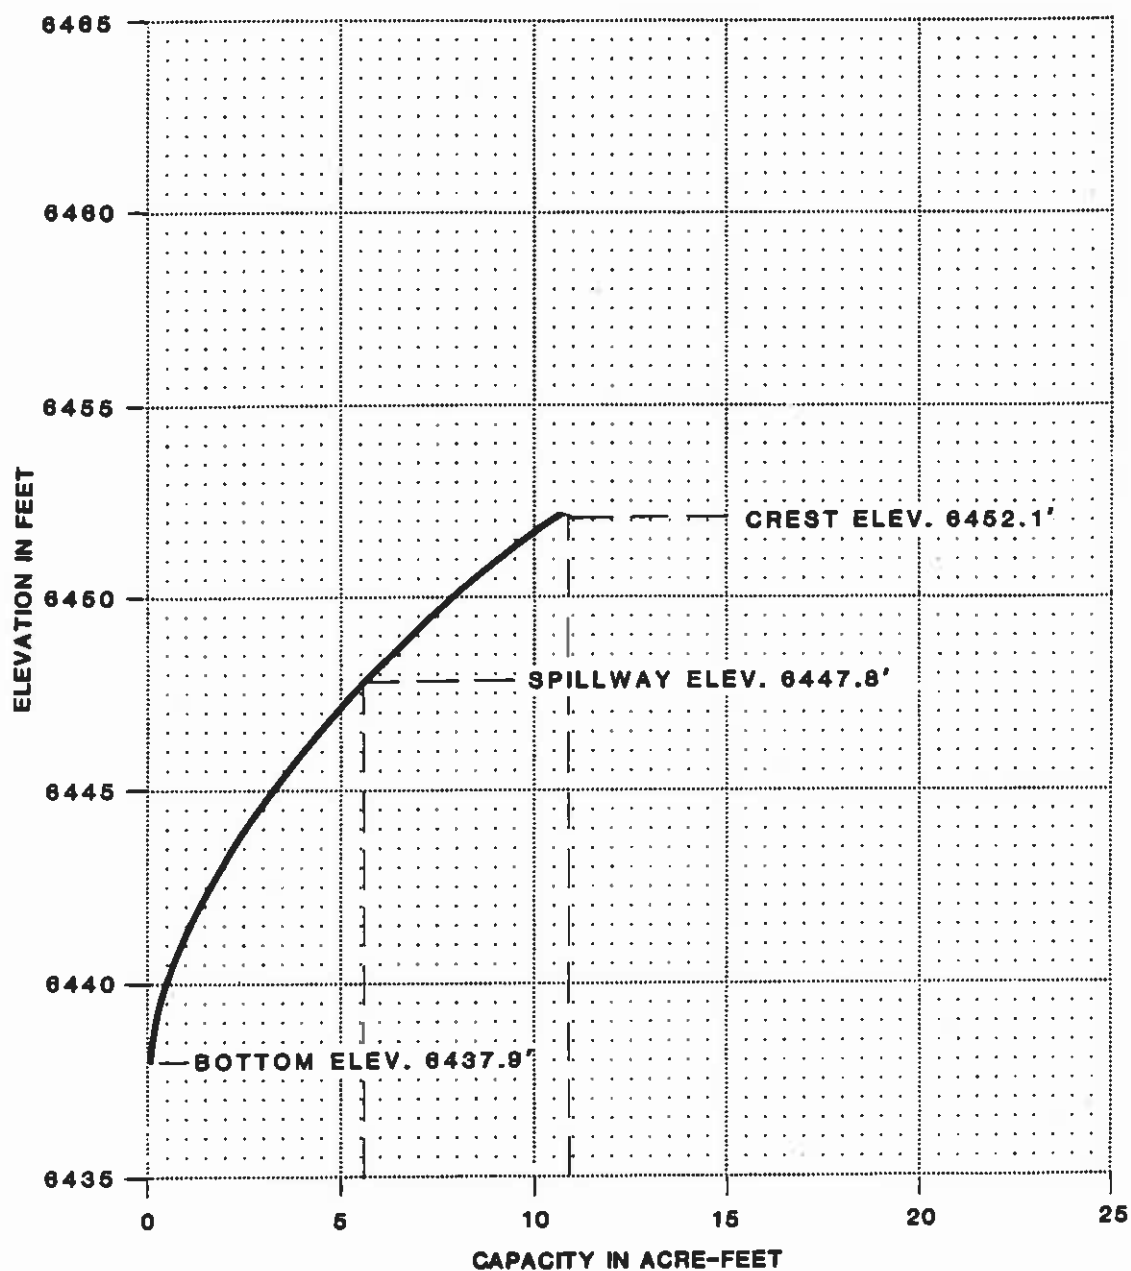
VOLUME-ELEVATION
CURVE
J7-K

The impoundment volume-elevation curve is based on site specific surveys conducted for Peabody Coal Company's August 1984 inspection, and 1985 resurveys, where available. Additionally, the most current topographic maps available were used in developing Plate 3, Volume-Elevation Curve, J7-K.

Total Storage Capacity	5.53	acre-ft
10-year, 24-hour Storm Inflow	3.38	acre-ft
Available Sediment Storage Capacity . .	2.15	acre-ft
Sediment Inflow Rate	0.259	acre-ft/yr
Sediment Storage Life	8	yrs

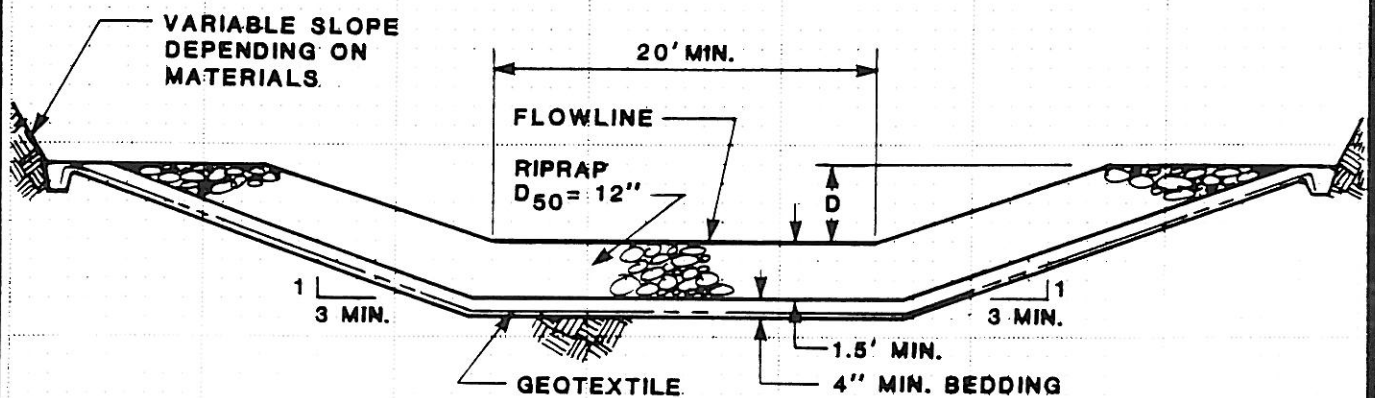
SPILLWAY AND OUTFLOW CHANNEL CROSS SECTION J7-K

There is presently no erosion protection within the channel.
