INSPECTION REPORT
Sedimentation Structure
J7-M
Black Mesa Mine
Navajo County, Arizona
for
PEABODY COAL COMPANY

Dames & Moore
10139-011-22

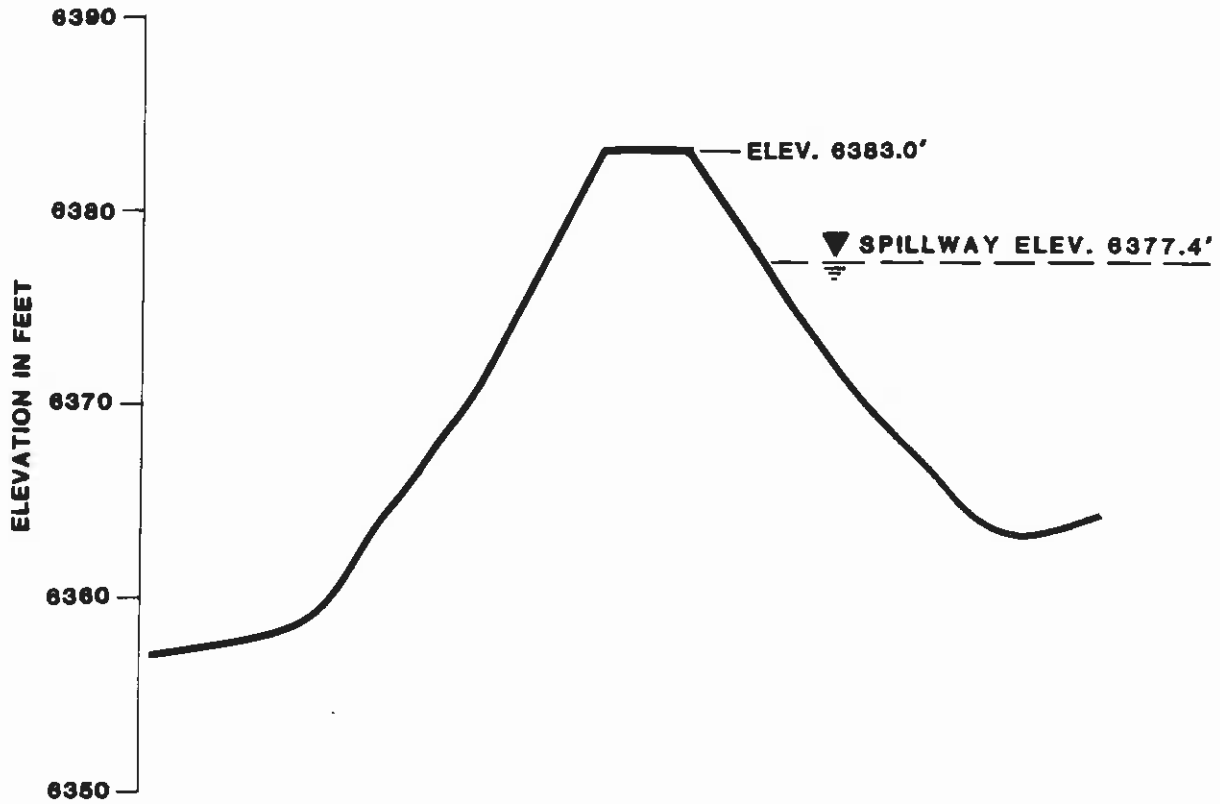
EXISTING
MAXIMUM CROSS-SECTION
A-A'
J7-M

A cross-section of the embankment is shown on Plate 2, Existing Maximum Cross Section J7-M, A-A'. Grass provides erosion protection on the upstream and downstream slopes of the embankment.

The J7-M embankment is lower in height; however, the downstream slope is steeper than the category standard; therefore, the embankment has factors of safety less than the design minimum.

The inspection of Structure J7-M indicated that the geotechnical problems consist of rills on the upstream and downstream slopes and gullies in the right and left abutments; and a steep downstream slope. Correction of erosion is considered a periodic maintenance task and does not require

remedial action. The downstream slope should be flattened to 4.0 horizontal to 1 vertical to meet stability requirements.

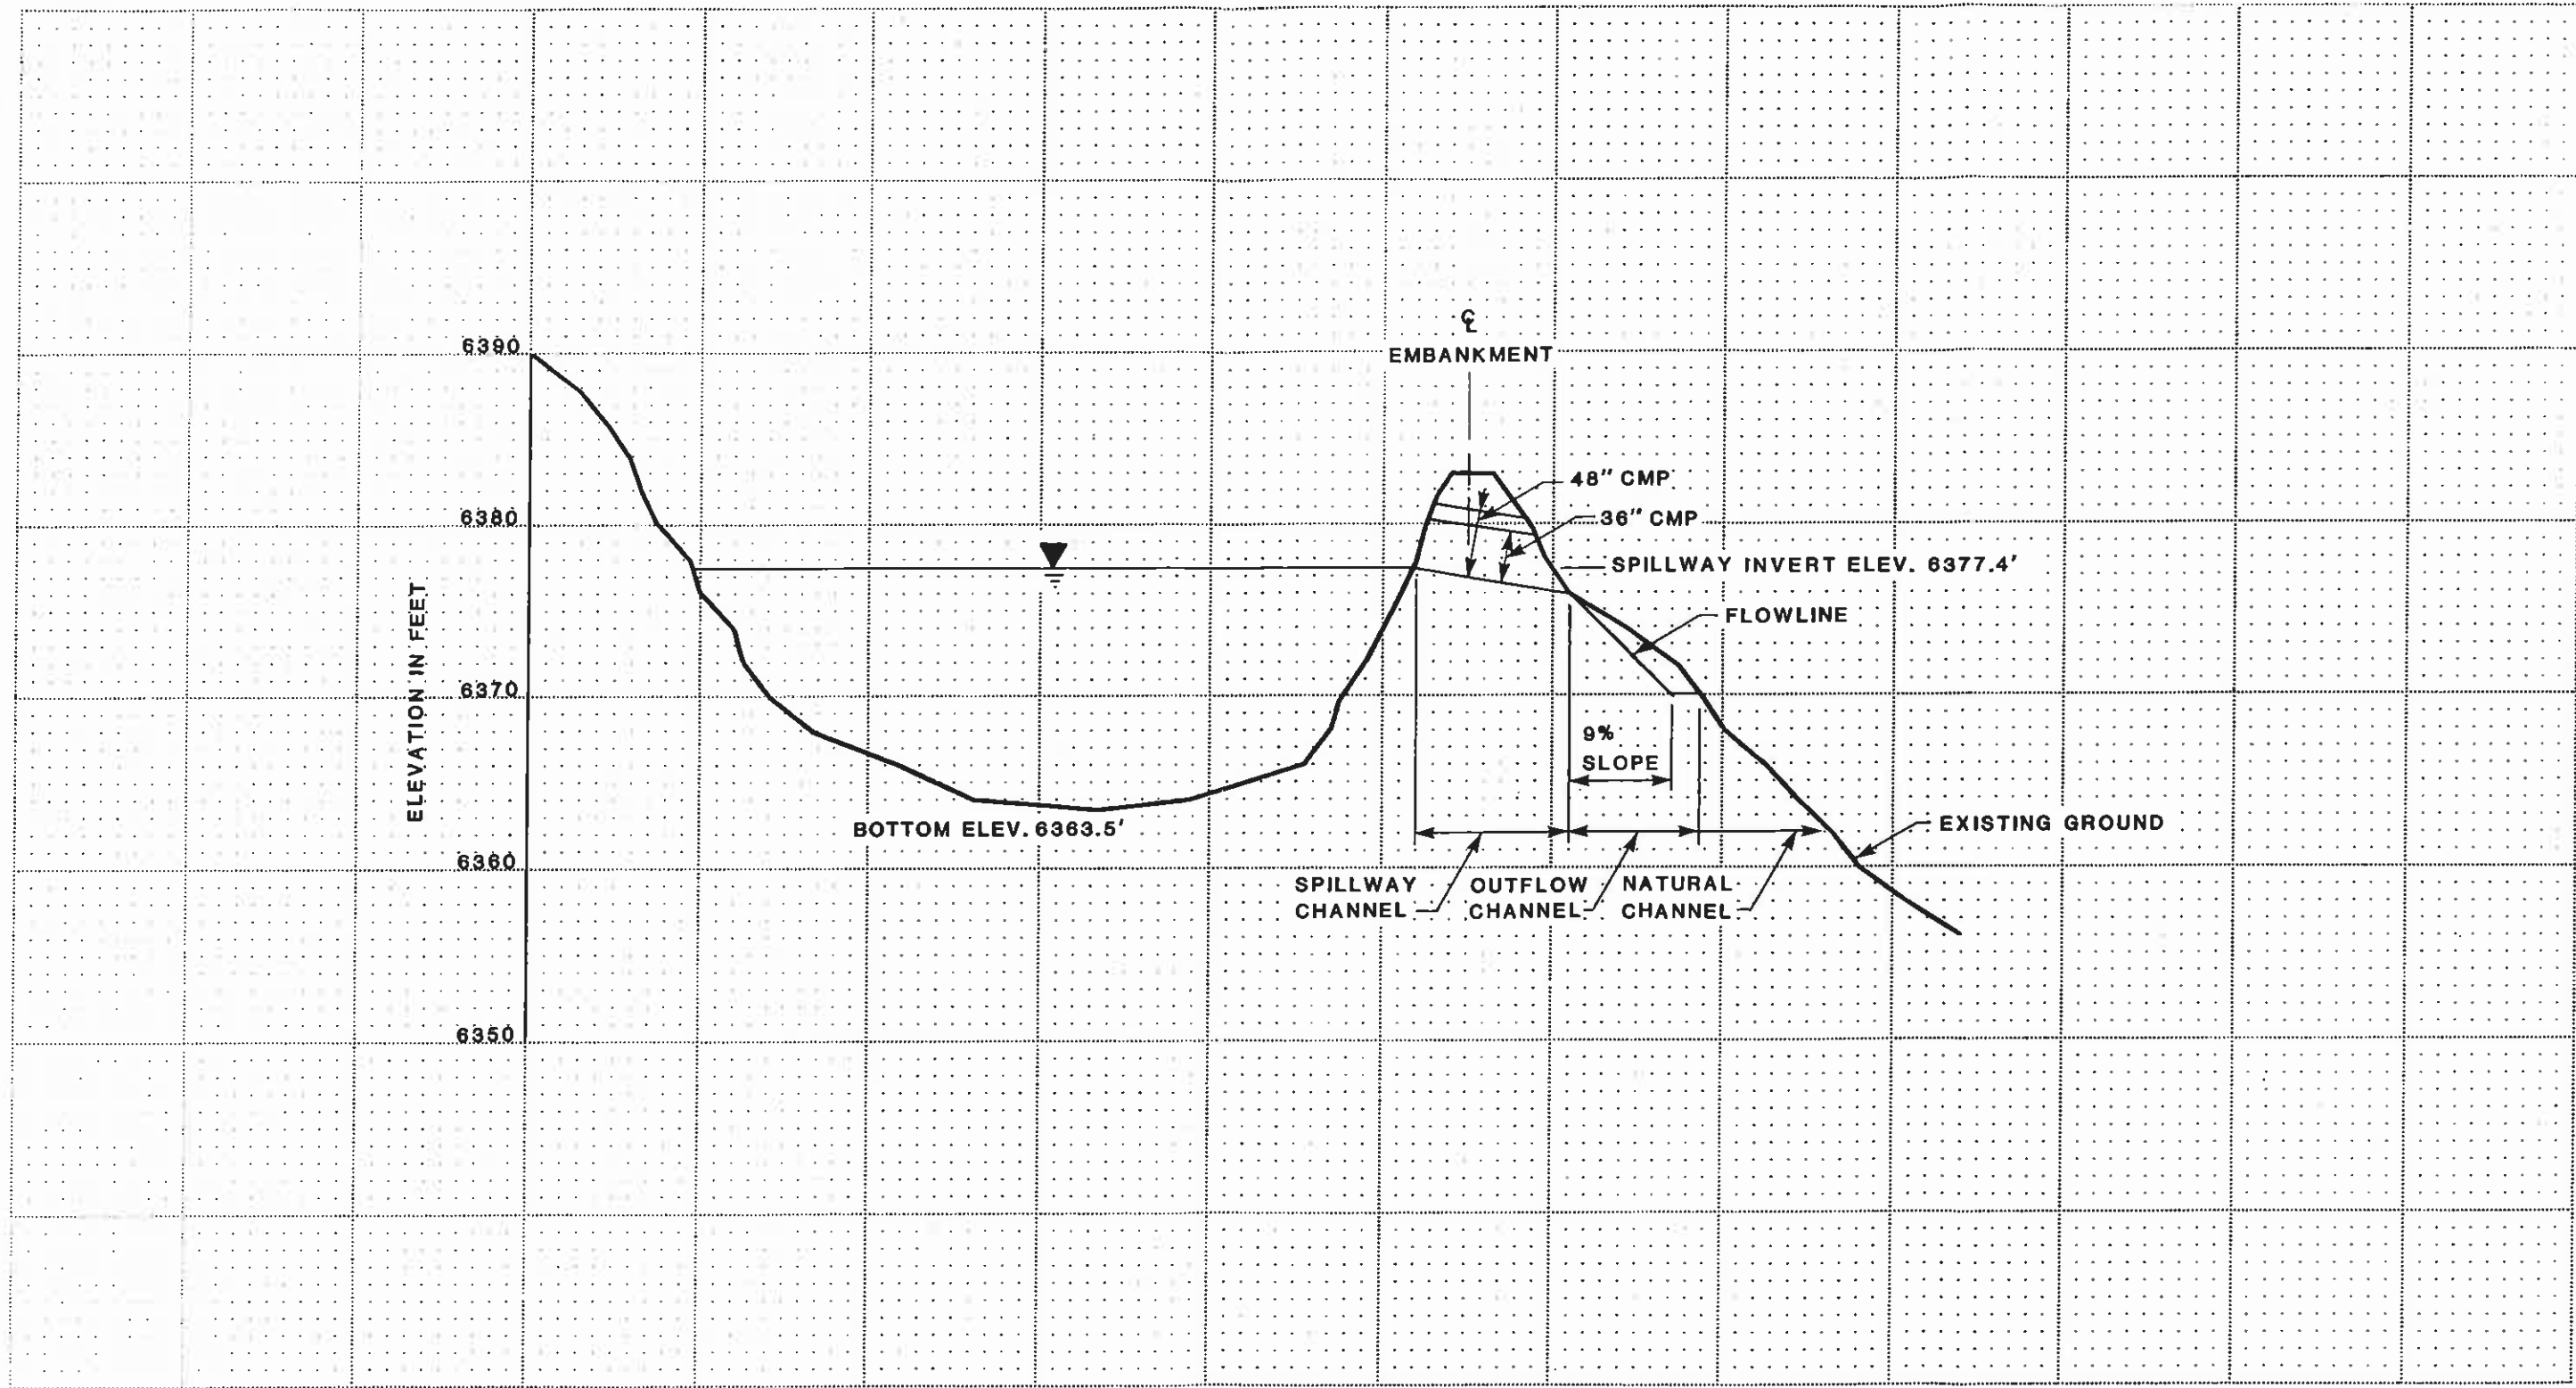
CHANNEL PROFILE B-B'
J7-M

The storage capacity and spillway capacity of Structure J7-M are adequate; however, the spillway does not have an adequate outflow channel. A trapezoidal outflow channel should be constructed along the alignment B-B' shown in Plate 1. The channel profile is shown in Plate 4 and the required dimensions are shown in Plate 5. The outflow channel should be protected against erosion using geotextile and riprap as shown in Plate 5. A trash-rack should be installed on the inlet of the CMP to prevent clogging of the spillway.
