INSPECTION REPORT
Sedimentation Structure
J28-B
Kayenta Mine
Navajo County, Arizona

for
PEABODY COAL COMPANY

Dames & Moore
10139-011-22

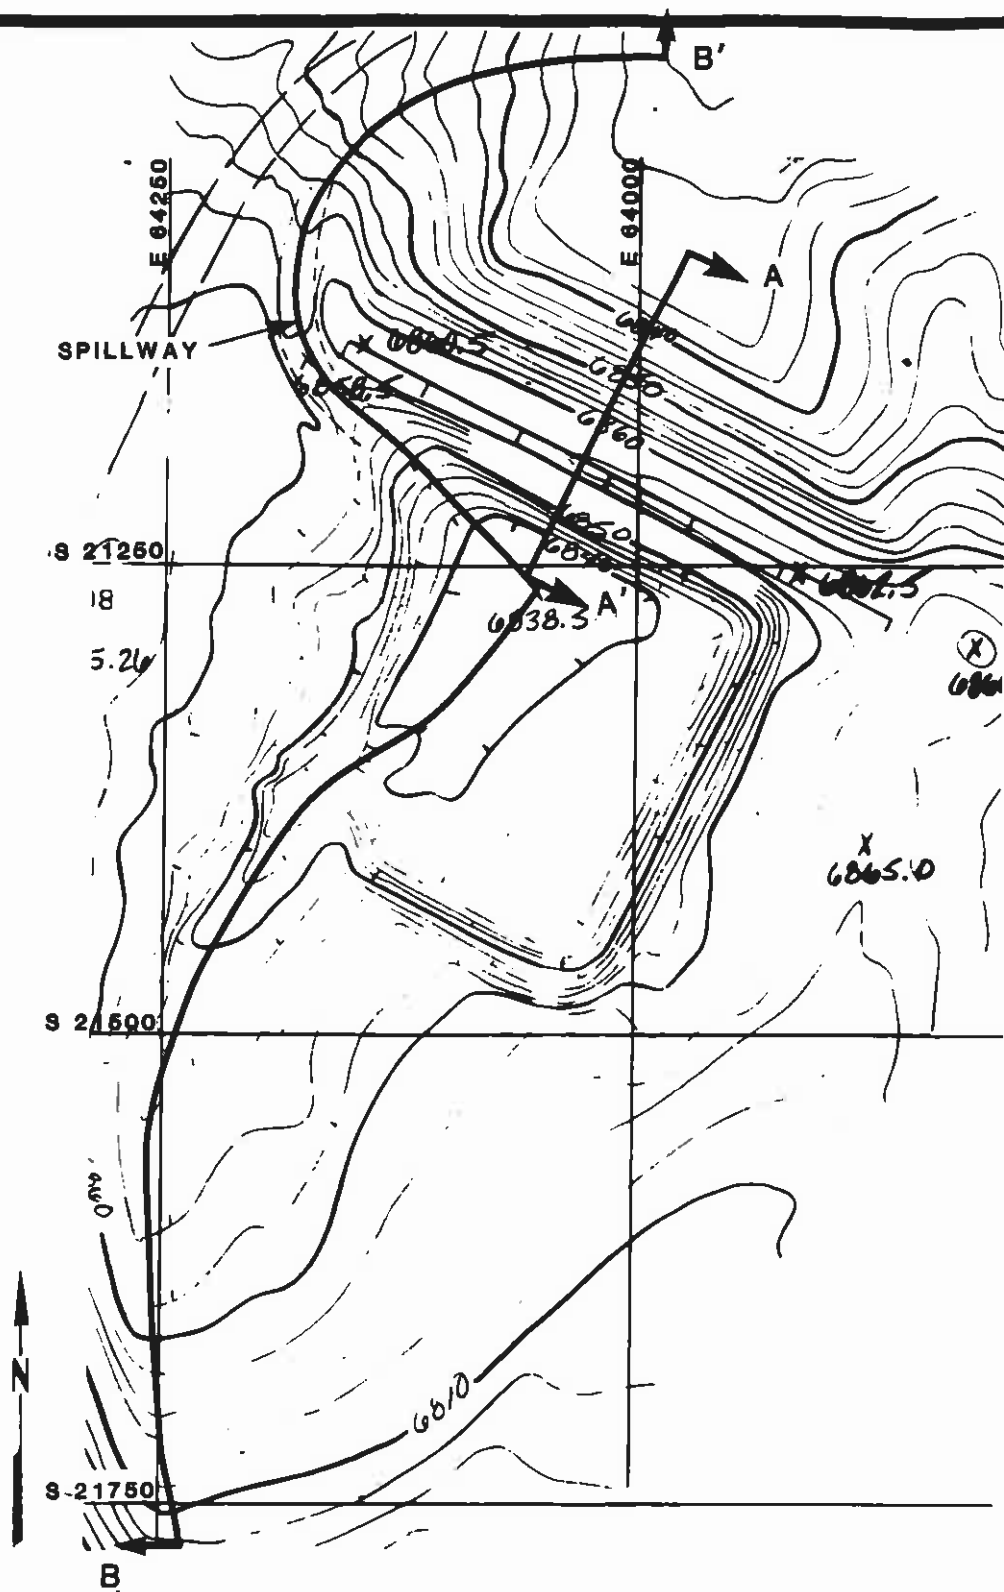
Plate 1

Sedimentation Structure J28-B is an earthen embankment, designed and constructed in 1983 by Peabody Coal Company as a temporary sedimentation structure to control runoff and sediment from the disturbed mining areas of the Kayenta Mine. The location of Structure J28-B is shown on Plate 1, Site Plan.

The storage capacity and spillway capacity of Structure J28-B are adequate; however, the spillway does not have an adequate outflow channel or adequate erosion protection. A trapezoidal outflow channel should be constructed along the alignment B-B' shown in Plate 1. The channel profile is shown in Plate 4 and the required dimensions are shown in Plate 5. Both the spillway and outflow channel should be protected against erosion using geotextile and gravel as shown in Plate 5.

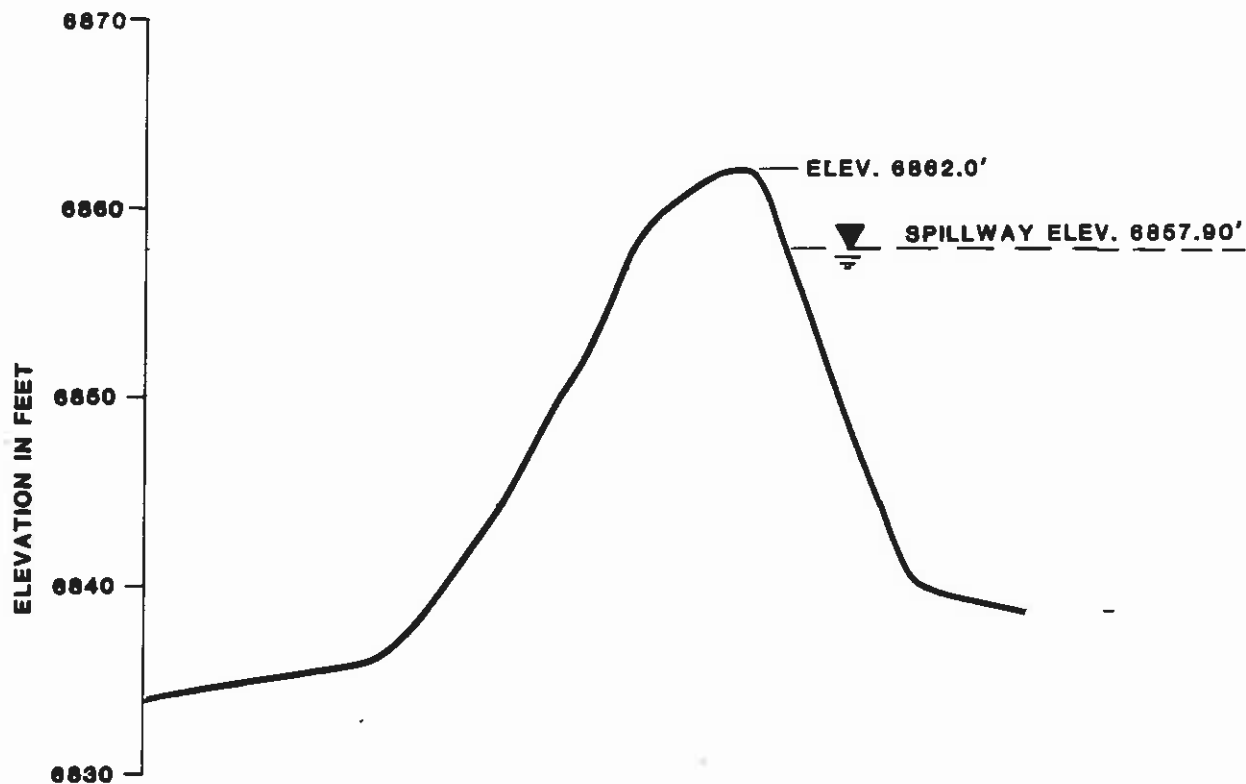
Plate 2

A cross-section of the embankment is shown on Plate 2, Existing Maximum Cross Section J28-B, A-A'. Grass provides erosion protection on the downstream slope of the embankment.

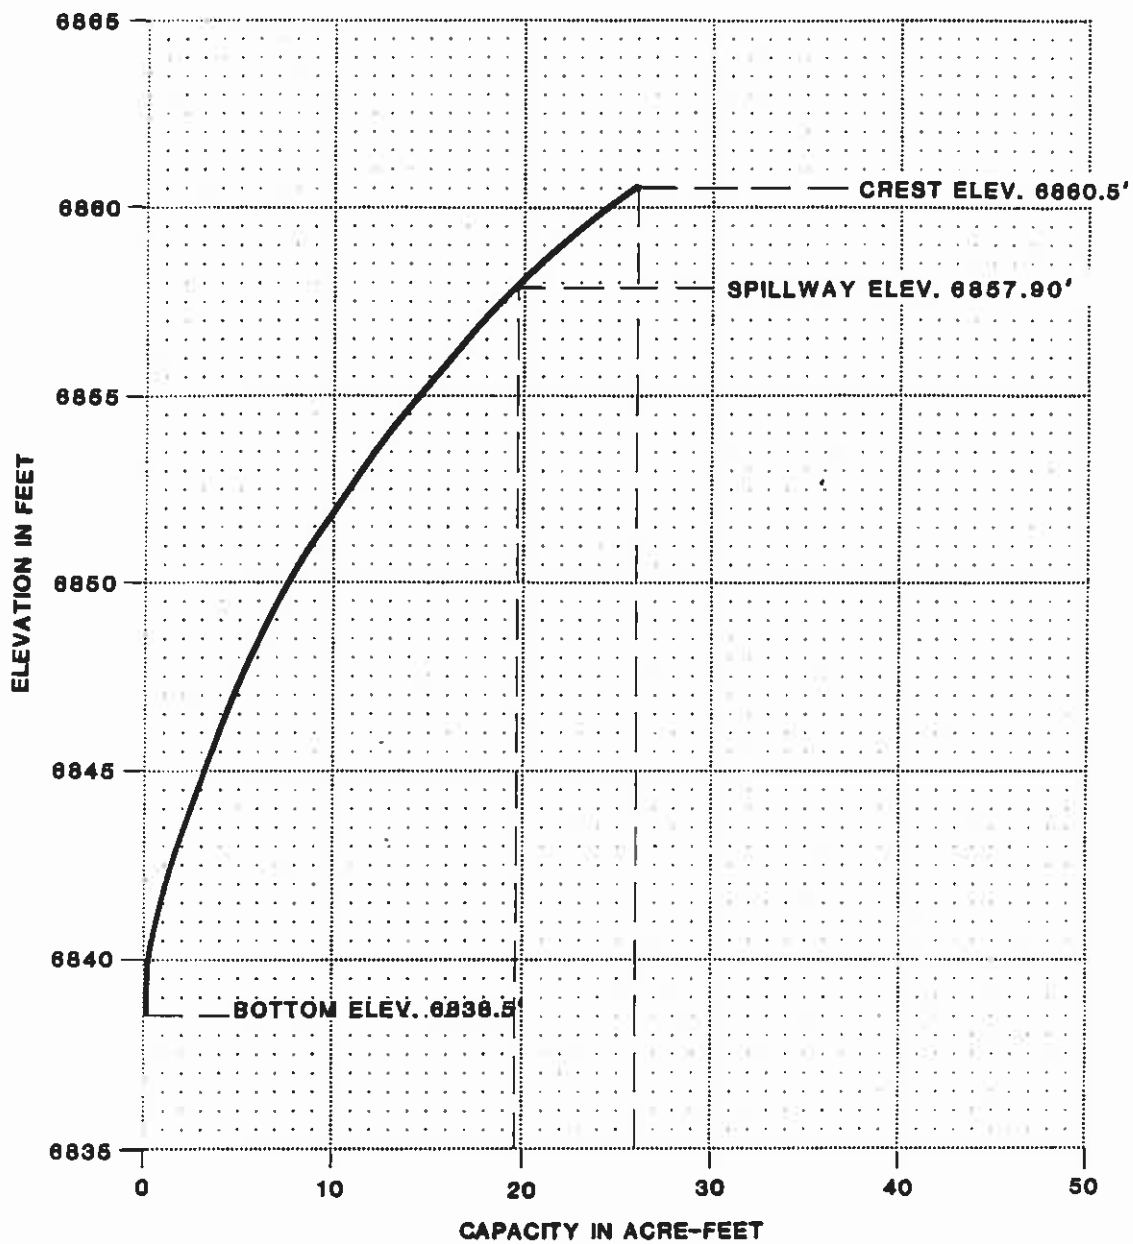
**VOLUME-ELEVATION
CURVE
J28-B**

The hydrologic analysis gives the storage volume required to contain the 10-year, 24-hour storm, and the remaining storage volume available for storing sediment. The existing storage capacity of J28-B is shown on Plate 3, Volume-Elevation Curve, J28-B, and the results of the analysis are summarized in the following table.

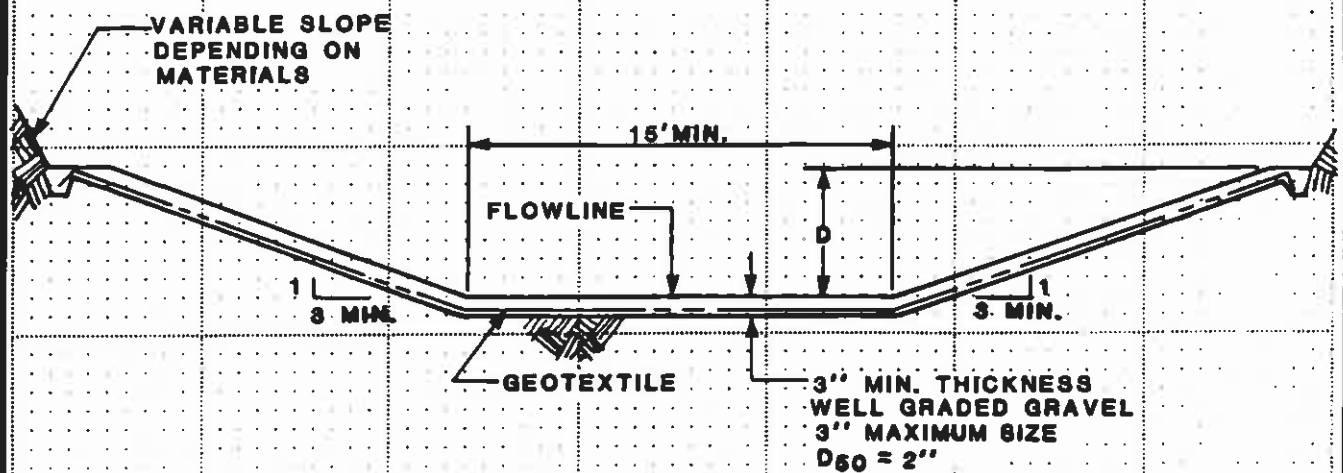
**SPILLWAY AND
OUTFLOW CHANNEL
CROSS SECTION
J28-B**

There is presently no erosion protection within the channel.
