INSPECTION REPORT
Sedimentation Structure
J28-C
Kayenta Mine
Navajo County, Arizona
for
PEABODY COAL COMPANY

Dames & Moore
10139-011-22

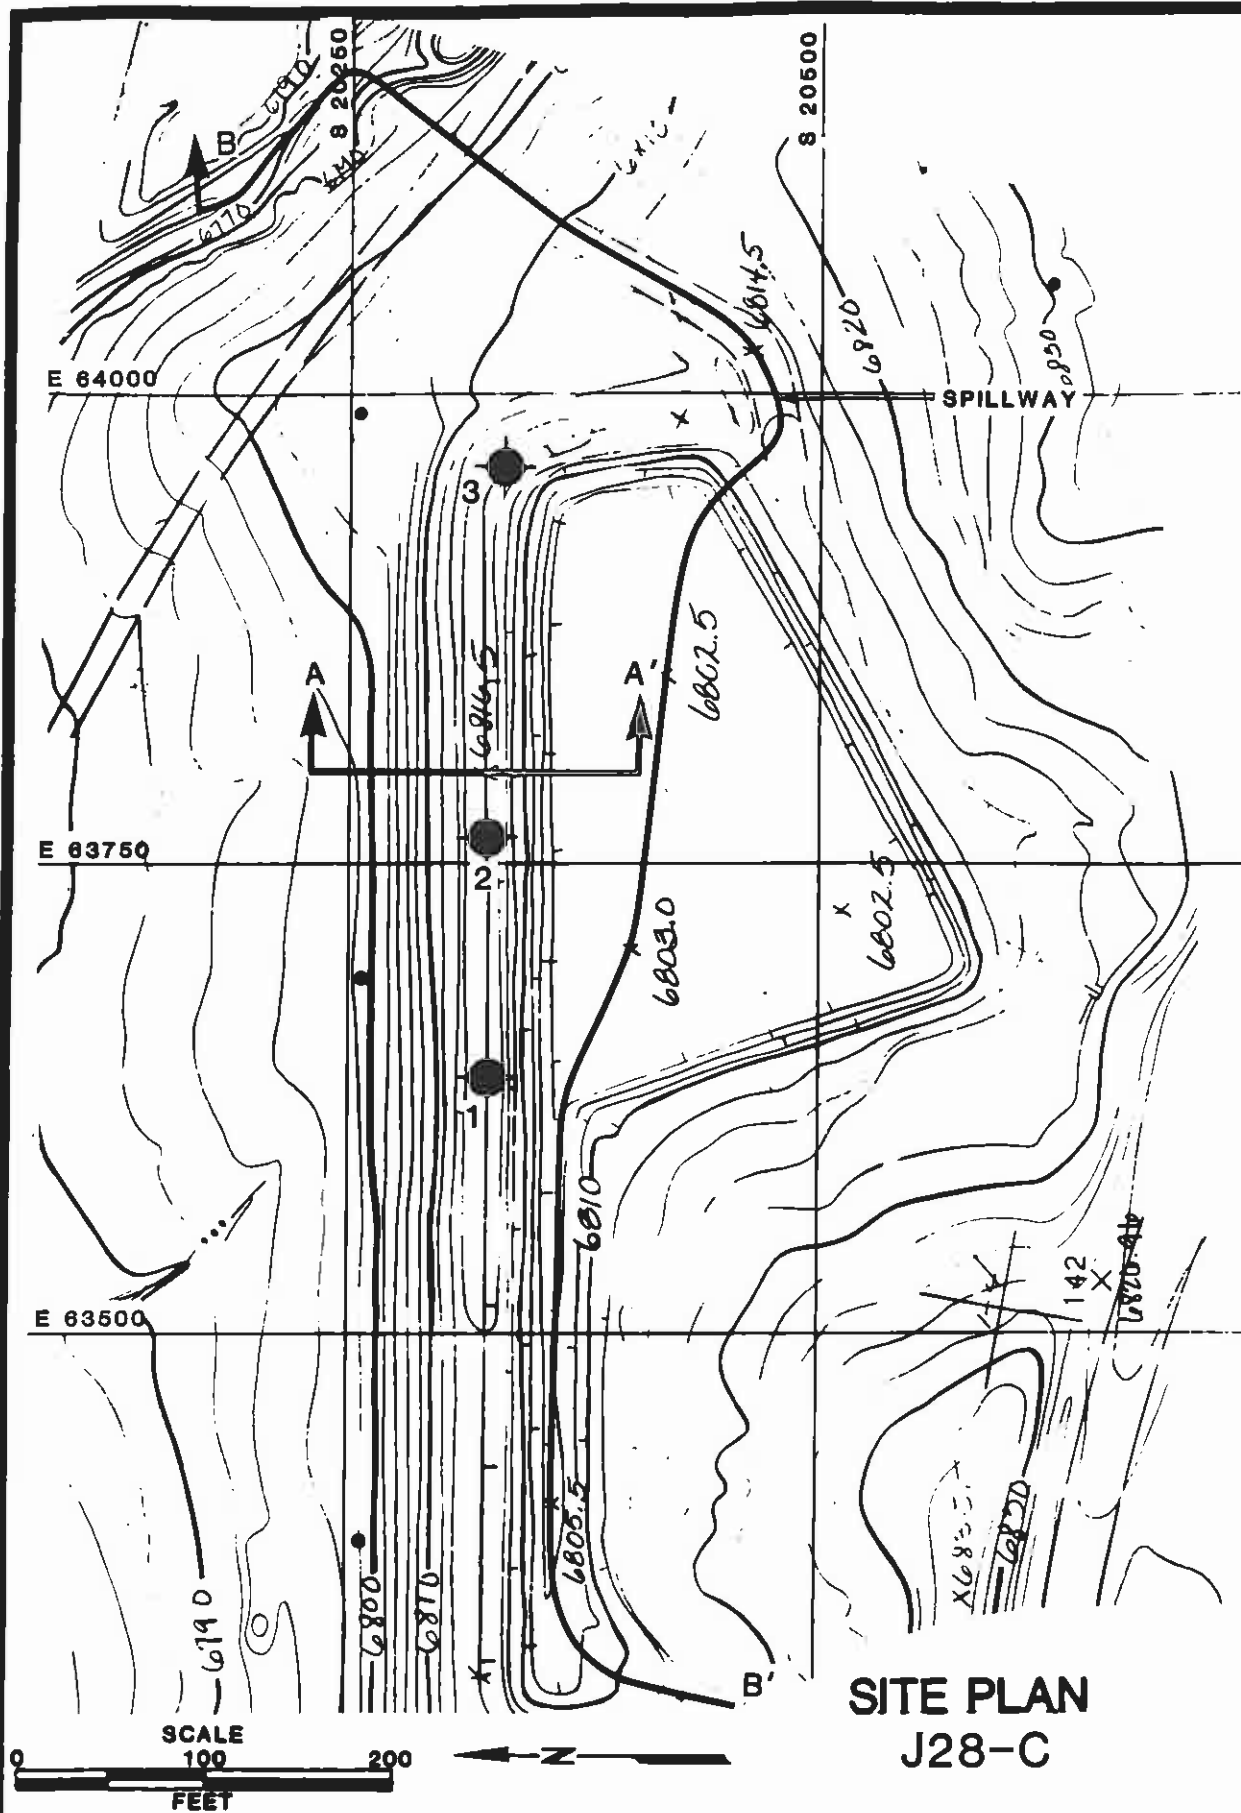
SITE PLAN
J28-C

Sedimentation Structure J28-C is an earthen embankment, designed and constructed in 1983 by Peabody Coal Company as a temporary sedimentation structure to control runoff and sediment from the disturbed mining areas of the Kayenta Mine. The location of Structure J28-C is shown on Plate 1, Site Plan.

The storage capacity and spillway capacity of Structure J28-C are adequate; however, the spillway does not have an adequate outflow channel or adequate erosion protection. A trapezoidal outflow channel should be constructed along the alignment B-B' shown in Plate 1. The channel profile is shown in Plate 4 and the required dimensions are shown in Plate 5. Both the spillway and outflow channel should be protected against erosion using geotextile and gravel as shown in Plate 5.

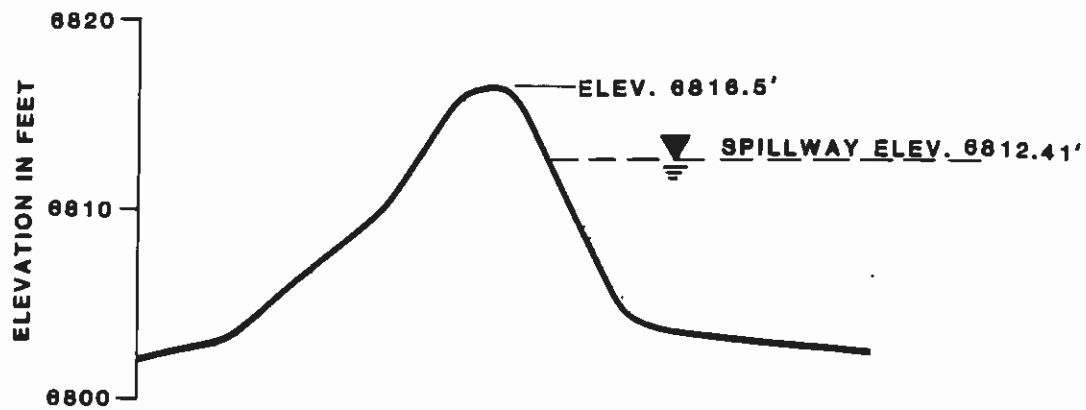
EXISTING
MAXIMUM CROSS-SECTION
A-A'
J28-C

A cross-section of the embankment is shown on Plate 2, Existing Maximum Cross Section J28-C, A-A'. Grass provides erosion protection on the upstream and downstream slopes of the embankment.

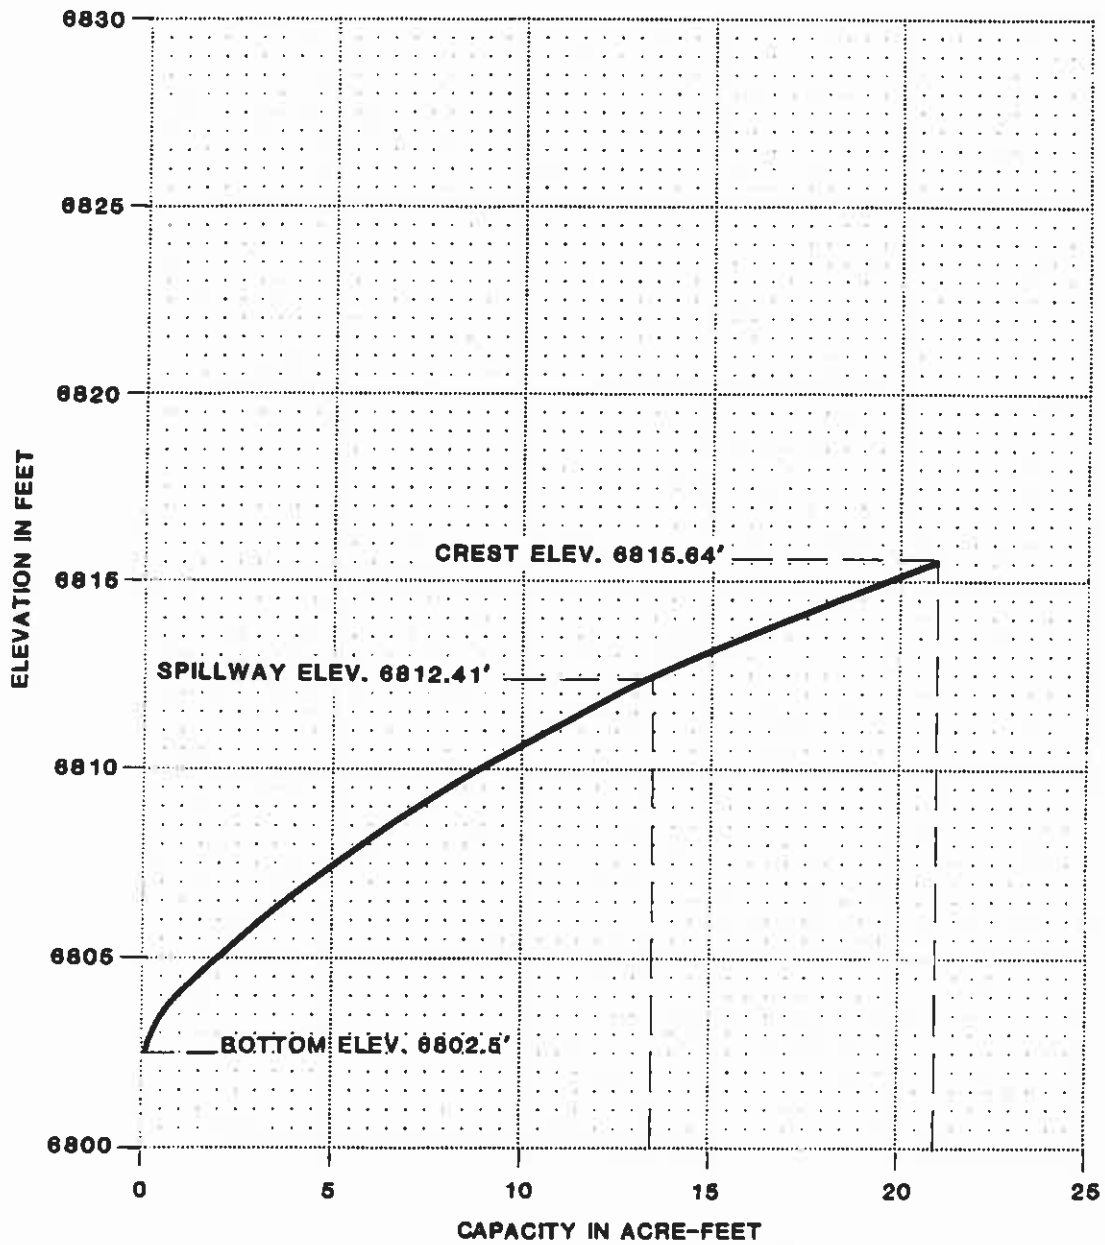
VOLUME-ELEVATION
CURVE
J28-C

The hydrologic analysis gives the storage volume required to contain the 10-year, 24-hour storm, and the remaining storage volume available for storing sediment. The existing storage capacity of J28-C is shown on Plate 3, Volume-Elevation Curve, J28-C, and the results of the analysis are summarized in the following table.

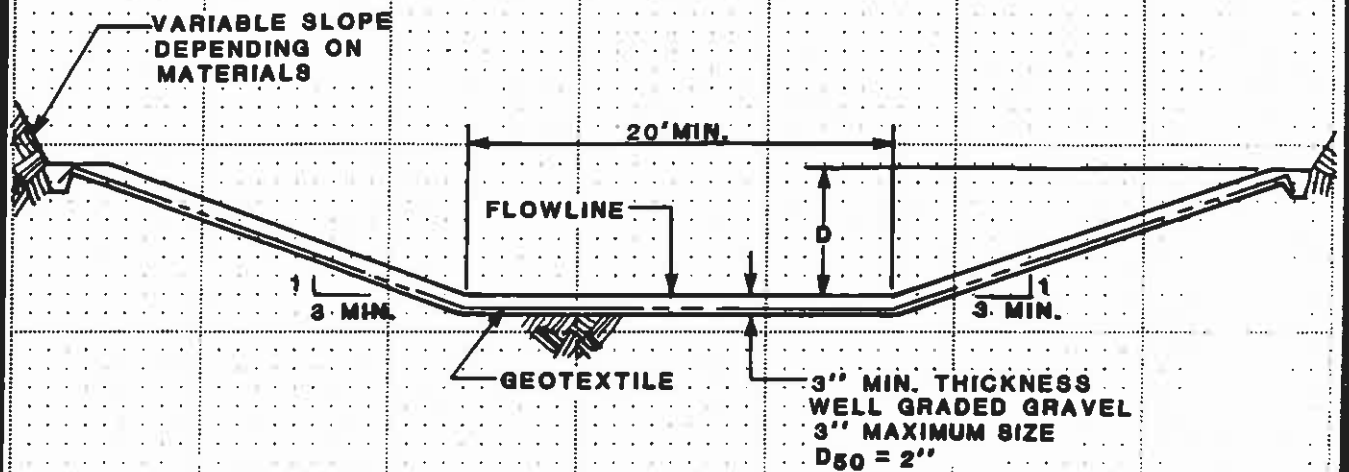
**SPILLWAY AND
OUTFLOW CHANNEL
CROSS SECTION**

There is presently no erosion protection within the channel.
