INSPECTION REPORT
Sedimentation Structure
J28-D
Kayenta Mine
Navajo County, Arizona
for
PEABODY COAL COMPANY

Dames & Moore
10139-011-22

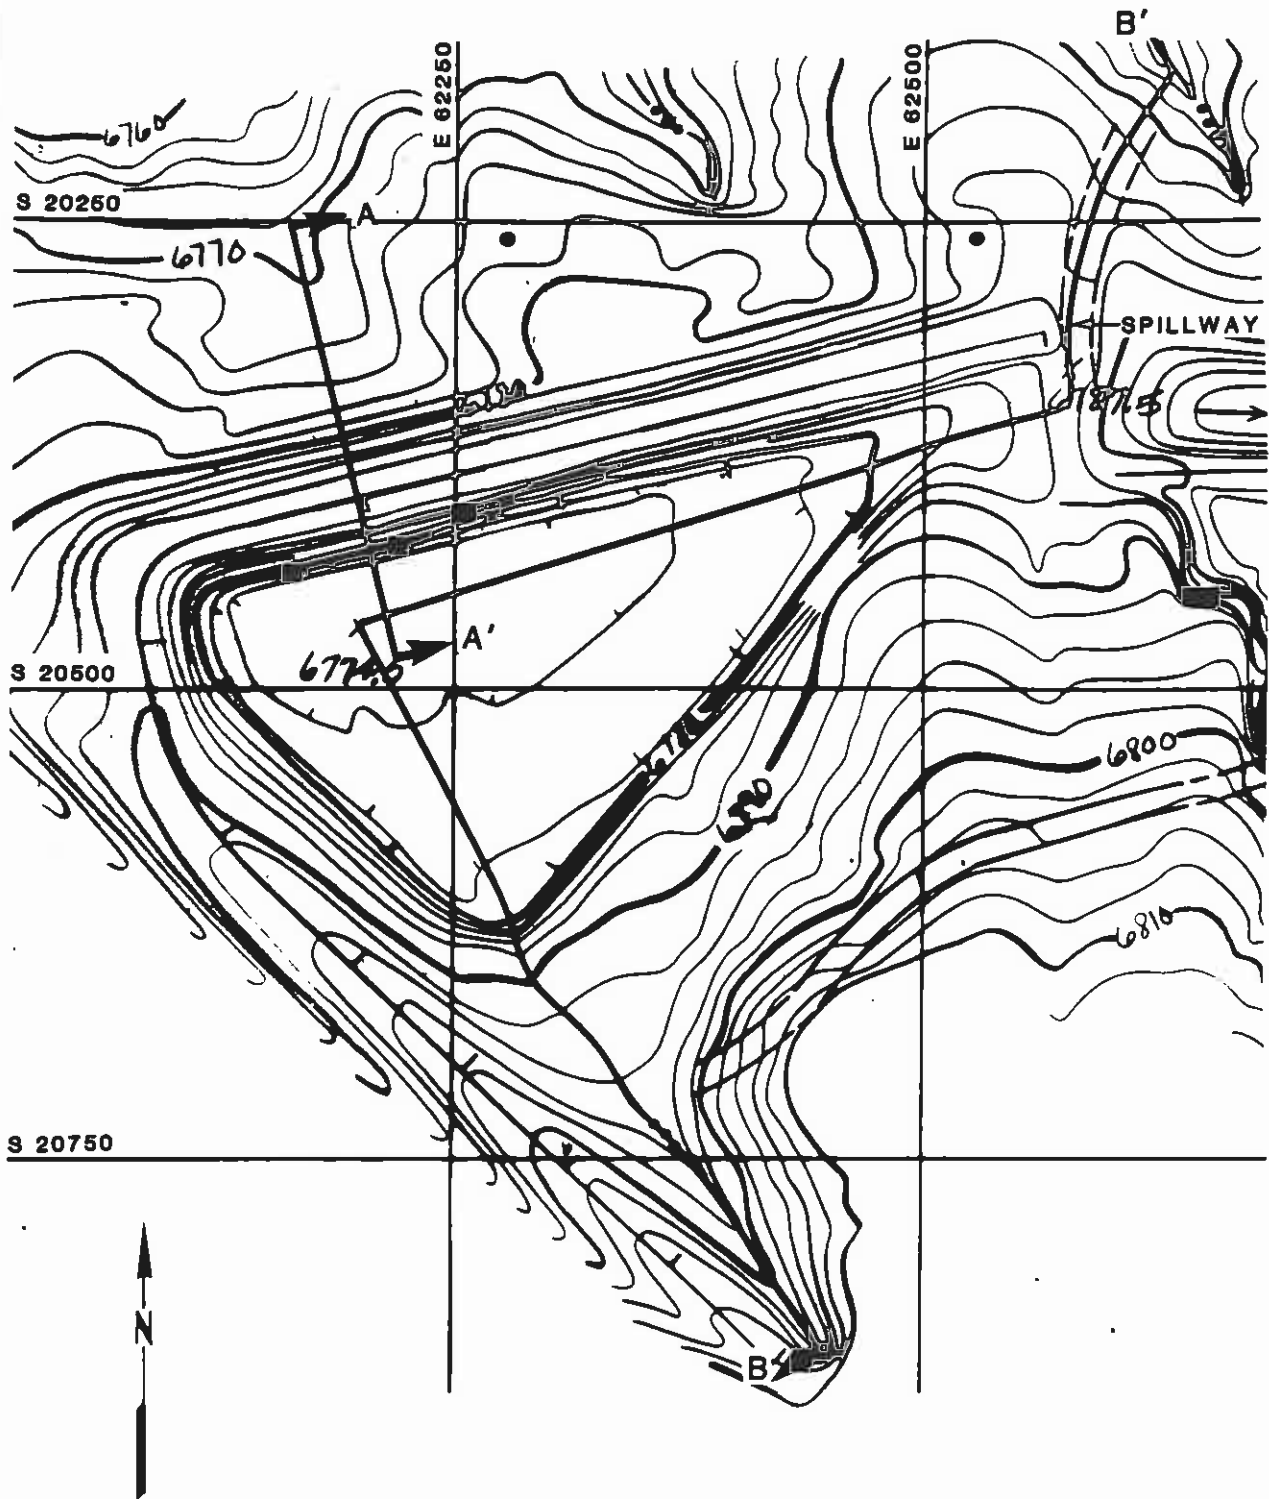
SITE PLAN
J28-D

The storage capacity and spillway capacity of Structure J28-D are adequate; however, the spillway does not have an adequate outflow channel or adequate erosion protection. A trapezoidal outflow channel should be constructed along the alignment B-B' shown in Plate 1. The channel profile is shown in Plate 4 and the required dimensions are shown in Plate 5. Both the spillway and outflow channel should be protected against erosion using geotextile and gravel as shown in Plate 5.

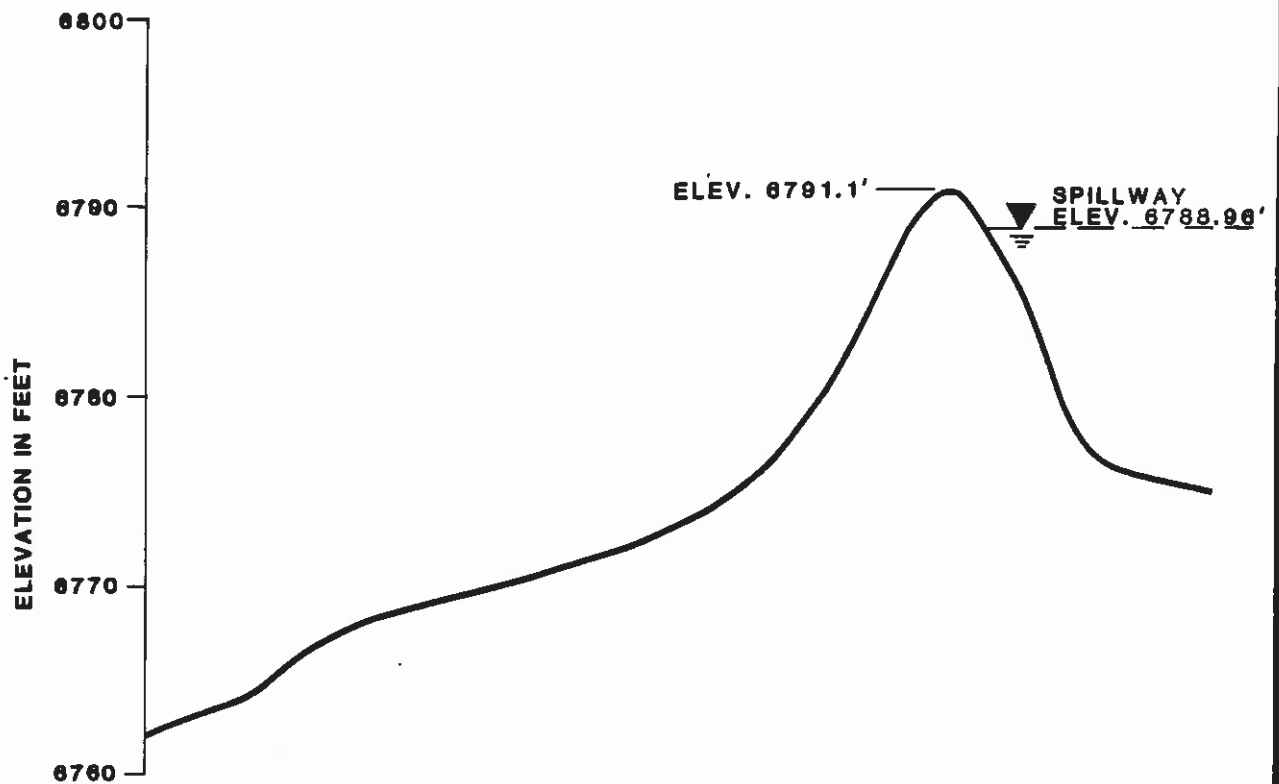
EXISTING
MAXIMUM CROSS-SECTION
A-A'
J28-D

A cross-section of the embankment is shown on Plate 2, Existing Maximum Cross Section J28-D, A-A'. Grass provides erosion protection on the downstream slope of the embankment.

The J28-D embankment is lower in height; however, the downstream slope is steeper than the category standard; therefore, the embankment has factors of safety less than the design minimum.

The inspection of Structure J28-D indicated that the only geotechnical problem is rill and gulley erosion on the upstream slope. Correction of erosion is considered a periodic maintenance task and does not require remedial action. The downstream slope should be flattened to 2.5 horizontal to 1 vertical to meet stability requirements.

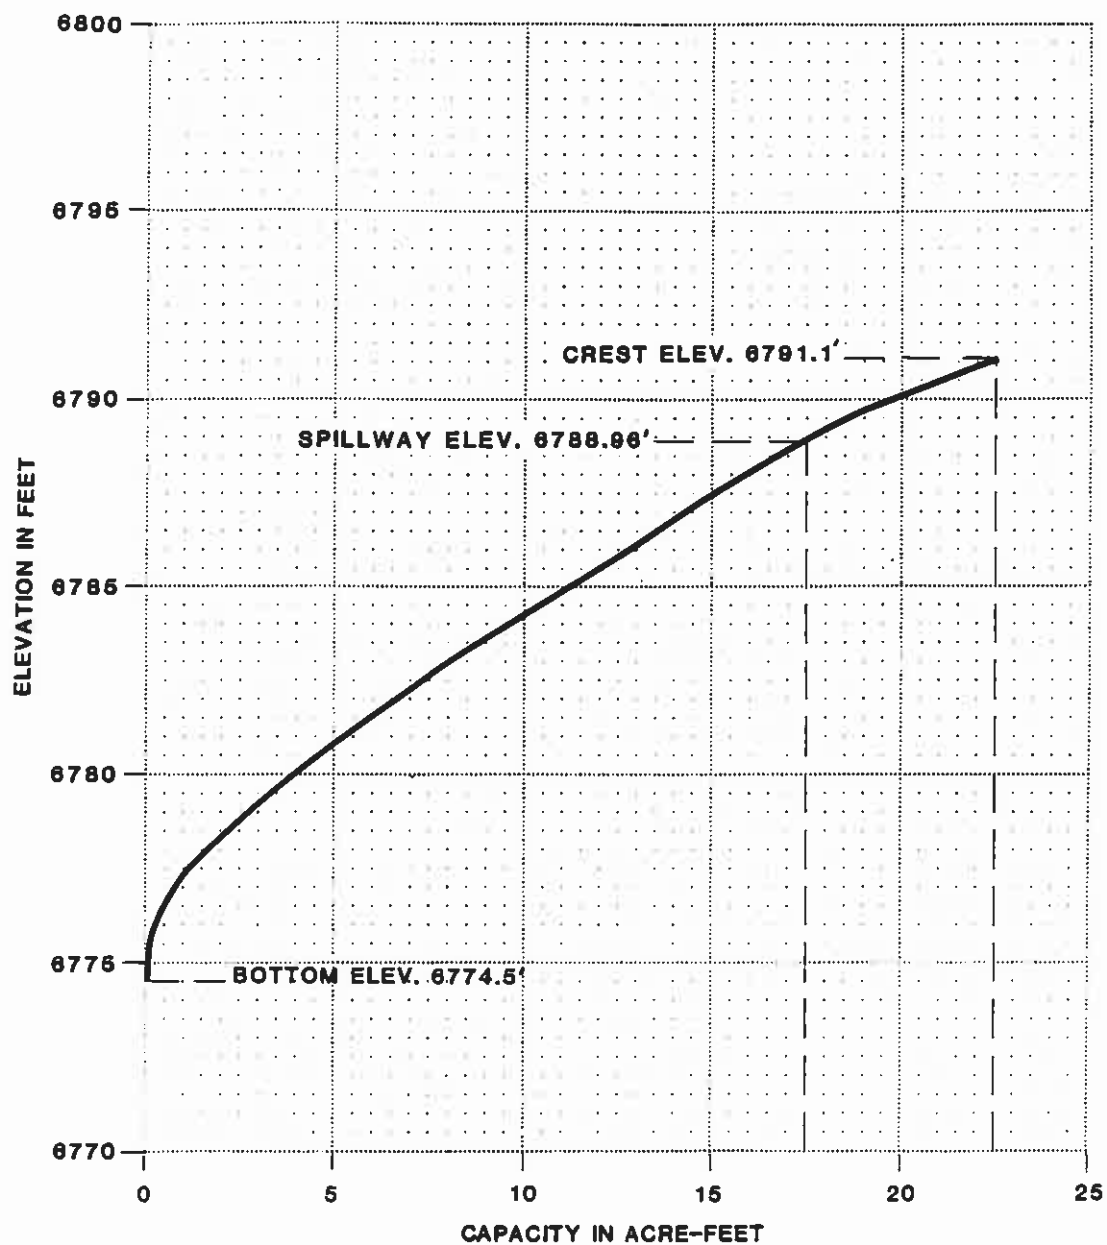
VOLUME-ELEVATION
CURVE
J28-D

The hydrologic analysis gives the storage volume required to contain the 10-year, 24-hour storm, and the remaining storage volume available for storing sediment. The existing storage capacity of J28-D is shown on Plate 3, Volume-Elevation Curve, J28-D, and the results of the analysis are summarized in the following table.

Total Storage Capacity	17.6	acre-ft
10-year, 24-hour Storm Inflow	2.79	acre-ft
Available Sediment Storage Capacity . .	14.77	acre-ft
Sediment Inflow Rate	1.22	acre-ft/yr
Sediment Storage Life	12	yrs

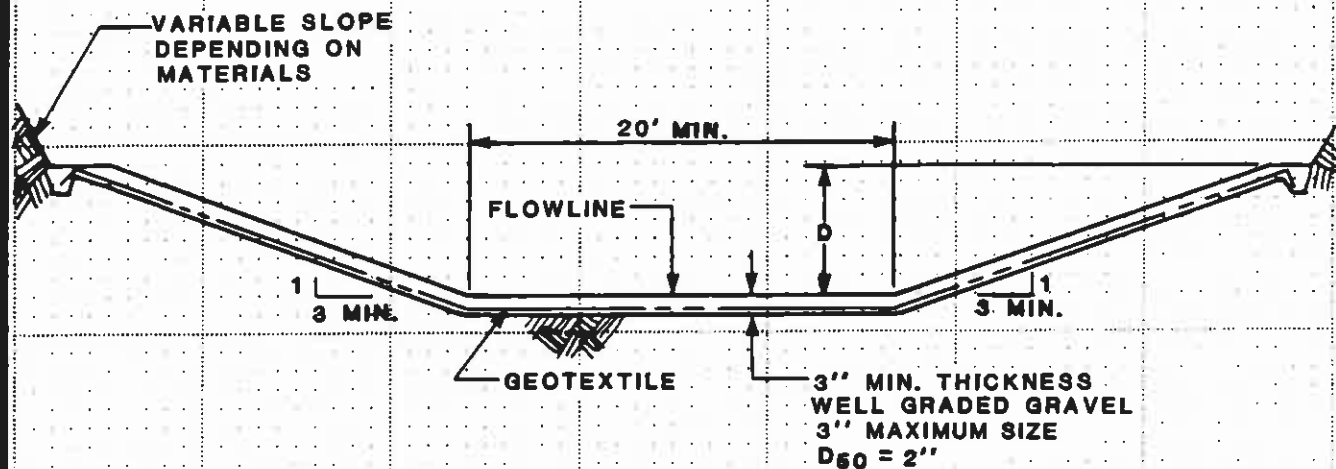
**SPILLWAY AND
OUTFLOW CHANNEL
CROSS SECTION
J28-D**

There is presently no erosion protection within the channel.
