INSPECTION REPORT
Sedimentation Structure
J28-G
Kayenta Mine
Navajo County, Arizona
for
PEABODY COAL COMPANY

Dames & Moore
10139-011-22

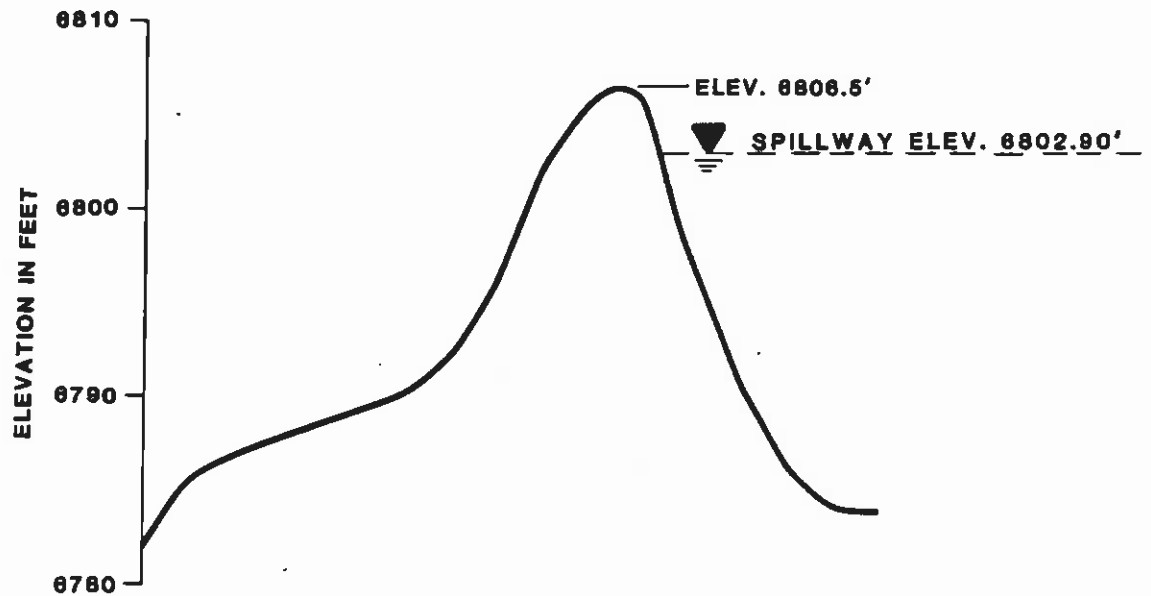
EXISTING
MAXIMUM CROSS-SECTION
A-A'
J28-G

Structure J28-G is a homogeneous earthen embankment classified as a sidehill embankment. Physical characteristics of the embankment are listed in the following table:

Embankment	Residual Shale Soils
Foundation	Residual Shale Soils
Right Abutment	Residual Shale Soils
Left Abutment	Residual Shale Soils
Height	18.5 ft
Crest Width	12 ft
Upstream Slope	2.6 H : 1 V
Downstream Slope	2.1 H : 1 V

The J28-G embankment is lower in height; however, the downstream slope is steeper than the category standard; therefore, the embankment has factors of safety less than the design minimum.

The downstream slope should be flattened to 2.5 horizontal to 1 vertical to meet stability requirements. The reason for this action is that the present condition may mask evidence of potential future problems.

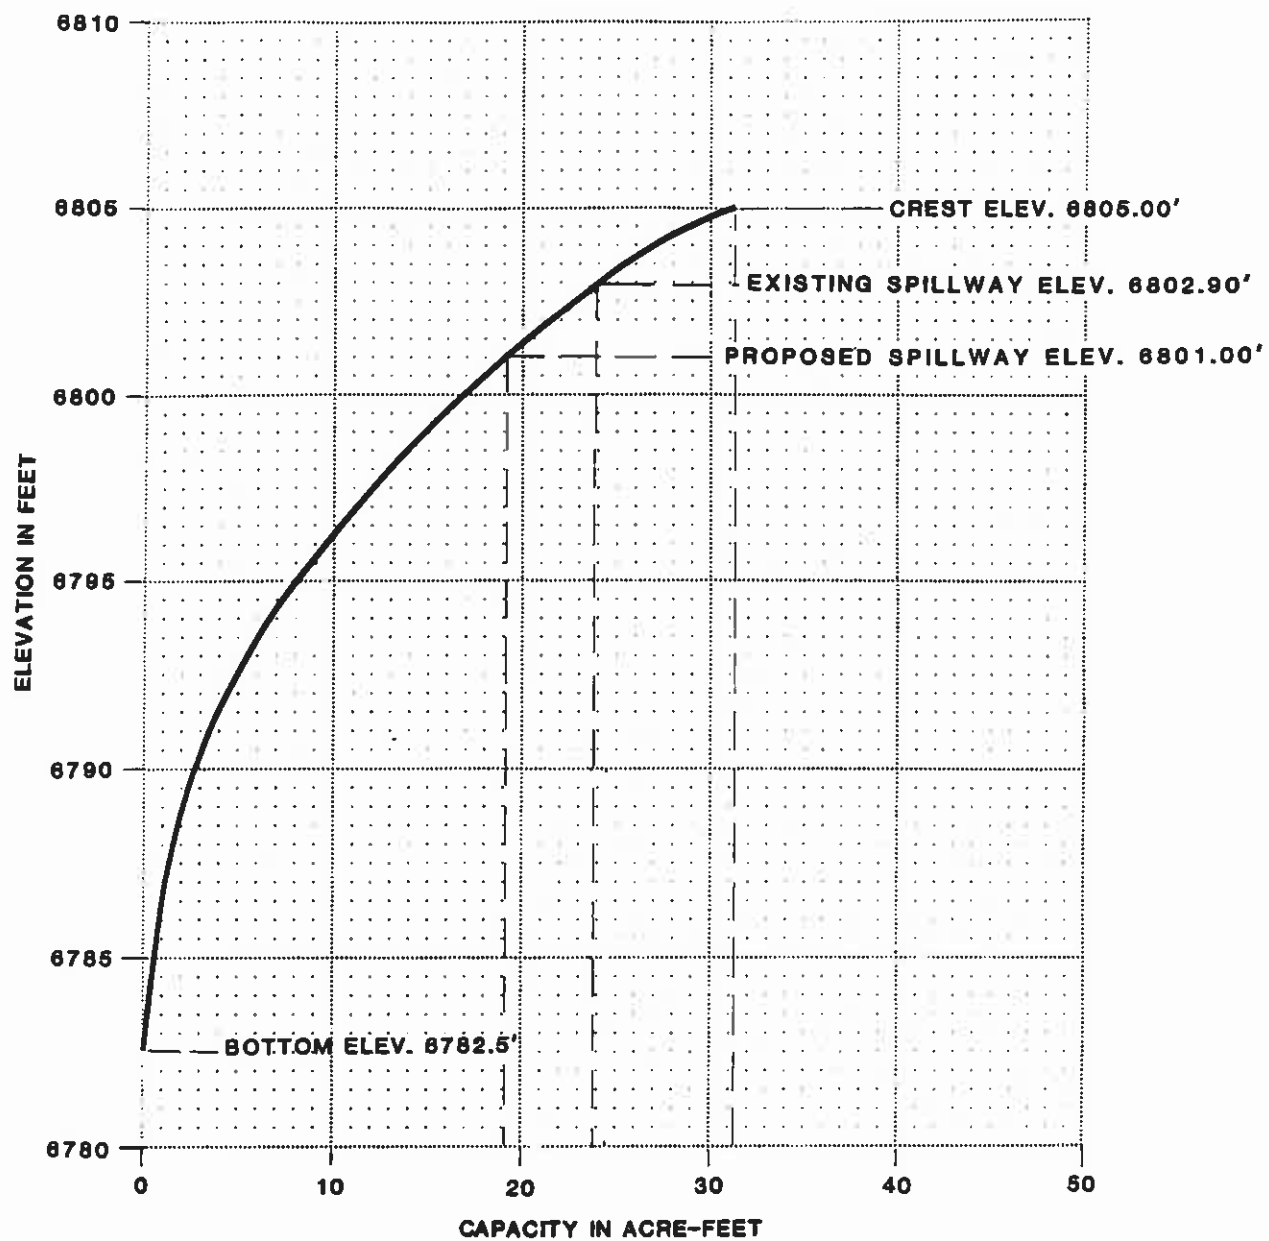
**VOLUME-ELEVATION
CURVE
J28-G**

The hydrologic analysis gives the storage volume required to contain the 10-year, 24-hour storm, and the remaining storage volume available for storing sediment. The existing storage capacity of J28-G is shown on Plate 3, Volume-Elevation Curve, J28-G, and the results of the analysis are summarized in the following table.

Total Storage Capacity	23.90	acre-ft
10-year, 24-hour Storm Inflow	4.26	acre-ft
Available Sediment Storage Capacity . .	19.64	acre-ft
Sediment Inflow Rate	0.666	acre-ft/yr
Sediment Storage Life	29	yrs

The storage capacity of Structure J28-G exceeds the maximum allowable capacity of 20 acre-feet. The spillway elevation should be reduced to 6801.0 feet, resulting in a storage capacity of 19.22 acre-feet.

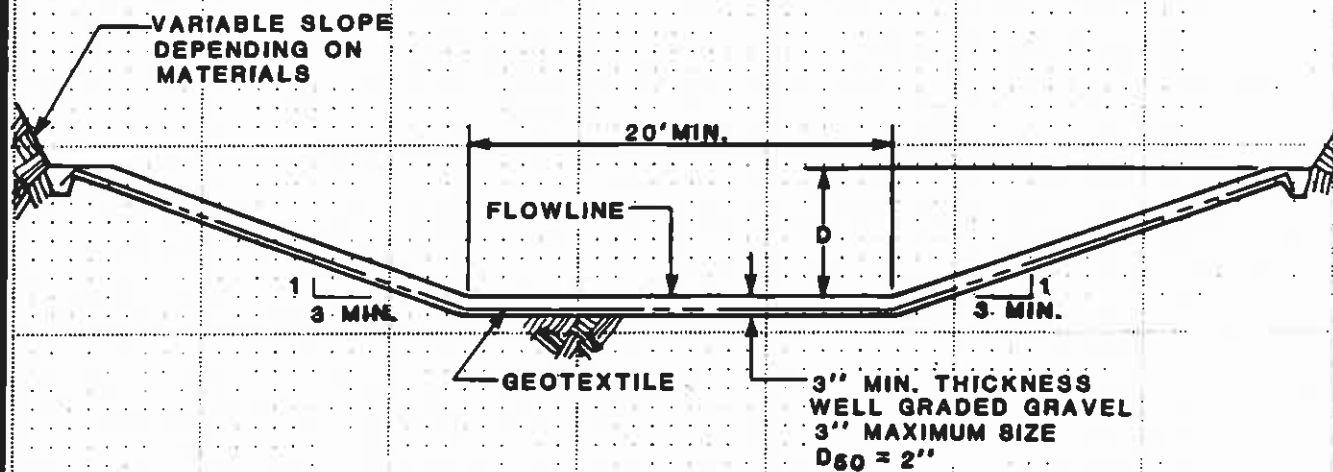
**SPILLWAY AND
OUTFLOW CHANNEL
CROSS SECTION
J28-G**

There is presently no erosion protection within the channel.

The reduced storage capacity and spillway capacity of Structure J28-G are adequate; however, the spillway and outflow channel do not have adequate erosion protection. Improvements to the trapezoidal outflow channel should be made along the alignment B-B' shown in Plate 1. The channel profile is shown in Plate 4 and the required dimensions are shown in Plate 5. Both the spillway and outflow channel should be protected against erosion using geotextile and gravel as shown in Plate 5.
