INSPECTION REPORT  
Sedimentation Structure  
KM-B  
Kayenta Mine  
Navajo County, Arizona  
for  
PEABODY COAL COMPANY

Dames & Moore  
10139-011-22

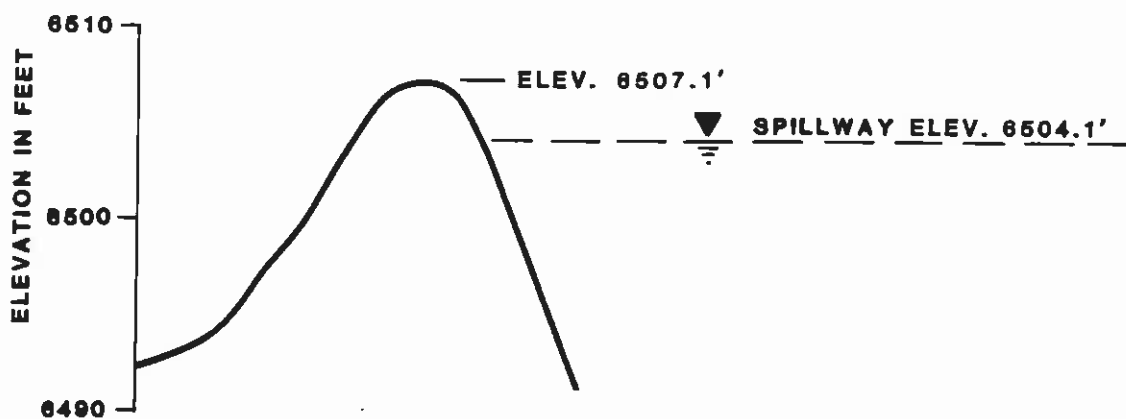
Plate 2

The KM-B embankment is lower in height; however, the upstream slope is steeper than the category standard; therefore, the embankment has factors of safety less than the design minimum.

MAXIMUM CROSS-SECTION  
A-A'  
KM-B

The upstream slope should be flattened to 2.0 horizontal to 1 vertical to meet stability requirements.

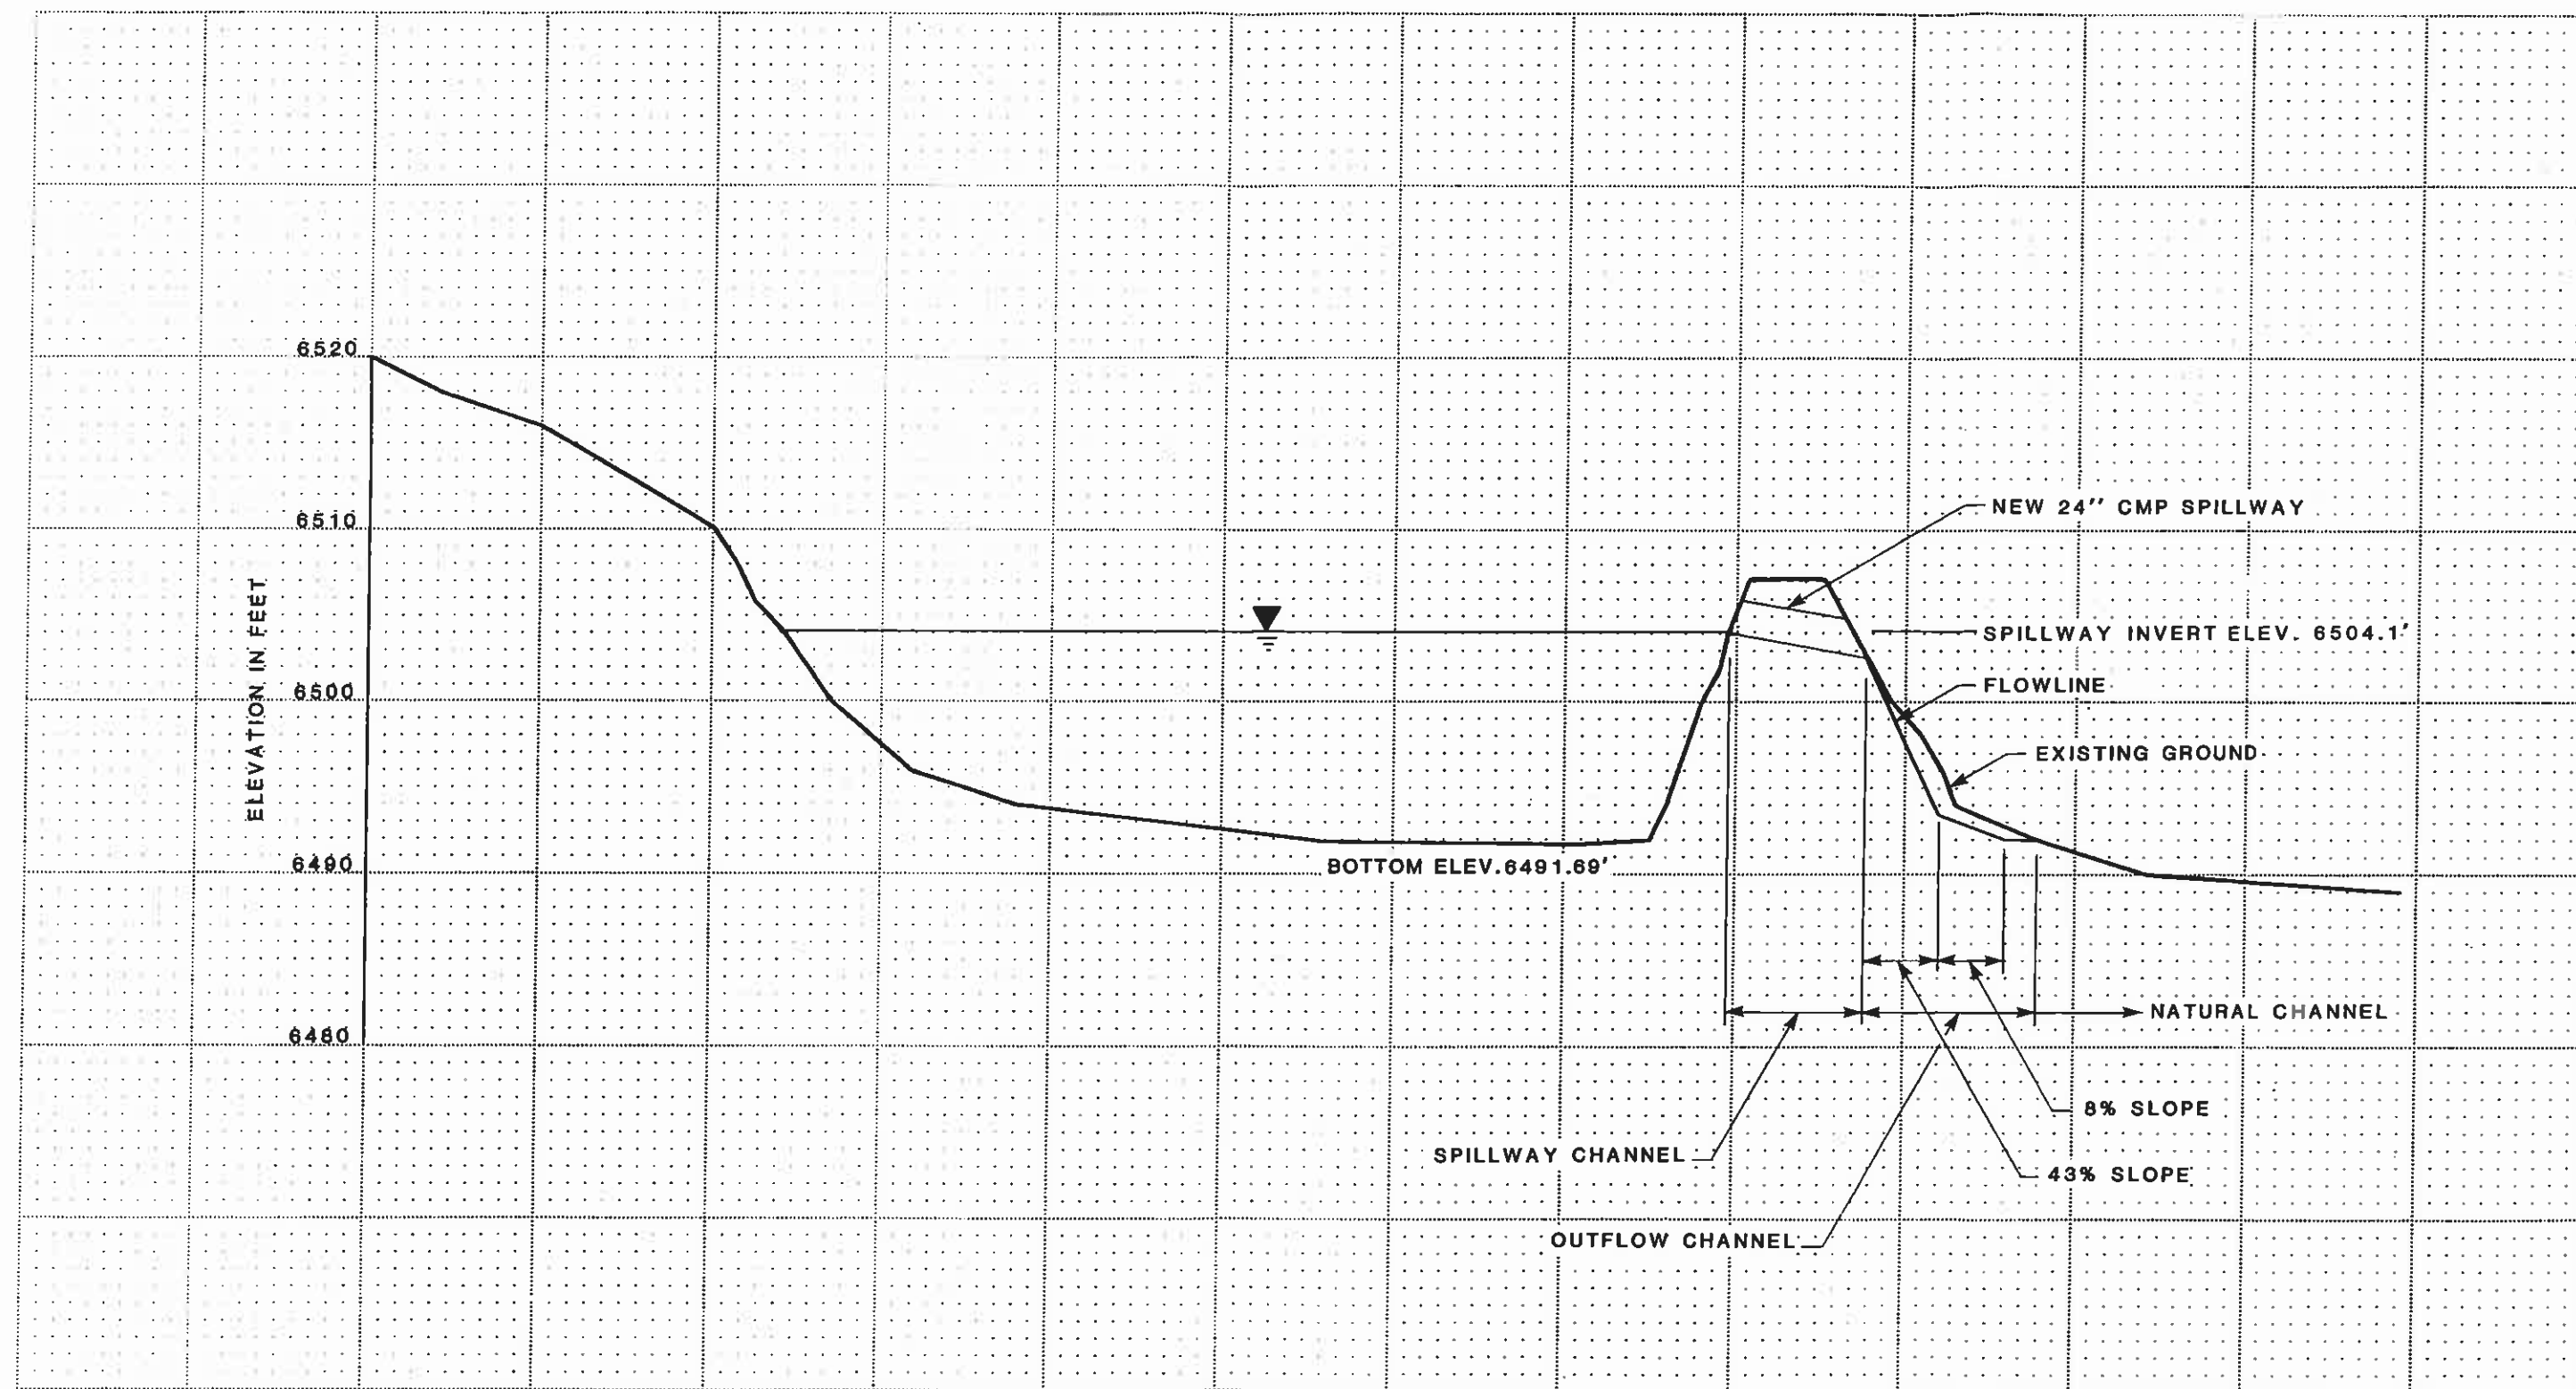
CHANNEL PROFILE B-B'  
KM-B

The storage capacity and spillway capacity of Structure KM-B are adequate; however, the spillway does not have an adequate outflow channel or adequate erosion protection. There is no suitable location for an improved outflow channel along the existing alignment. Therefore, a new pipe spillway and outflow channel should be constructed along the alignment B-B' shown in Plate 1. The existing spillway should be abandoned. The spillway and outflow channel profile is shown in Plate 4 and the required dimensions are shown in Plate 5. The outflow channel should be protected against erosion using geotextile and riprap as shown in Plate 5. A trashrack should be installed on the inlet of the CMP to prevent clogging of the spillway.

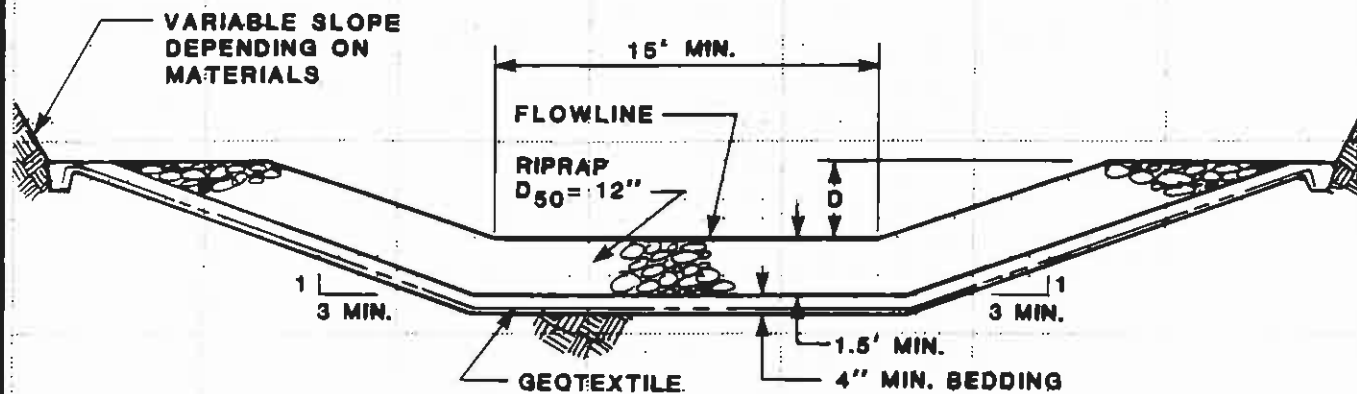
# OUTFLOW CHANNEL CROSS SECTION KM-B

There is presently no erosion protection within the channel.
