INSPECTION REPORT
Sedimentation Structure
KM-C
Kayenta Mine
Navajo County, Arizona

for
PEABODY COAL COMPANY

Dames & Moore
10139-011-22

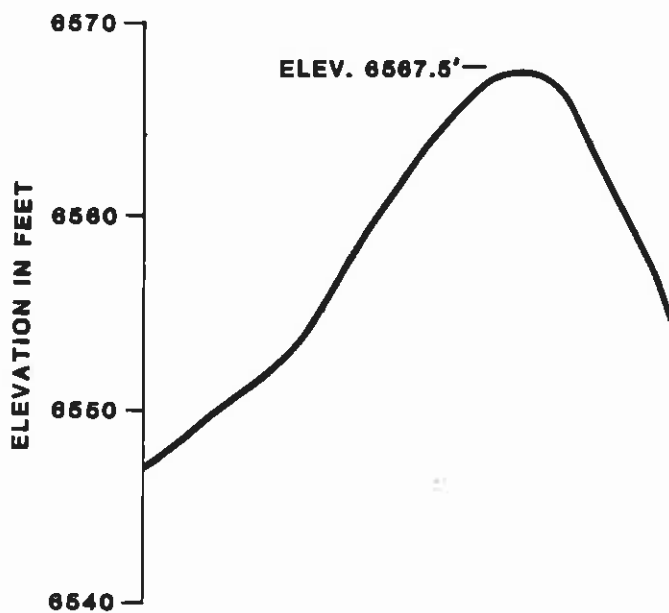
Plate 2

A cross-section of the embankment is shown on Plate 2, Existing Maximum Cross Section KM-C, A-A'. Grass provides erosion protection on the upstream and downstream slopes of the embankment.

EXISTING
MAXIMUM CROSS-SECTION
A-A'
KM-C

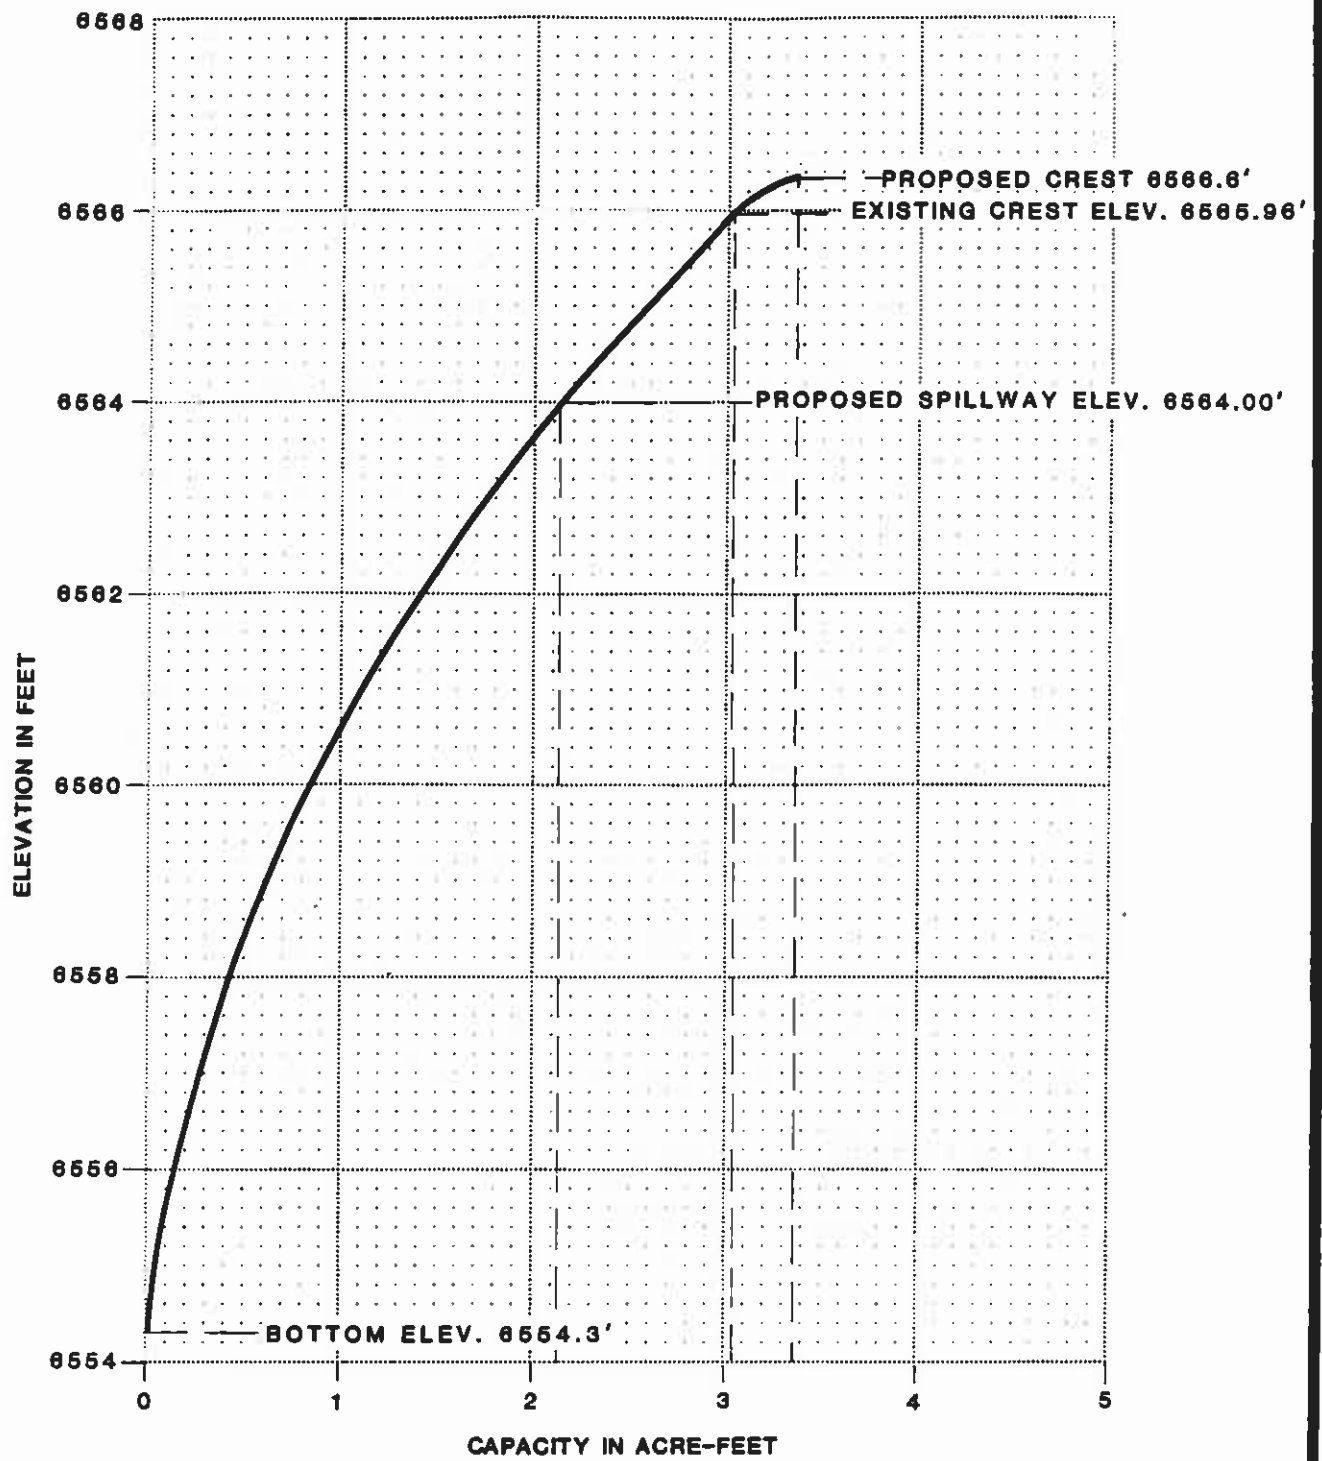
VOLUME-ELEVATION
CURVE
KM-C

The impoundment volume-elevation curve is based on site specific surveys conducted for Peabody Coal Company's August 1984 inspection, and 1985 resurveys, where available. Additionally, the most current topographic maps available were used in developing Plate 3, Volume-Elevation Curve, KM-C.

The hydrologic analysis gives the storage volume required to contain the 10-year, 24-hour storm, and the remaining storage volume available for storing sediment. Constructing a new spillway at structure KM-C reduces the storage capacity so that the structure does not have sufficient storage capacity by itself. However, KM-C together with Structure KM-D located downstream gives sufficient storage for the combined drainage basin. The 10-year, 24-hour storm was routed through KM-C and KM-D. The results of this analysis are summarized below.

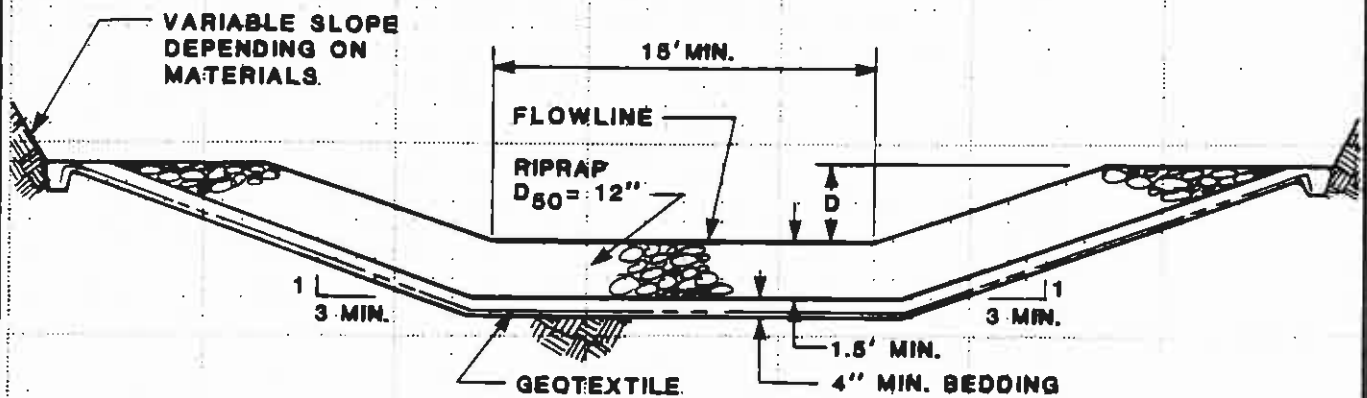
**SPILLWAY AND
OUTFLOW CHANNEL
CROSS SECTION
KM-C**

Structure KM-C does not have a spillway. Therefore, the hydraulic analysis is presented in the remedial compliance plan.

The structure presently has no spillway channel.

The structure presently has no outflow channel.

Structure KM-C has sufficient storage capacity but it does not have a spillway or outflow channel. A trapezoidal spillway channel should be constructed at elevation 6564.0 feet. The dam crest should be raised to elevation 6566.6 feet. A trapezoidal outflow channel with the same bottom width as the spillway should be constructed along the alignment shown in Plate 1. The spillway and outflow channel profile is shown in Plate 4 and the required dimensions are shown in Plate 5. Both the spillway and outflow channel should be protected against erosion using geotextile and riprap as shown in Plate 5.

SPILLWAY CHANNEL

$D = 2.6'$

LENGTH = 30'

FLOWLINE ELEV. = 6564.00'

OUTFLOW CHANNEL

$D = 1.5'$
