INSPECTION REPORT
Sedimentation Structure
KM-D
Kayenta Mine
Navajo County, Arizona
for
PEABODY COAL COMPANY

Dames & Moore
10139-011-22

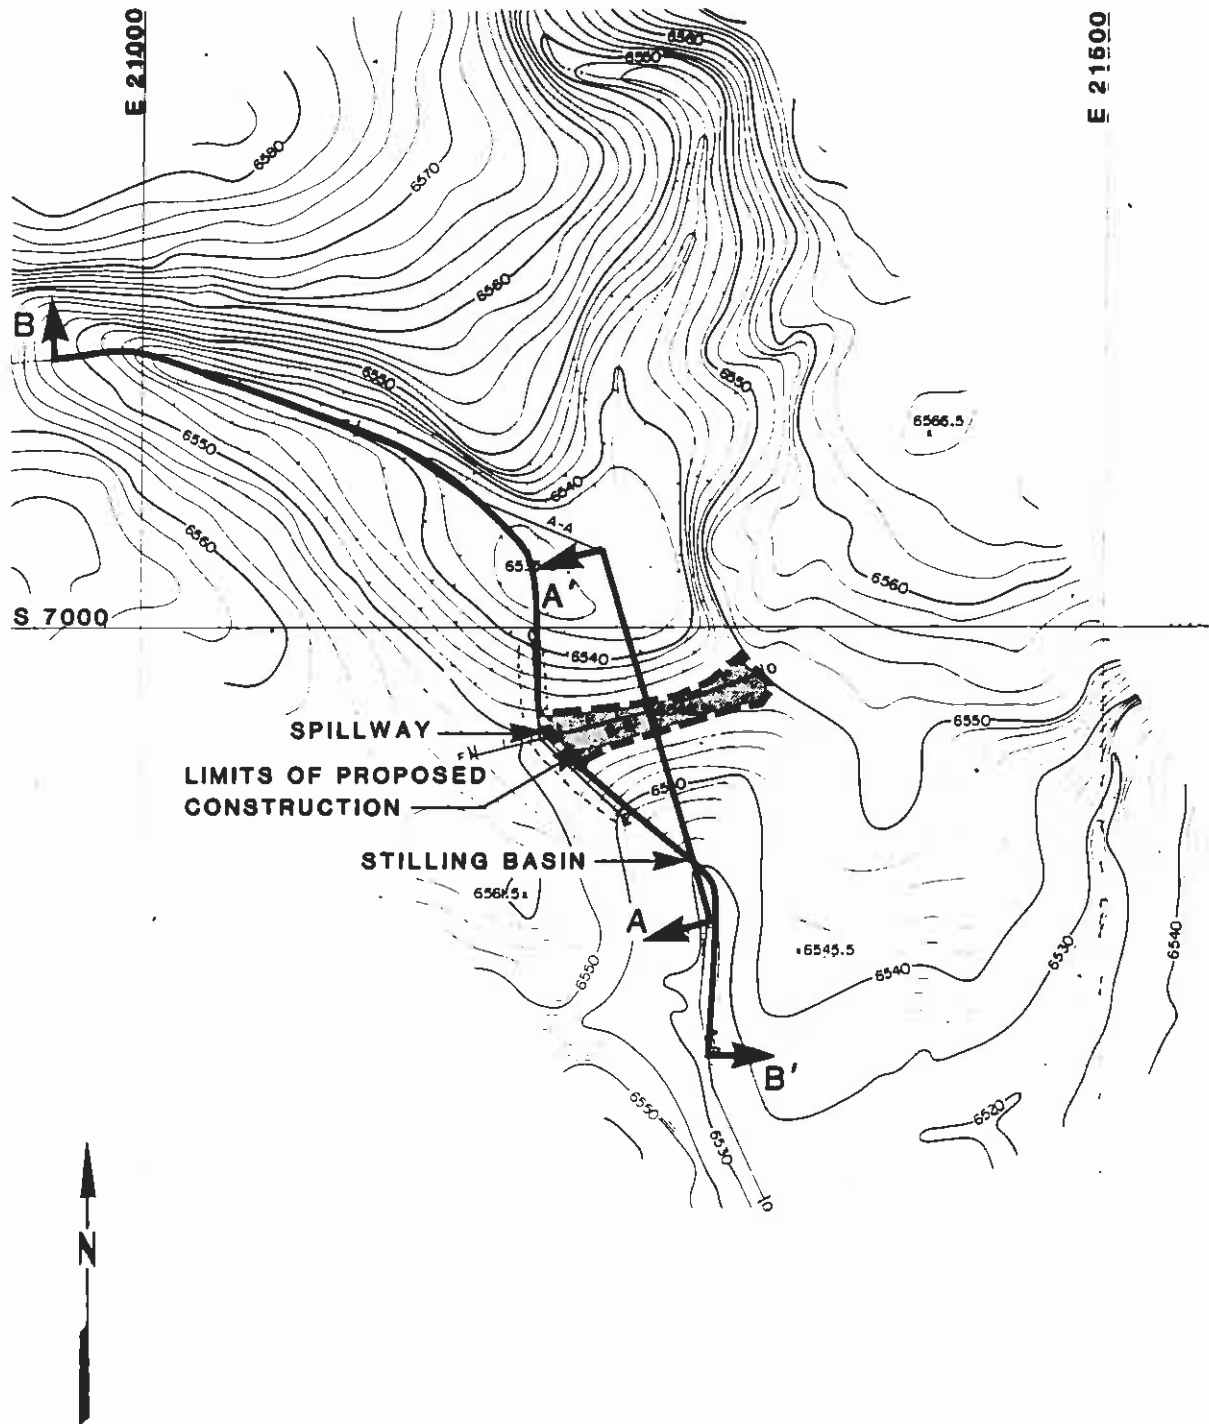
SITE PLAN KM-D

Sedimentation Structure KM-D is an earthen embankment, designed and constructed in 1979 by Peabody Coal Company as a temporary sedimentation structure to control runoff and sediment from the disturbed mining areas of the Kayenta Mine. The location of Structure KM-D is shown on Plate 1, Site Plan.

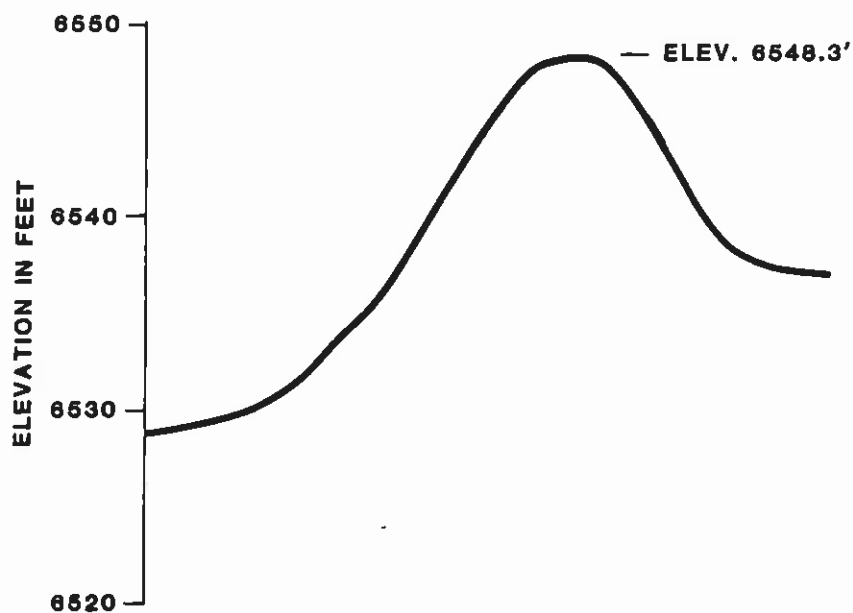
EXISTING
MAXIMUM CROSS-SECTION
A-A'
KM-D

A cross-section of the embankment is shown on Plate 2, Existing Maximum Cross Section KM-D, A-A'. Grass provides erosion protection on the upstream and downstream slopes of the embankment.

The inspection of Structure KM-D indicated that the only geotechnical problem is rill erosion on the upstream slope. Correction of erosion is considered a periodic maintenance task and does not require remedial action.

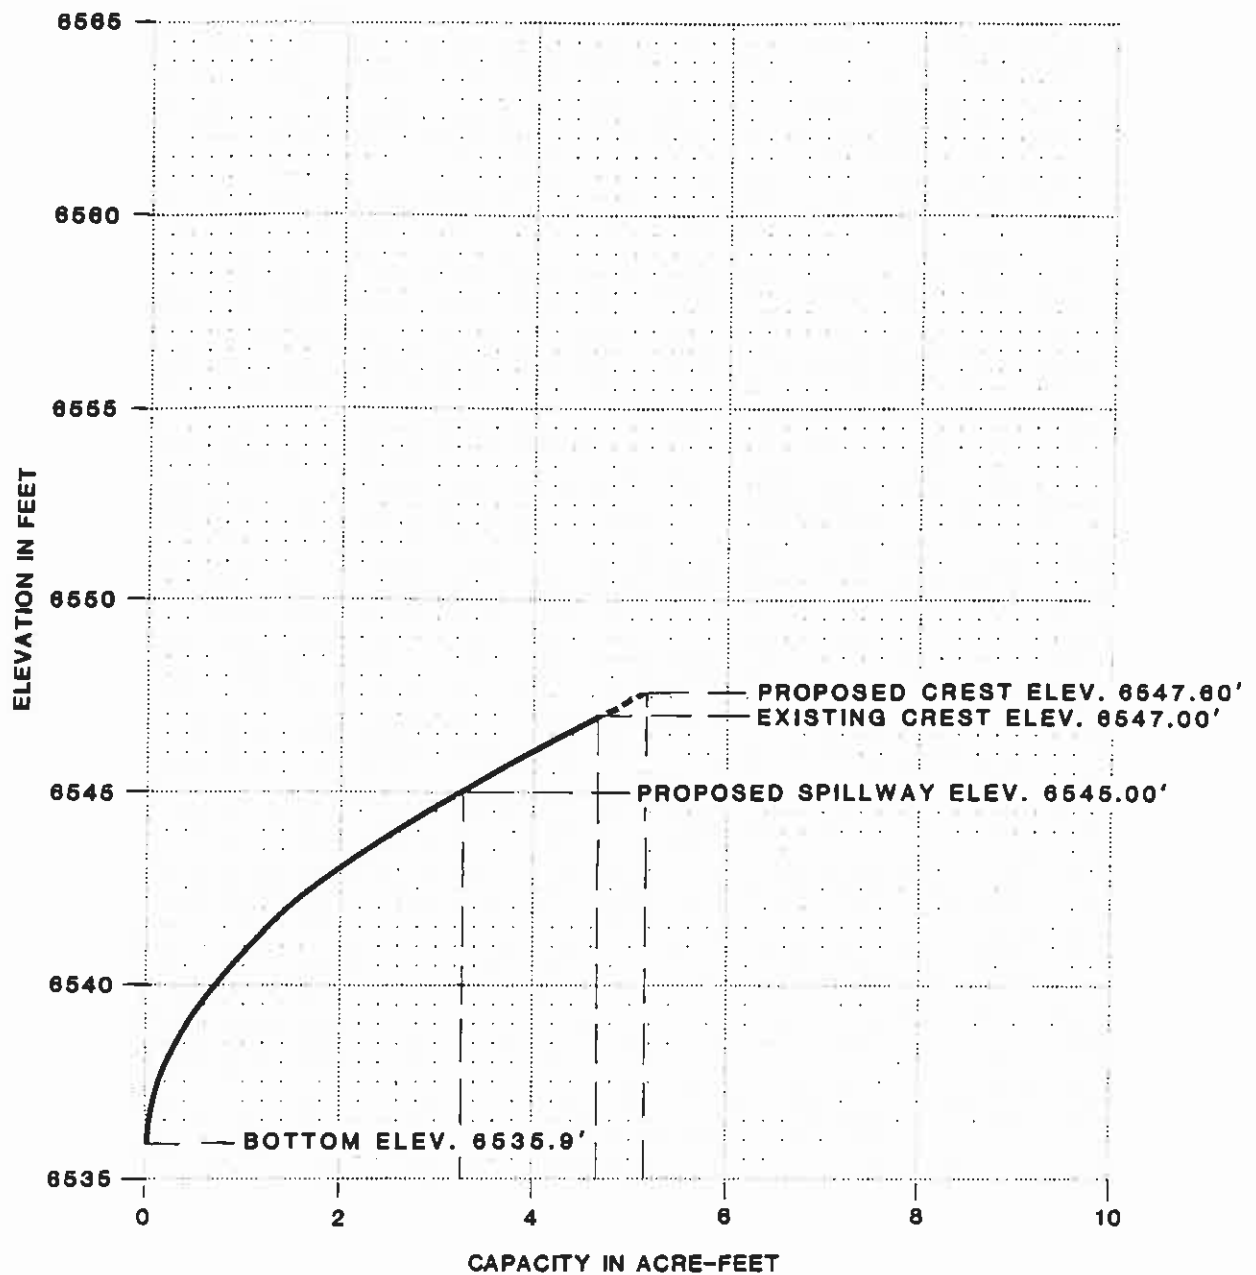
**VOLUME-ELEVATION
CURVE
KM-D**

The impoundment volume-elevation curve is based on site specific surveys conducted for Peabody Coal Company's August 1984 inspection, and 1985 resurveys, where available. Additionally, the most current topographic maps available were used in developing Plate 3, Volume-Elevation Curve, KM-D.

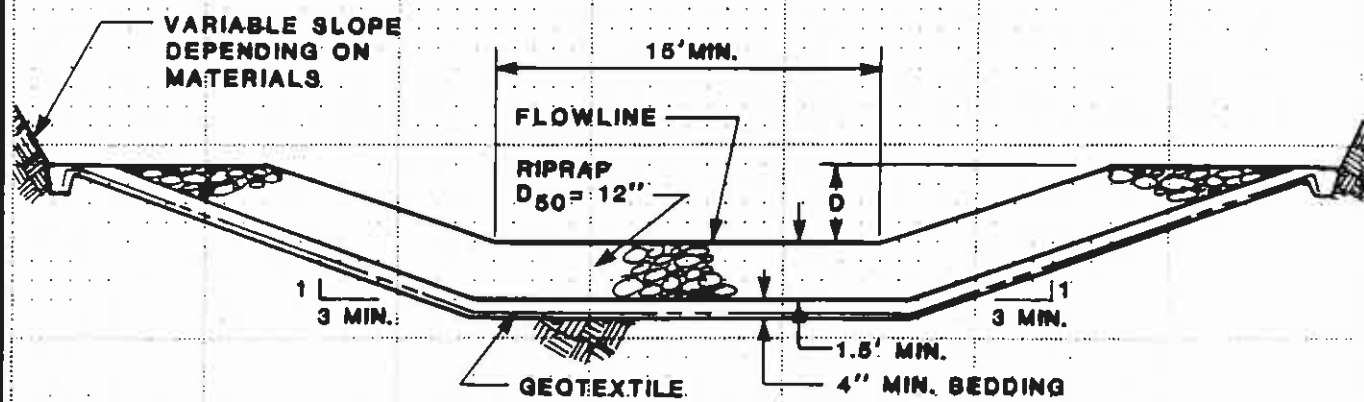
**SPILLWAY AND
OUTFLOW CHANNEL
CROSS SECTION
KM-D**

Structure KM-D does not have a spillway. Therefore, the hydraulic analysis is presented in the remedial compliance plan.

The structure does not have a spillway channel.

The structure presently has no outflow channel.

Structure KM-D has sufficient storage capacity but it does not have a spillway or outflow channel. A trapezoidal spillway channel should be constructed at elevation 6545.0 feet. The embankment crest elevation should be raised to elevation 6547.60 feet. The outflow channel and stilling basin should be constructed along the alignment shown in Plate 1. The spillway channel, outflow channel, and stilling basin profile is shown in Plate 4 and the required dimensions are shown in Plate 5. The spillway, outflow channel, and stilling basin should be protected against erosion using geotextile and riprap as shown in Plate 5.
