INSPECTION REPORT  
Sedimentation Structure  
KM-E1  
Kayenta Mine  
Navajo County, Arizona  
for  
PEABODY COAL COMPANY

Dames & Moore  
10139-011-22

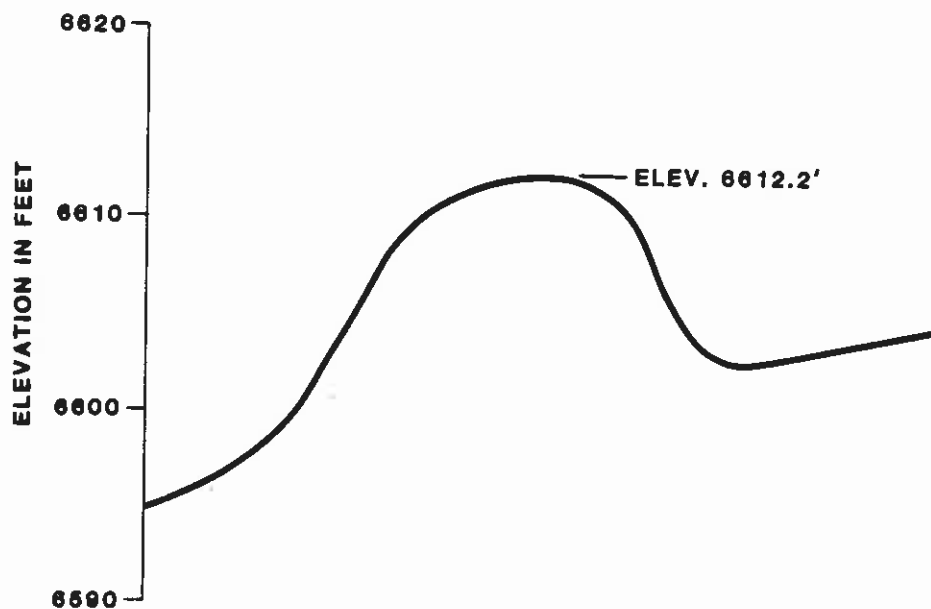
EXISTING  
MAXIMUM CROSS-SECTION  
A-A'  
KM-E1

Structure KM-E1 is a homogeneous earthen embankment classified as a sidehill embankment. Physical characteristics of the embankment are listed in the following table:

Embankment . . . . .	Residual Shale Soils
Foundation . . . . .	Residual Shale Soils/Scoria
Right Abutment . . . .	Residual Shale Soils
Left Abutment . . . .	Residual Shale Soils
Height . . . . .	5.5 ft
Crest Width . . . . .	15 ft
Upstream Slope . . . .	3.5 H : 1 V
Downstream Slope . . .	3.5 H : 1 V

A cross-section of the embankment is shown on Plate 2, Existing Maximum Cross Section KM-E1, A-A'.

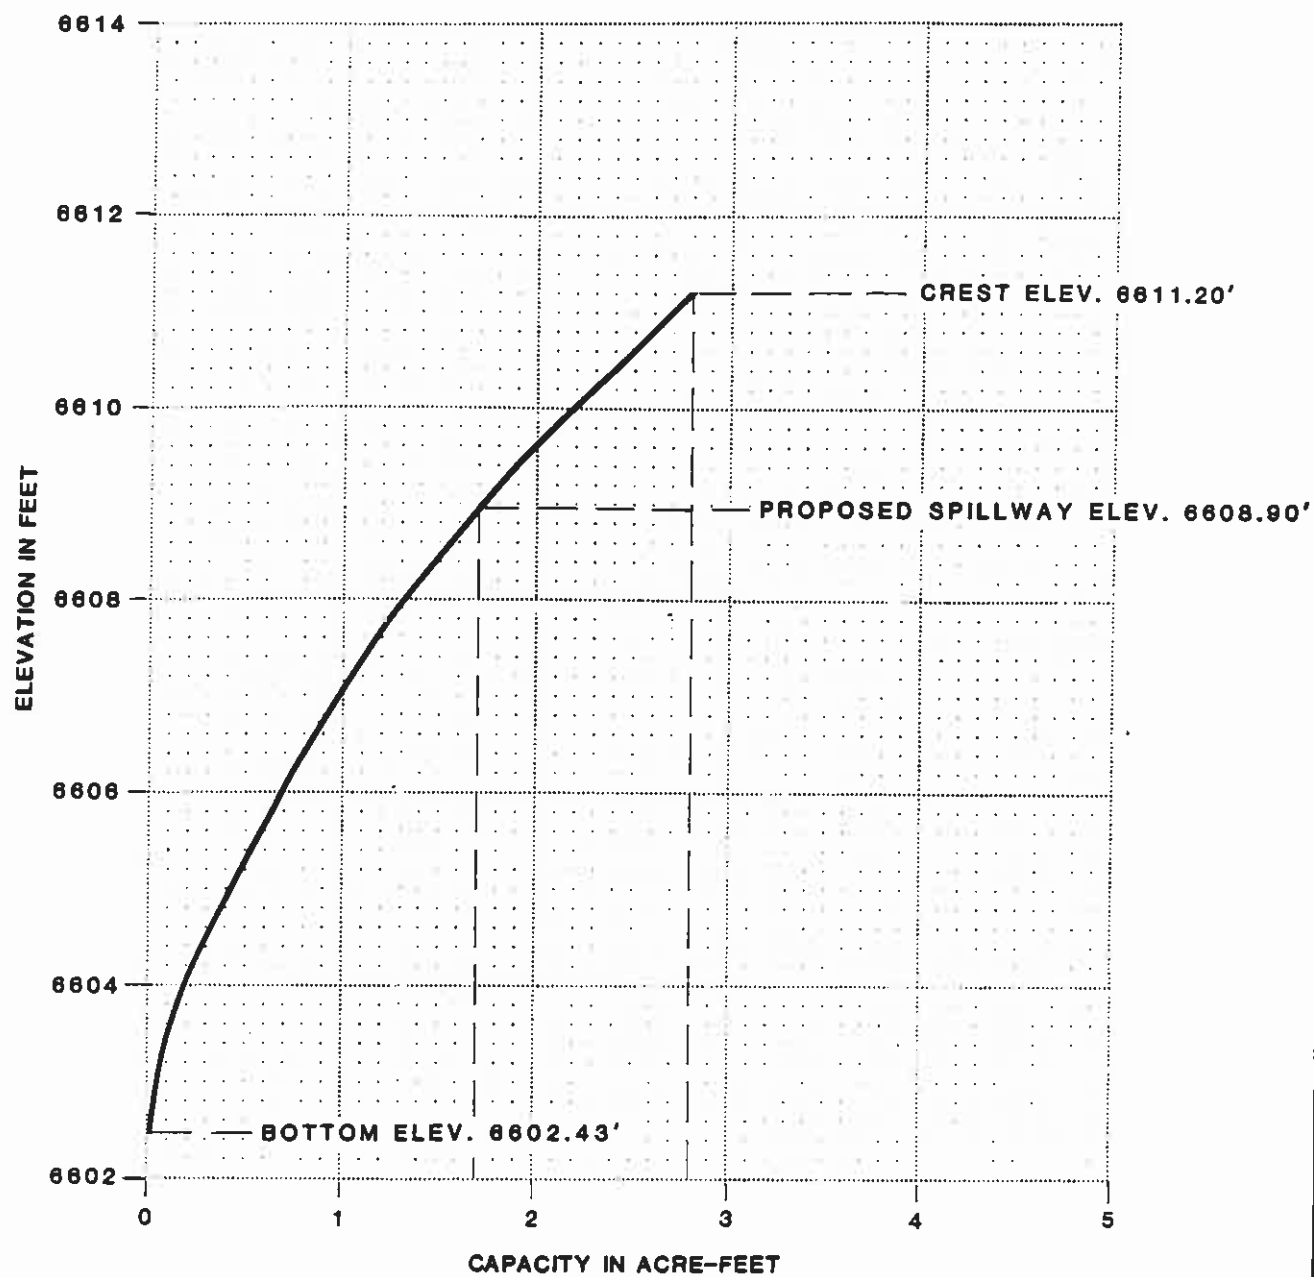
VOLUME-ELEVATION  
CURVE  
KM-E1

The impoundment volume-elevation curve is based on site specific surveys conducted for Peabody Coal Company's August 1984 inspection, and 1985 resurveys, where available. Additionally, the most current topographic maps available were used in developing Plate 3, Volume-Elevation Curve, KM-E1.

Total Storage Capacity . . . . .	1.71	acre-ft
10-year, 24-hour Storm Inflow . . . . .	1.37	acre-ft
Available Sediment Storage Capacity . .	0.34	acre-ft
Sediment Inflow Rate . . . . .	0.058	acre-ft/yr
Sediment Storage Life . . . . .	6	yrs

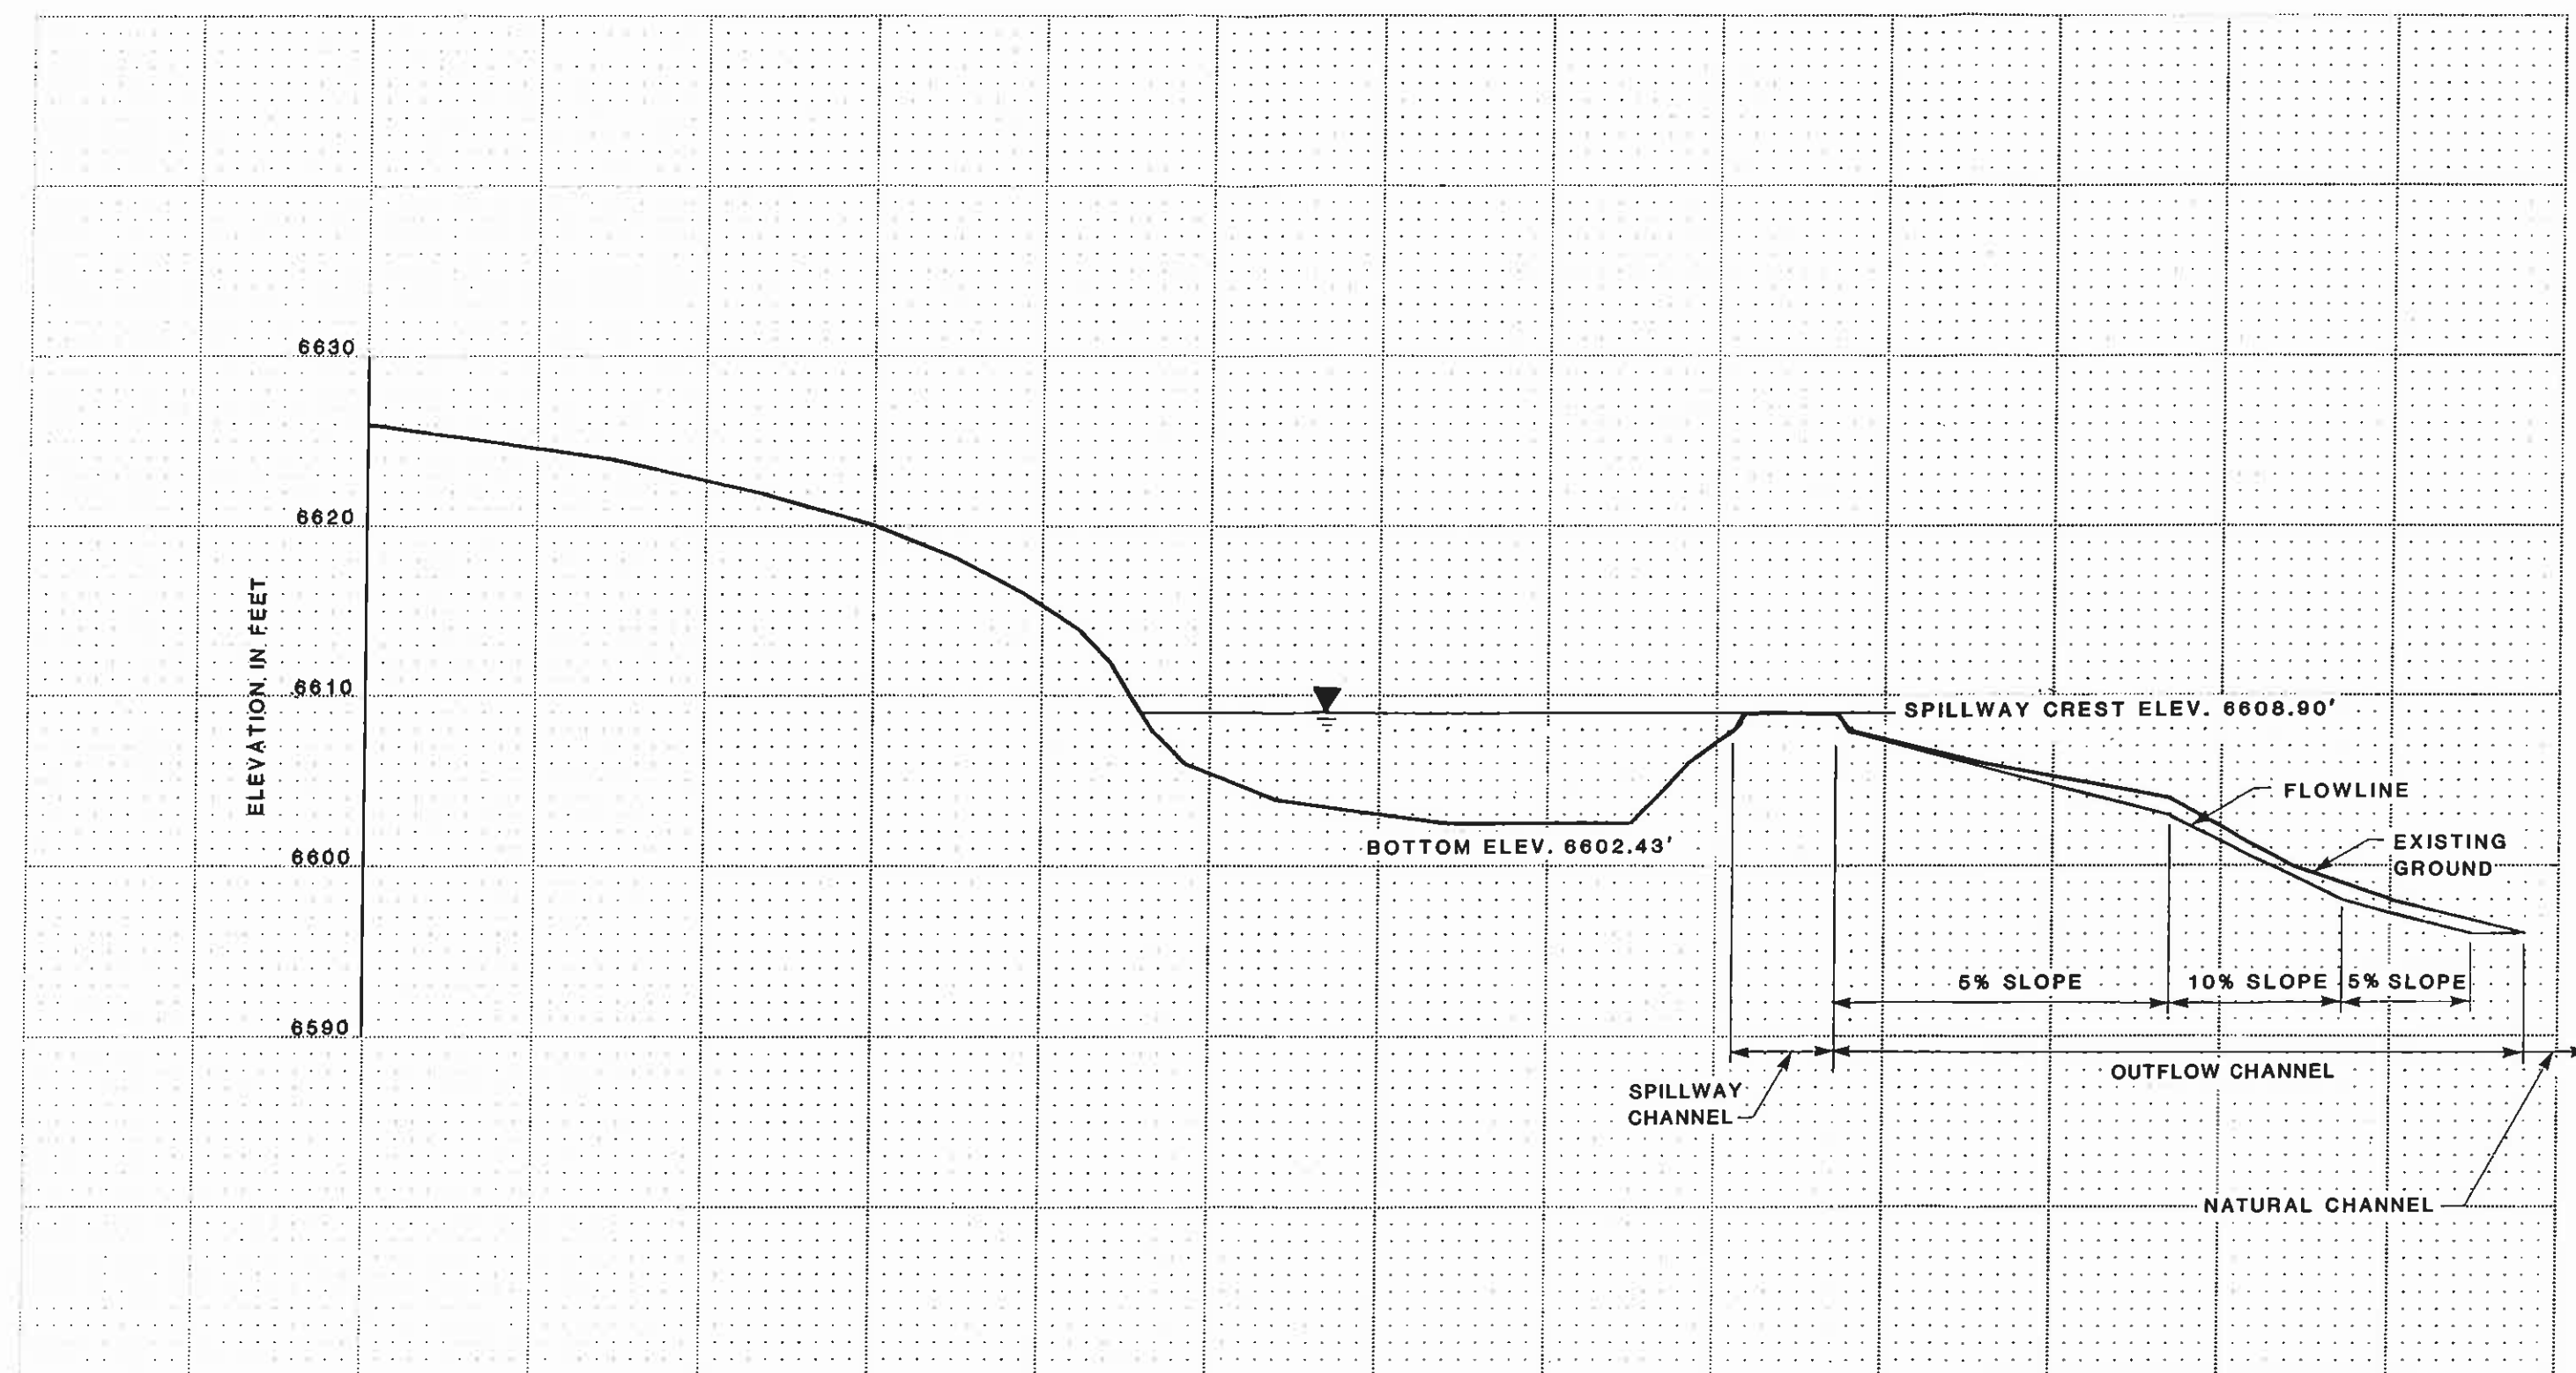
CHANNEL PROFILE B-B'  
KM-E1

Structure KM-E1 has sufficient storage capacity when analyzed in series with Structure KM-E located downstream, but it does not have an adequate spillway or outflow channel. A trapezoidal spillway channel should be constructed at elevation 6608.90 feet. The existing CMP spillway should be abandoned. A trapezoidal outflow channel with the same bottom width as the spillway should be constructed along the alignment shown in Plate 1. The spillway and outflow channel profile is shown in Plate 4 and the required dimensions are shown in Plate 5. Both the spillway and outflow channel should be protected against erosion using geotextile and gravel as shown in Plate 5.

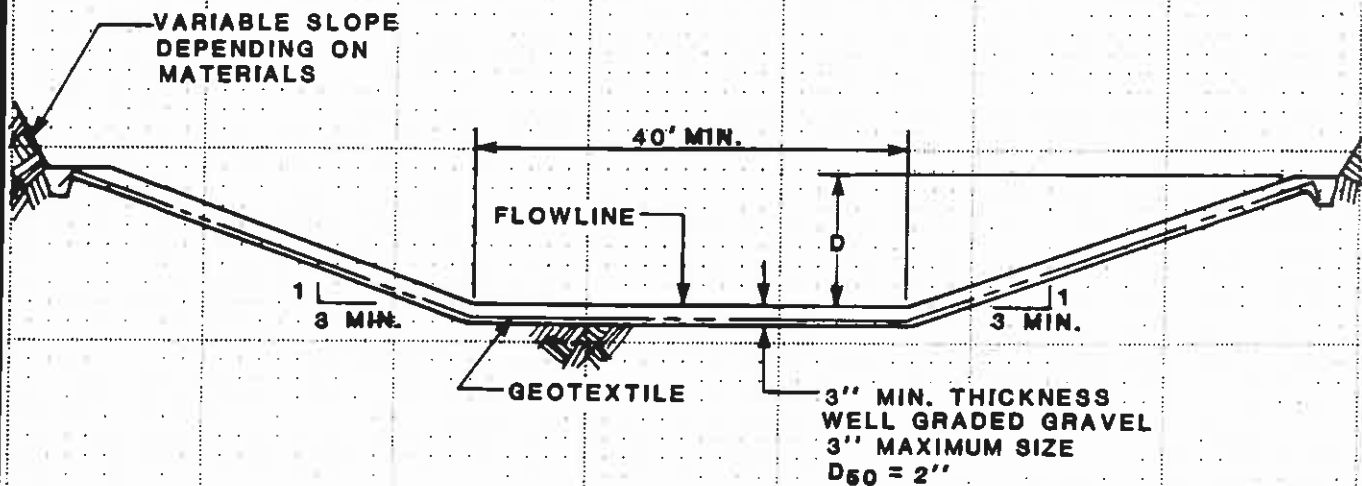
**SPILLWAY AND  
OUTFLOW CHANNEL  
CROSS SECTION  
KM-E1**

The existing corrugated metal pipe spillway is damaged and should be replaced by an open channel spillway. Therefore, the hydraulic analysis is presented in the remedial compliance plan.

The existing spillway for KM-E1 is a partially crushed 24-inch corrugated metal pipe (CMP).

The structure presently has no outflow channel.

**SPILLWAY CHANNEL**

D = 2.0'

LENGTH = 30'

FLOWLINE ELEV. = 6608.90'

**OUTFLOW CHANNEL**

D = 1'
