INSPECTION REPORT
Sedimentation Structure
MW-A
Black Mesa Mine
Navajo County, Arizona
for
PEABODY COAL COMPANY

Dames & Moore
10139-011-22

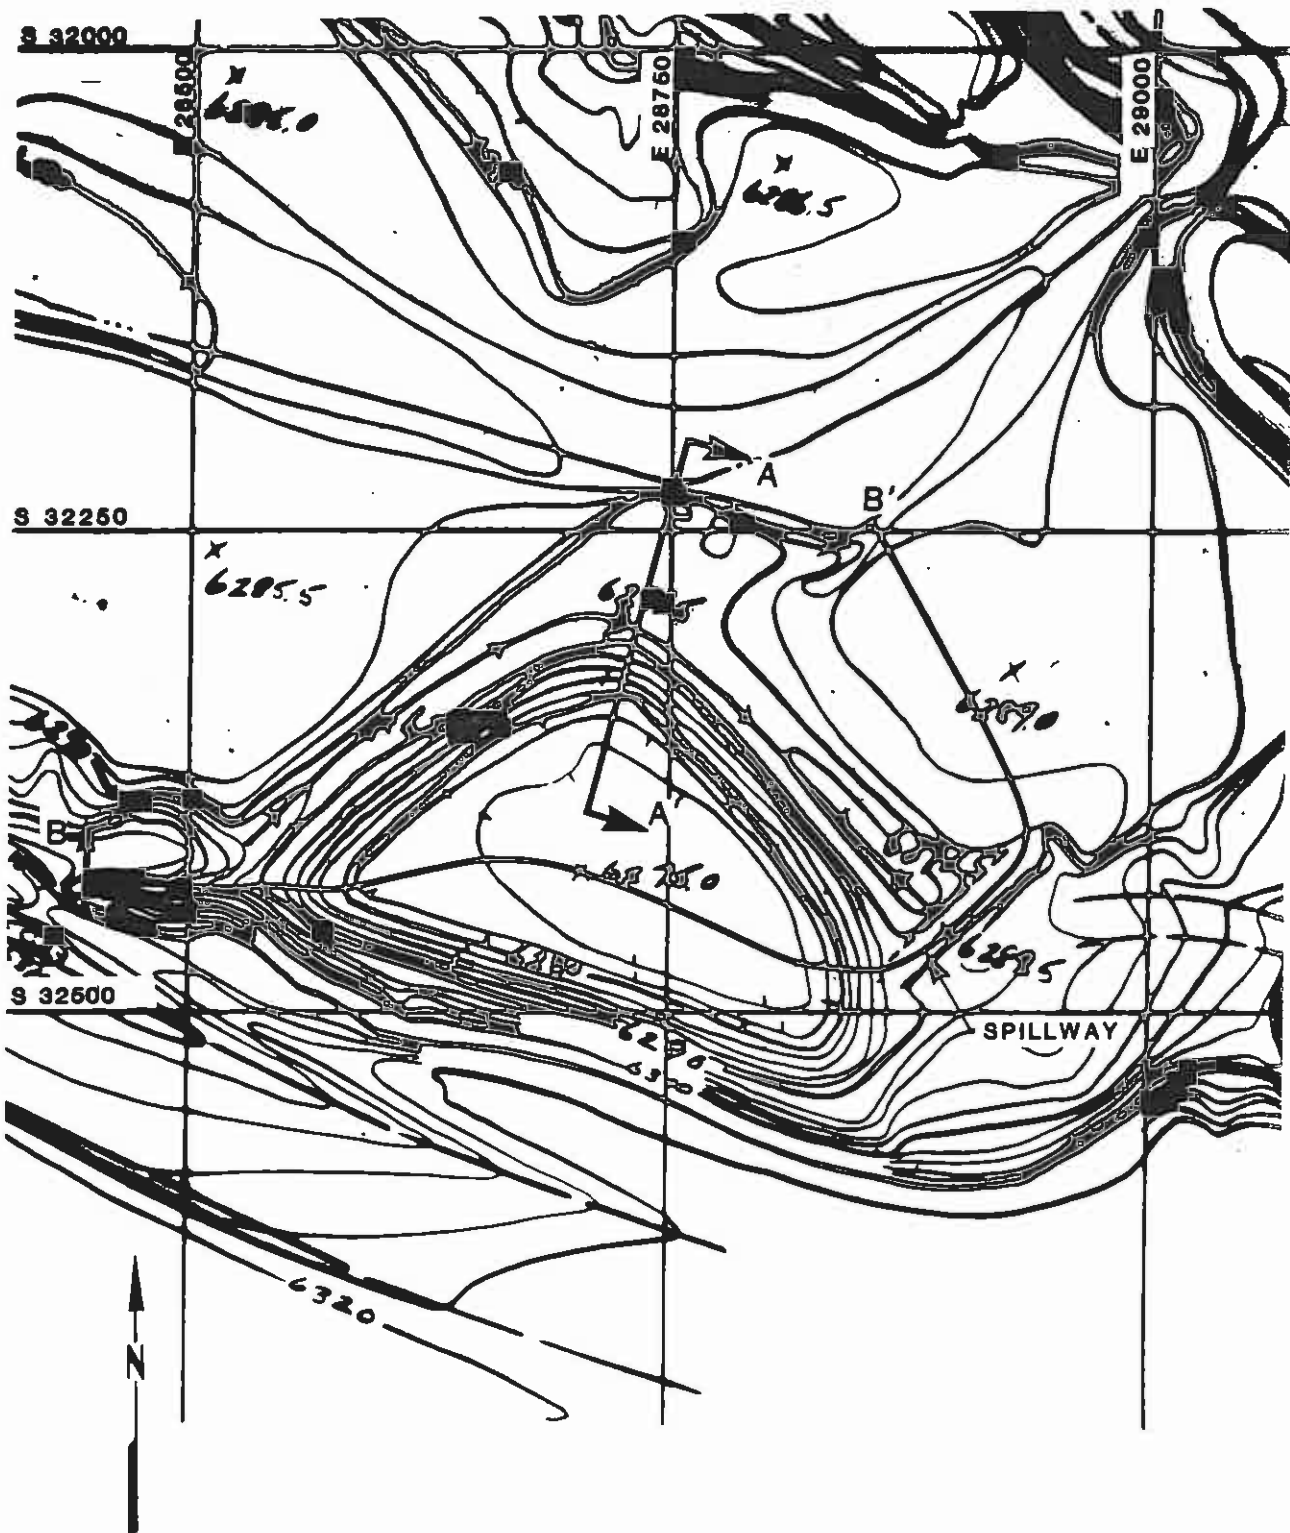
SITE PLAN
MW-A

Sedimentation Structure MW-A is an earthen embankment, designed and constructed in 1979 by Peabody Coal Company as a temporary sedimentation structure to control runoff and sediment from the disturbed mining areas of the Black Mesa Mine. The location of Structure MW-A is shown on Plate 1, Site Plan.

The storage capacity and spillway capacity of Structure MW-A are adequate; however, the spillway does not have an outflow channel or adequate erosion protection. A trapezoidal outflow channel should be constructed along the alignment B-B' shown in Plate 1. The channel profile is shown in Plate 4 and the required dimensions are shown in Plate 5. Both the spillway and outflow channel should be protected against erosion using geotextile and gravel as shown in Plate 5.

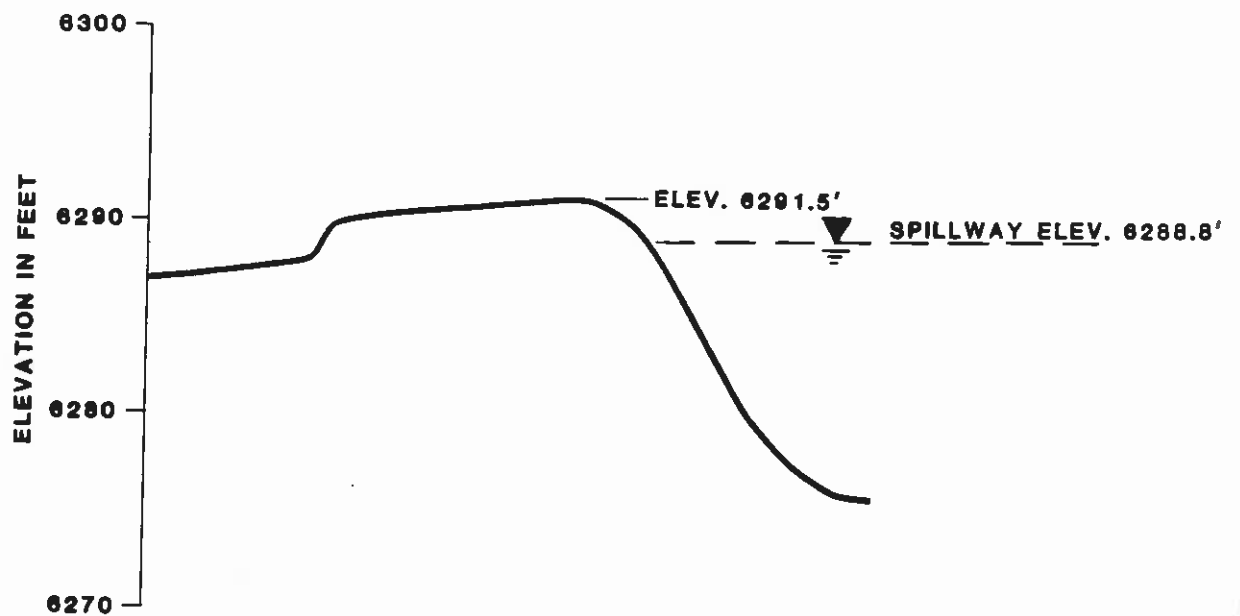
EXISTING
MAXIMUM CROSS-SECTION
A-A'
MW-A

A cross-section of the embankment is shown on Plate 2, Existing Maximum Cross Section MW-A, A-A'. Grass provides erosion protection on the upstream and downstream slopes of the embankment.

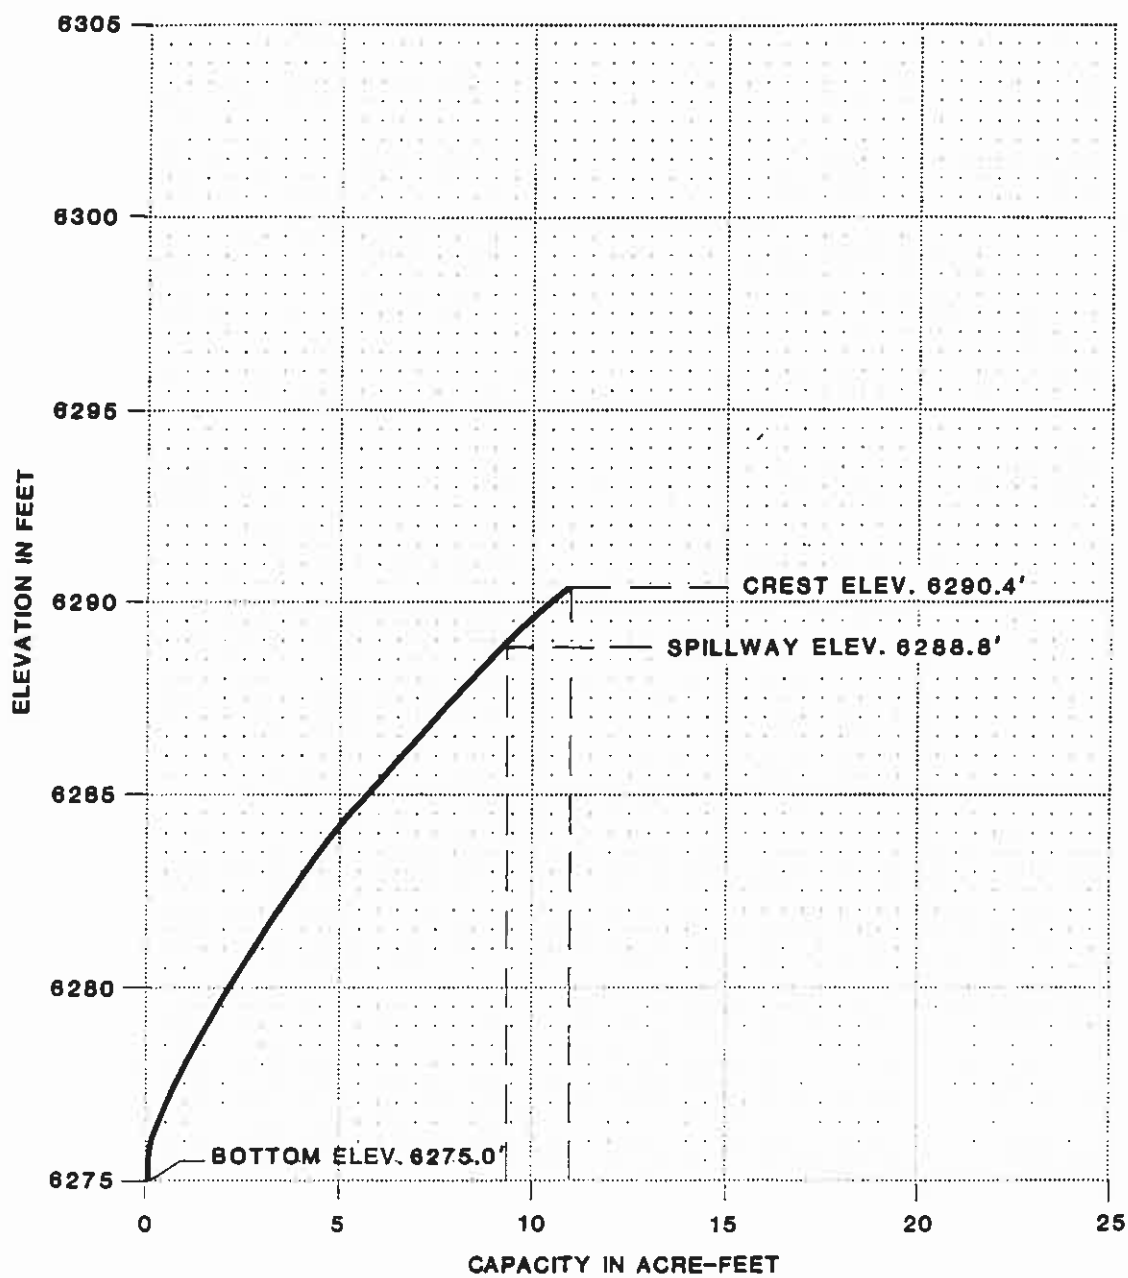
VOLUME-ELEVATION
CURVE
MW-A

The impoundment volume-elevation curve is based on site specific surveys conducted for Peabody Coal Company's August 1984 inspection, and 1985 resurveys, where available. Additionally, the most current topographic maps available were used in developing Plate 3, Volume-Elevation Curve, MW-A.

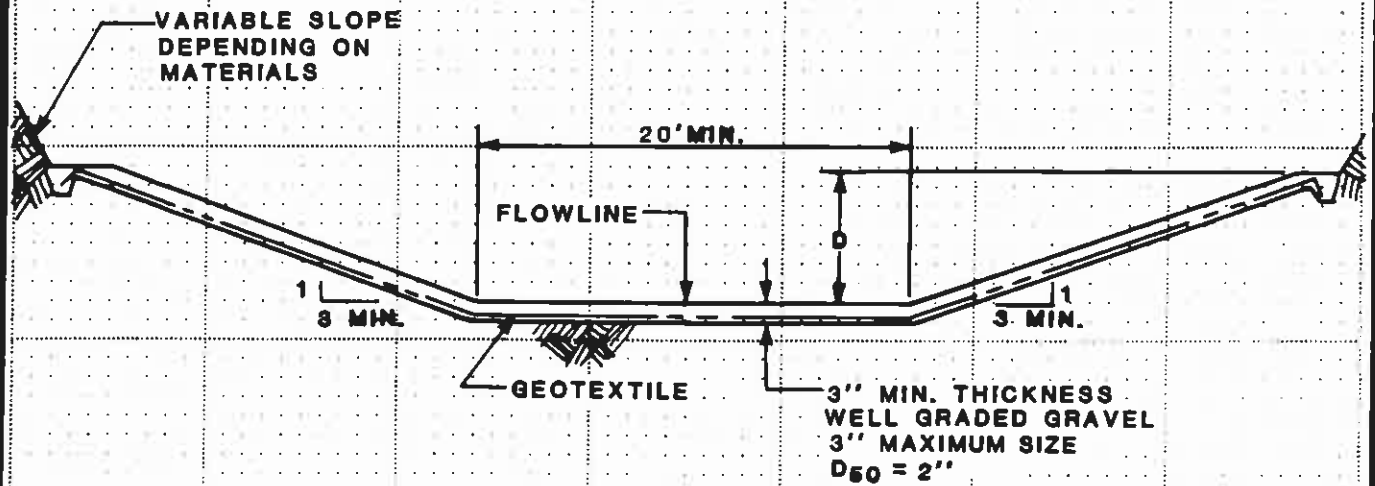
**SPILLWAY AND
OUTFLOW CHANNEL
CROSS SECTION
MW-A**

There is presently no erosion protection within the channel.

The structure presently has no outflow channel.
