INSPECTION REPORT
Sedimentation Structure
MW-B
Black Mesa Mine
Navajo County, Arizona
for
PEABODY COAL COMPANY

Dames & Moore
10139-011-22

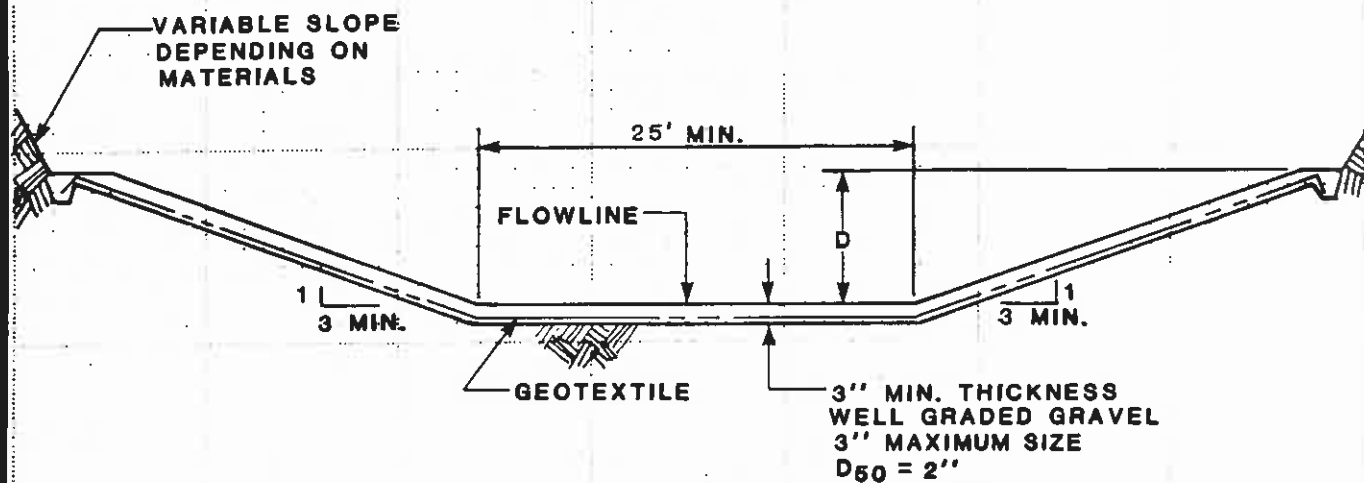
**SPILLWAY AND
OUTFLOW CHANNEL
CROSS SECTION
MW-B**

The storage capacity and spillway capacity of Structure MW-B are adequate; however, the spillway does not have an adequate outflow channel or adequate erosion protection. The proposed embankment relocation provides the opportunity to construct a new spillway and outflow channel in a location that minimizes the difficulties in providing adequate erosion protection. A trapezoidal outflow channel constructed along the alignment B-B' shown in Plate 1 will have a much flatter slope than a channel at the existing spillway location. The channel profile is shown in Plate 4 and the

required dimensions are shown in Plate 5. Both the spillway and outflow channel should be protected against erosion using geotextile and gravel as shown in Plate 5.

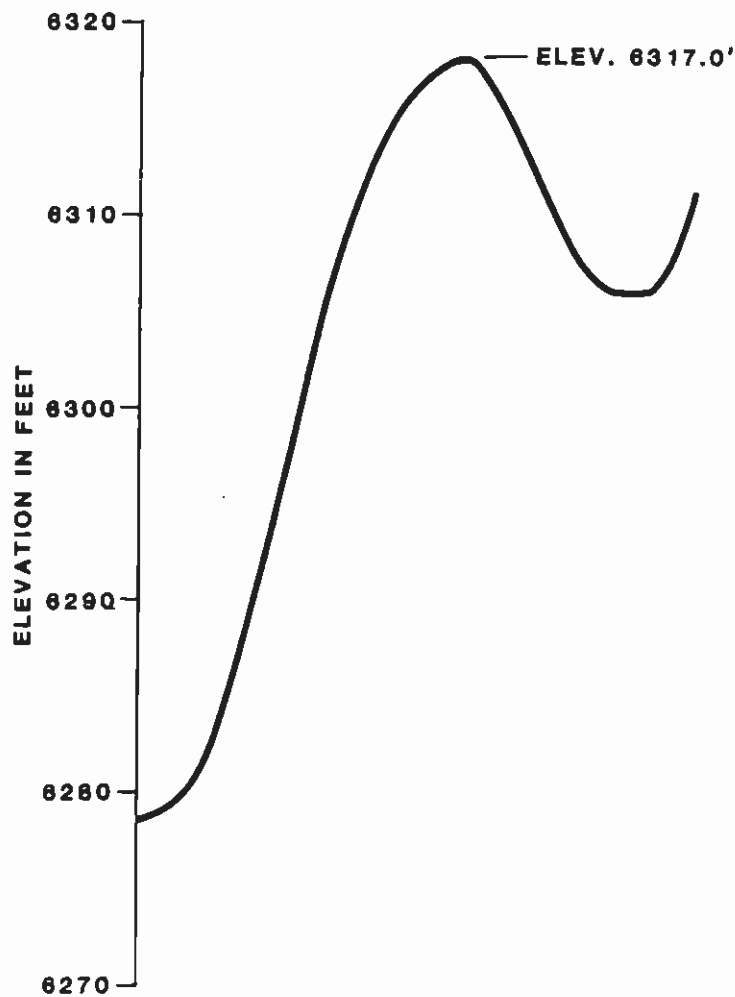
EXISTING
MAXIMUM CROSS-SECTION
A-A'
MW-B

Embankment	Residual Sandstone Soils
Foundation	Alluvium/Residual Sandstone Soils
Right Abutment	Haul Road Fill
Left Abutment	Sandstone
Height	9.4 ft
Crest Width	11 ft
Upstream Slope	2.25 H : 1 V
Downstream Slope . . .	2 H : 1 V, 1.6 H : 1 V, 1.3 H : 1 V
	left abut. center right abut.

The MW-B embankment is lower in height; however, the downstream slope is steeper than the category standard; therefore, the embankment has factors of safety less than the design minimum.

The inspection of Structure MW-B indicated that the geotechnical problems consist of rill and gully erosion on the downstream slope and a steep and uneven downstream slope. Correction of erosion is considered a periodic maintenance task and does not require remedial action. The downstream slope is uneven due to either lack of fine grading after initial construction or shallow surficial slope failures. The downstream slope should be flattened to 3.25 horizontal to 1 vertical to meet stability requirements. This flatter slope was selected due to a foundation slope greater than 5 percent. The downstream toe of this embankment needs to be riprapped to protect the slope from undercutting by flows in the Moenkopi Wash.

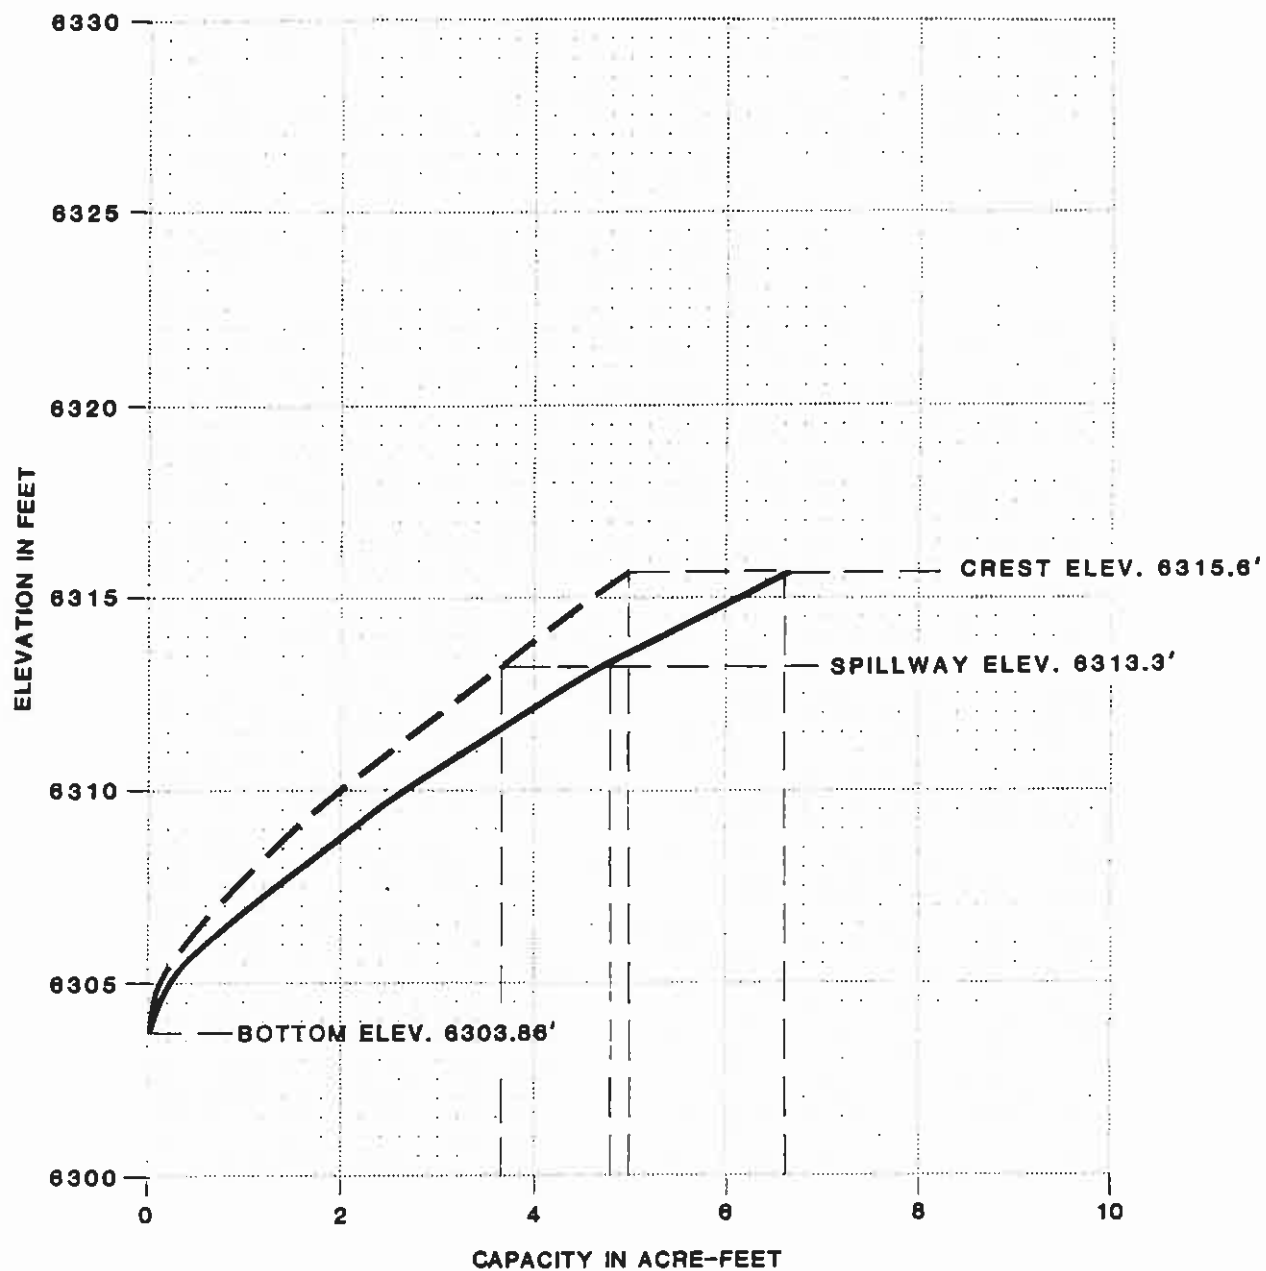
VOLUME-ELEVATION CURVE MW-B

The hydrologic analysis gives the storage volume required to contain the 10-year, 24-hour storm, and the remaining storage volume available for storing sediment. The existing storage capacity of MW-B is shown on Plate 3, Volume-Elevation Curve, MW-B, and the results of the analysis are summarized in the following table.

Total Storage Capacity	4.79	acre-ft
10-year, 24-hour Storm Inflow	1.44	acre-ft
Available Sediment Storage Capacity	3.35	acre-ft
Sediment Inflow Rate	0.236	acre-ft/yr
Sediment Storage Life	14	yrs

Relocating the embankment reduces the storage capacity. The analysis of these conditions is summarized in the following table.
