INSPECTION REPORT
Sedimentation Structure
N1-AC
Kayenta Mine
Navajo County, Arizona
for
PEABODY COAL COMPANY

Dames & Moore
10139-011-22

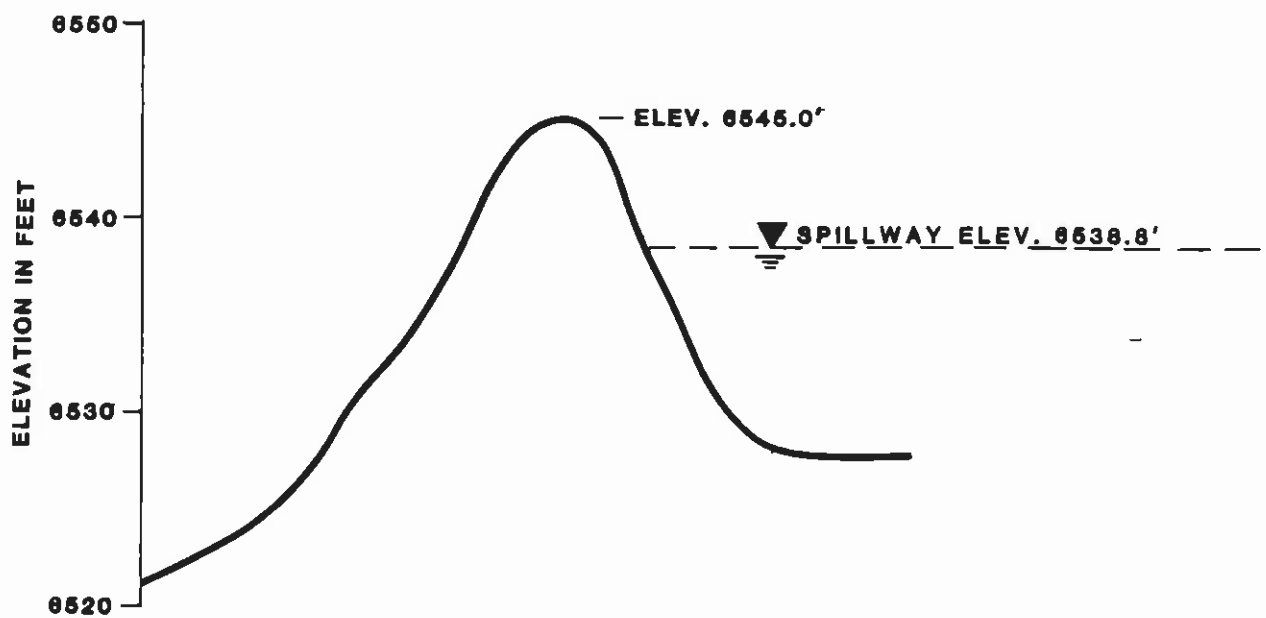
EXISTING
MAXIMUM CROSS-SECTION
A-A'
N1-AC

A cross-section of the embankment is shown on Plate 2, Existing Maximum Cross Section N1-AC, A-A'. Grass provides erosion protection on the upstream and downstream slopes of the embankment.

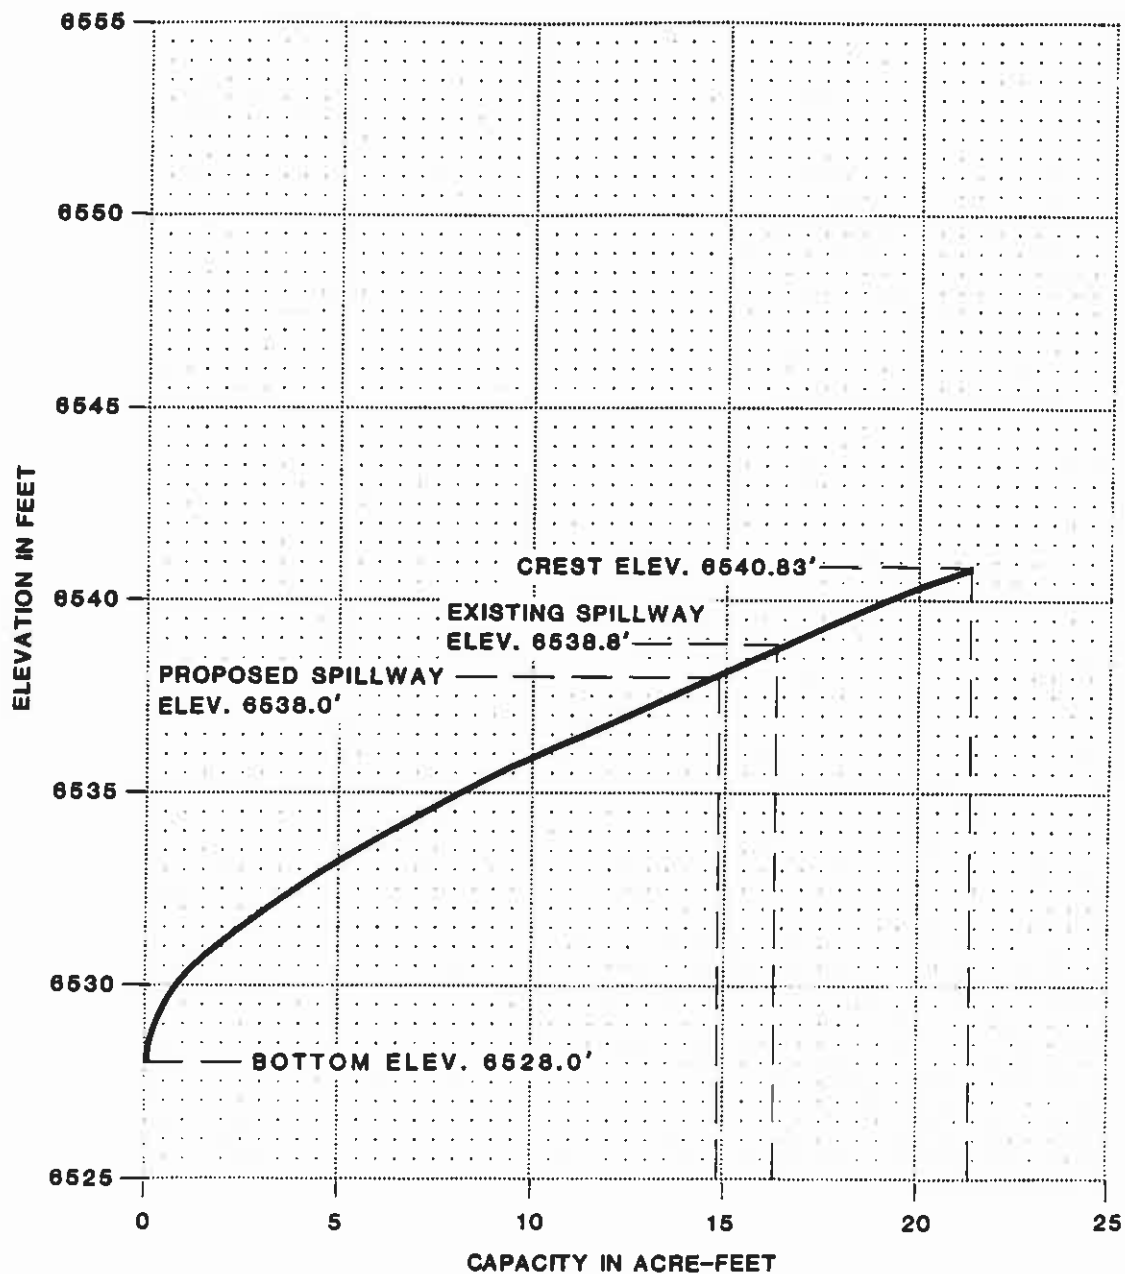
VOLUME-ELEVATION
CURVE
N1-AC

The impoundment volume-elevation curve is based on site specific surveys conducted for Peabody Coal Company's August 1984 inspection, and 1985 resurveys, where available. Additionally, the most current topographic maps available were used in developing Plate 3, Volume-Elevation Curve, N1-AC.

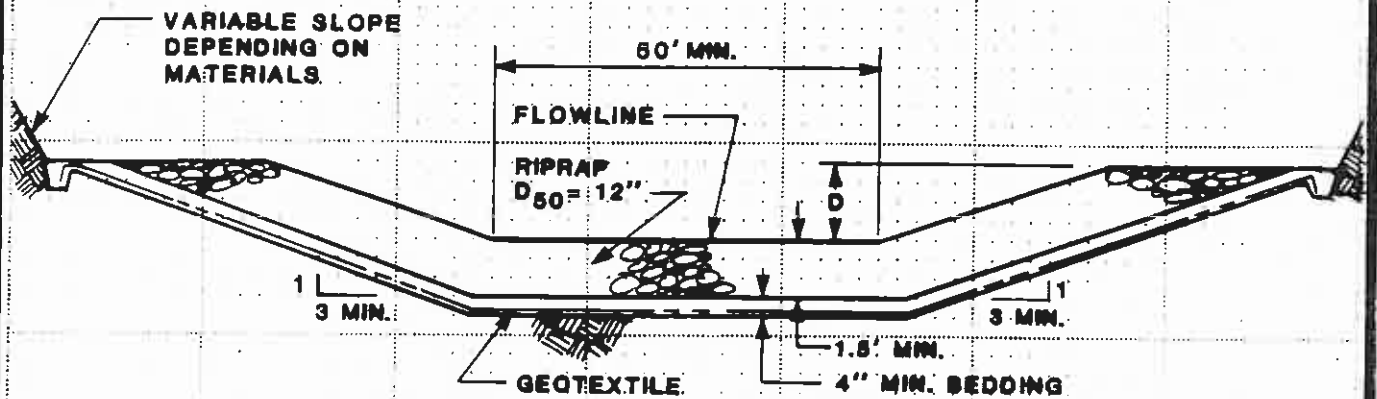
**SPILLWAY AND
OUTFLOW CHANNEL
CROSS SECTION
N1-AC**

The storage capacity of Structure N1-AC is adequate but the spillway capacity is inadequate. The structure does not have an adequate outflow channel. The bottom elevation of the existing spillway channel should be lowered to elevation 6538.0 feet while maintaining the bottom width of 50 feet as shown on Plate 5. A trapezoidal outflow channel with the same bottom width as the spillway should be constructed along the alignment shown in Plate 1. The channel profile is shown in Plate 4 and required dimensions are shown in Plate 5 and Plate 6. The spillway, outflow channel and stilling basin should be protected against erosion using geotextile and riprap as shown in Plate 5.

SPILLWAY CHANNEL

$D = 2.7'$

LENGTH = 50'

FLOWLINE ELEV. = 6538.00'

OUTFLOW CHANNEL

$D = 1.5'$
