INSPECTION REPORT
Sedimentation Structure
N1-F
Kayenta Mine
Navajo County, Arizona
for
PEABODY COAL COMPANY

Dames & Moore
10139-011-22

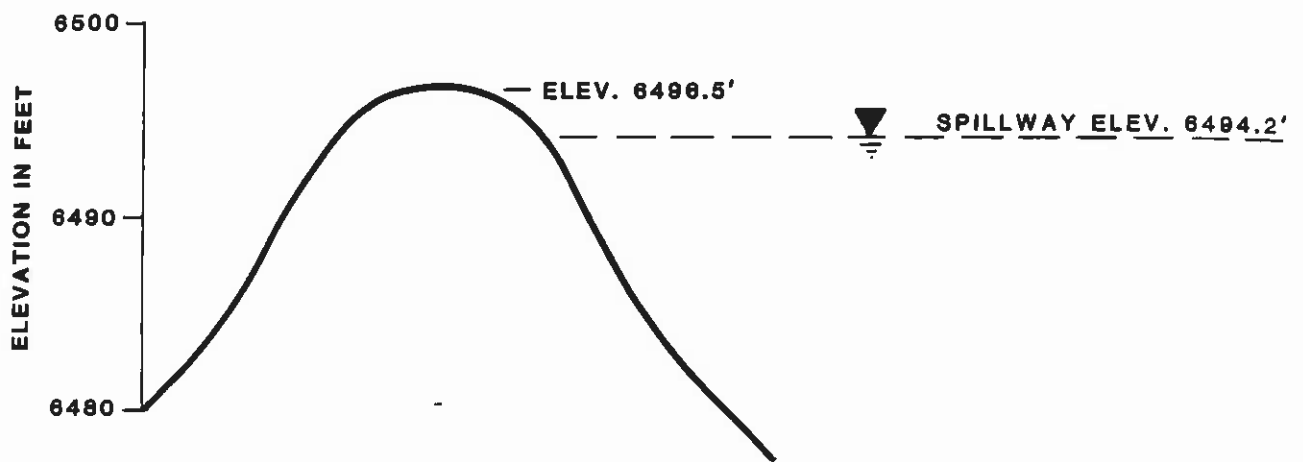
Plate 2

A cross-section of the embankment is shown on Plate 2, Existing Maximum Cross Section N1-F, A-A'.

The N1-F embankment is lower in height; however, the downstream slope is steeper than the category standard; therefore, the embankment has factors of safety less than the design minimum.

The inspection of Structure N1-F indicated that the only geotechnical problem is rill and gully erosion on the upstream slope and the right and left abutments. Correction of erosion is considered a periodic maintenance task and does not require remedial action. The downstream slope should be flattened to 4.0 horizontal to 1 vertical to meet stability requirements.

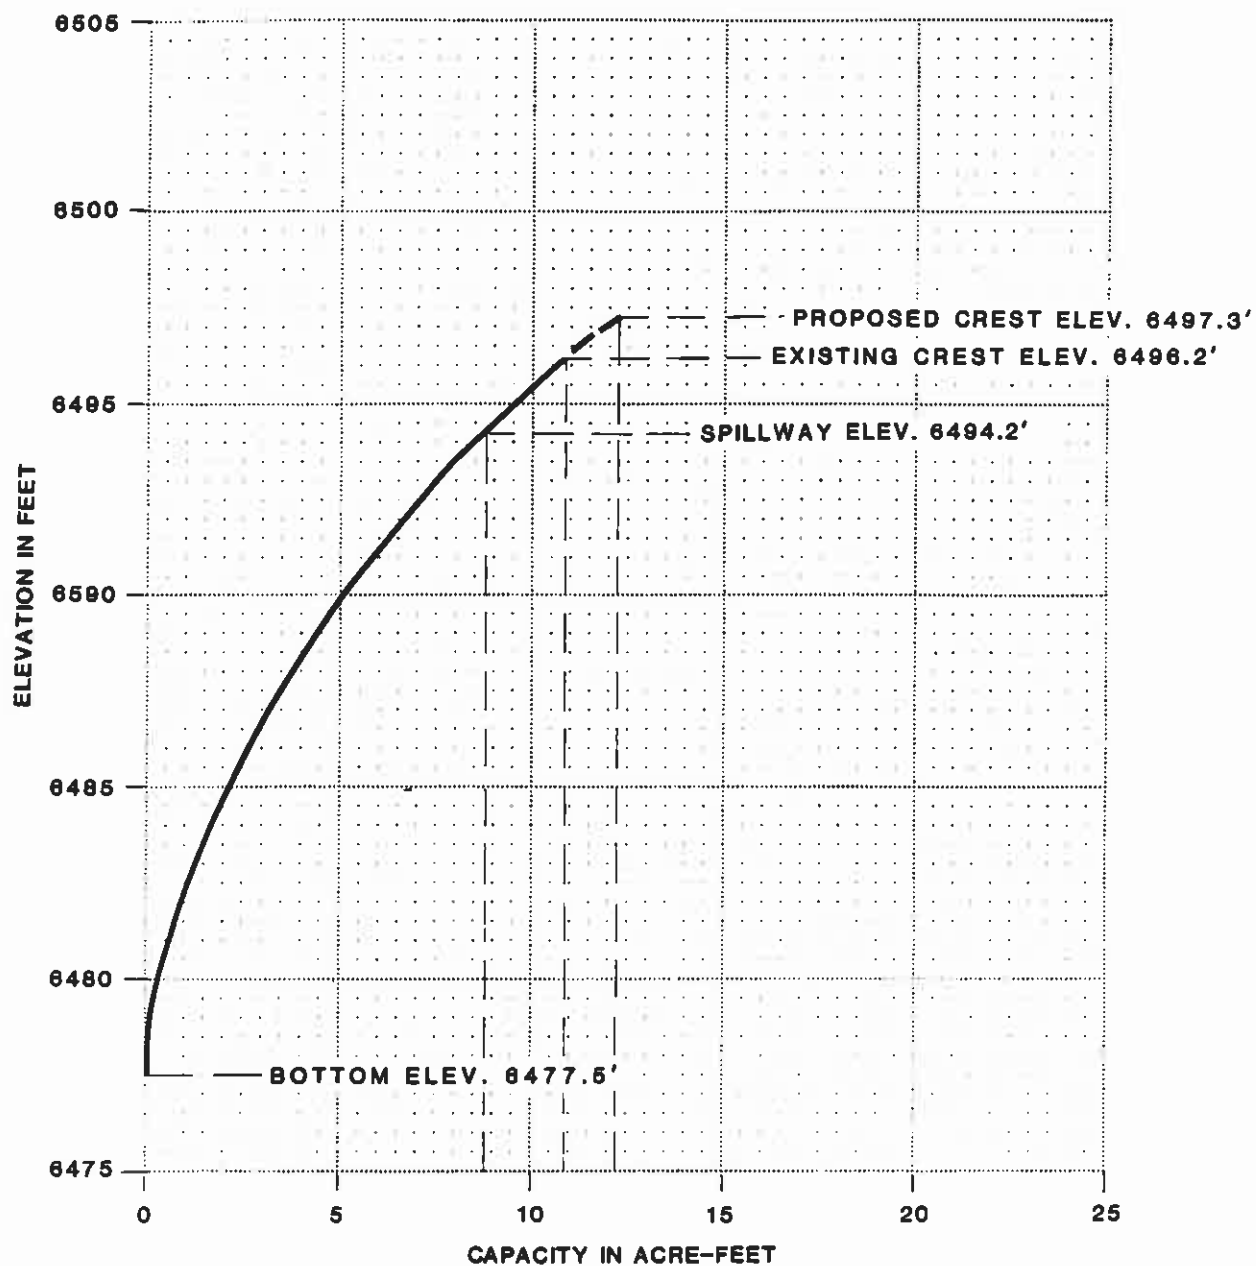
VOLUME-ELEVATION CURVE N1-F

The impoundment volume-elevation curve is based on site specific surveys conducted for Peabody Coal Company's August 1984 inspection, and 1985 resurveys, where available. Additionally, the most current topographic maps available were used in developing Plate 3, Volume-Elevation Curve, N1-F.

Total Storage Capacity	8.58	acre-ft
10-year, 24-hour Storm Inflow	7.04	acre-ft
Available Sediment Storage Capacity	1.53	acre-ft
Sediment Inflow Rate	0.627	acre-ft/yr
Sediment Storage Life	2	yrs

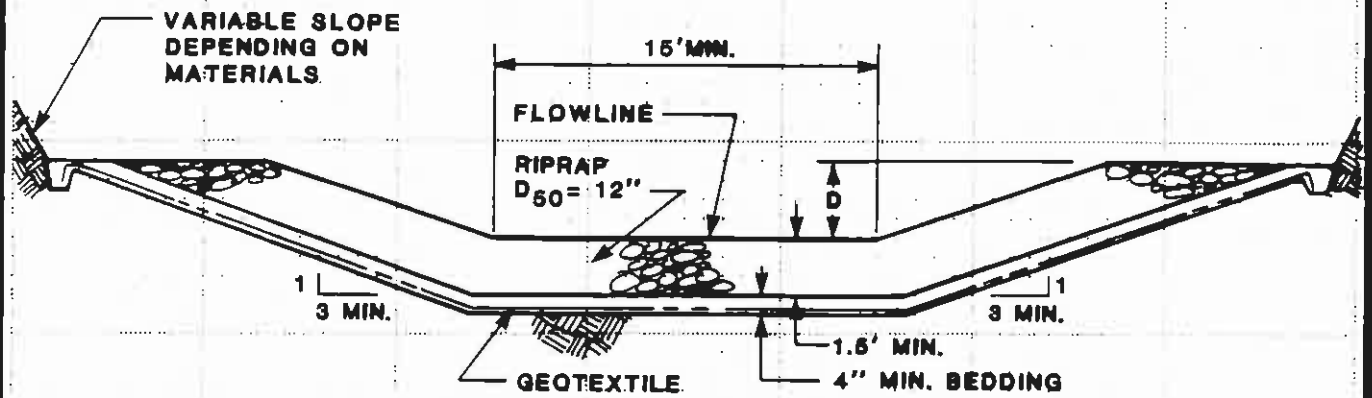
SPILLWAY AND
OUTFLOW CHANNEL
CROSS SECTION
N1-F

There is presently no erosion protection within the channel.

The storage capacity of Structure N1-F is adequate but the spillway capacity is inadequate. The structure does not have an adequate outflow channel. The embankment crest should be raised to elevation 6497.30 feet. The existing outflow channel should be extended and improved and a stilling basin should be constructed along the alignment shown in Plate 1. The channel and stilling basin profile is shown in Plate 4 and required dimensions are shown in Plate 5 and Plate 6. The spillway, outflow channel, and stilling basin should be protected against erosion using geotextile and riprap as shown in Plate 5.
