INSPECTION REPORT  
Sedimentation Structure  
N1-L  
Kayenta Mine  
Navajo County, Arizona  
for  
PEABODY COAL COMPANY

Dames & Moore  
10139-011-22

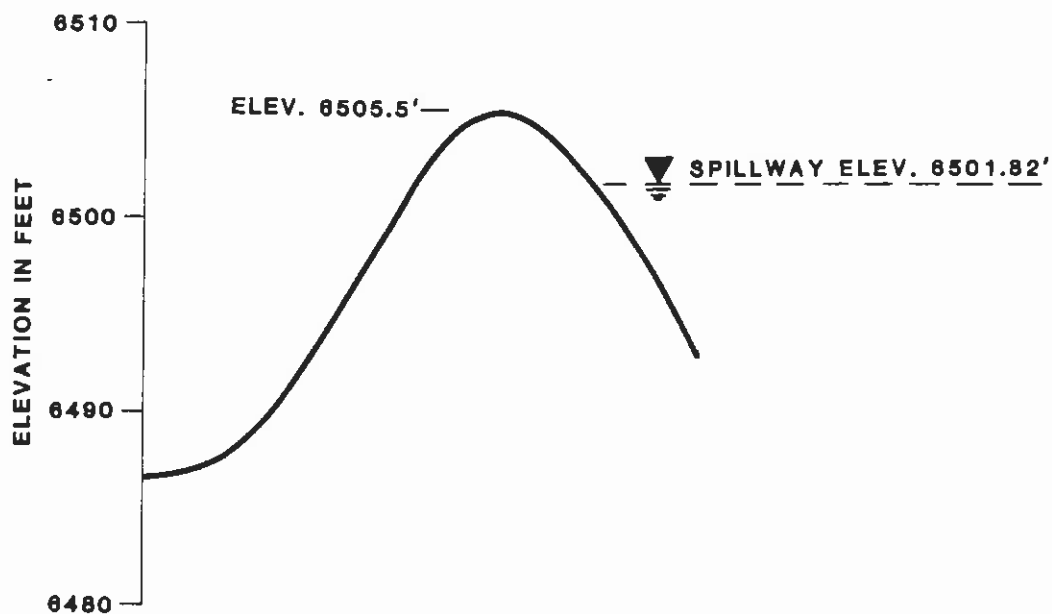
Plate 2

The N1-L embankment is lower in height; however, the downstream slope is steeper than the category standard; therefore, the embankment has factors of safety less than the design minimum.

EXISTING  
MAXIMUM CROSS-SECTION  
A-A'  
N1-L

The inspection of Structure N1-L indicated that the only geotechnical problem is rill and gully erosion on the upstream and downstream slopes, the side slopes of the approach and spillway channel; and the bottom of approach channel. The downstream slope should be flattened to 4.0 horizontal to 1 vertical to meet stability requirements. Correction of erosion is considered a periodic maintenance task and does not require remedial action.

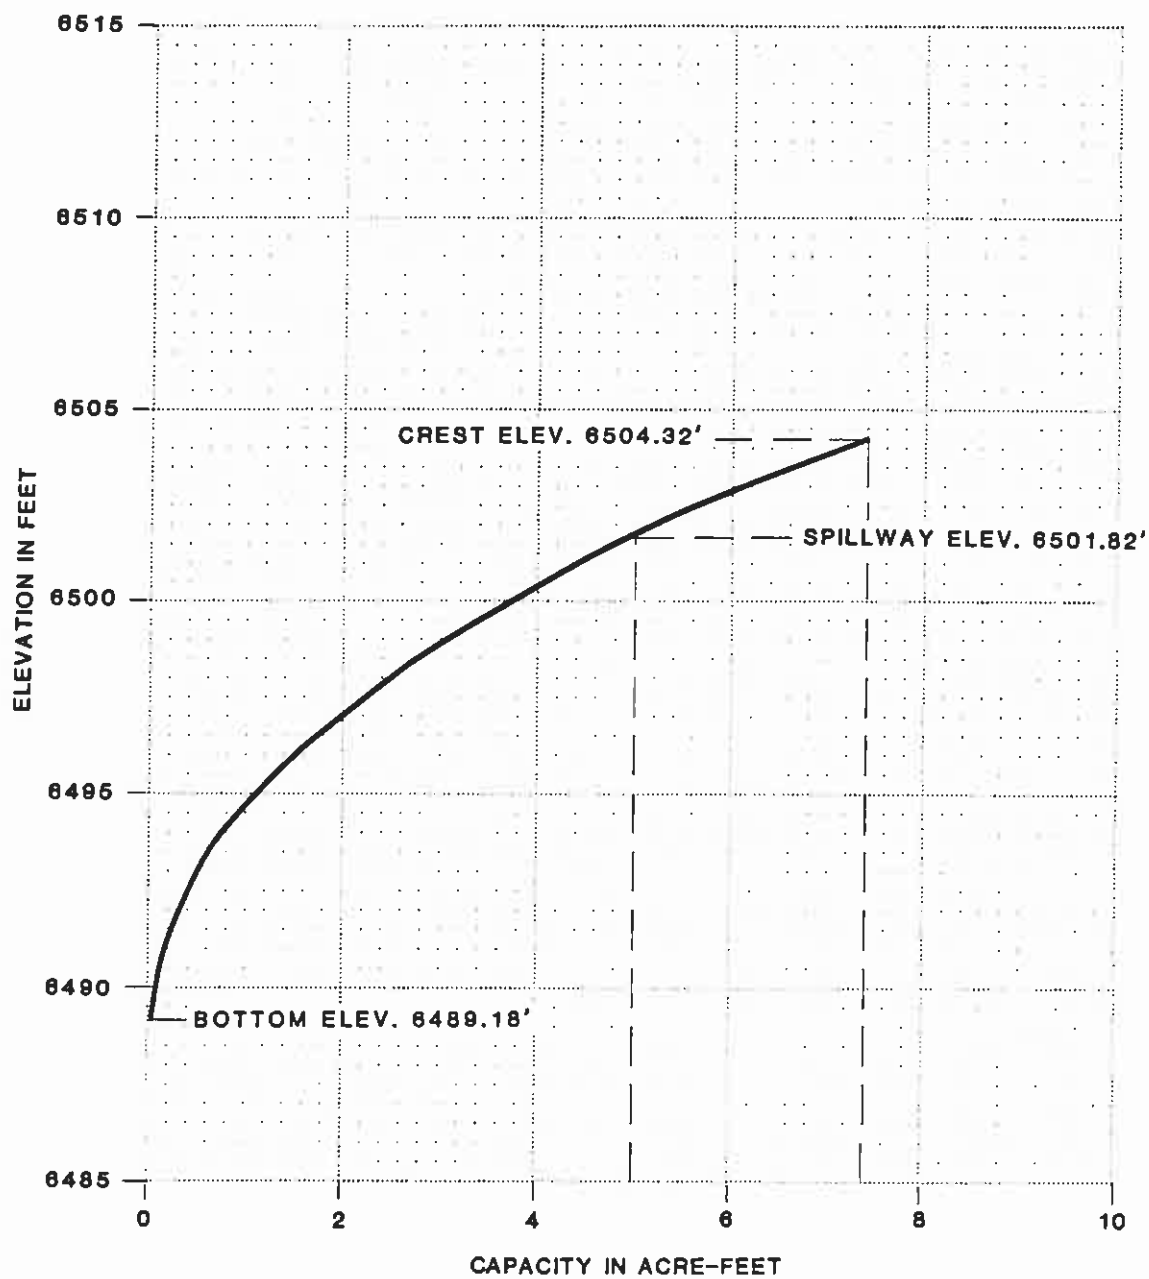
VOLUME-ELEVATION  
CURVE  
N1-L

The impoundment volume-elevation curve is based on site specific surveys conducted for Peabody Coal Company's August 1984 inspection, and 1985 resurveys, where available. Additionally, the most current topographic maps available were used in developing Plate 3, Volume-Elevation Curve, N1-L.

Total Storage Capacity . . . . .	5.02	acre-ft
10-year, 24-hour Storm Inflow . . . . .	2.22	acre-ft
Available Sediment Storage Capacity . . . . .	2.80	acre-ft
Sediment Inflow Rate . . . . .	0.224	acre-ft/yr
Sediment Storage Life . . . . .	12	yrs

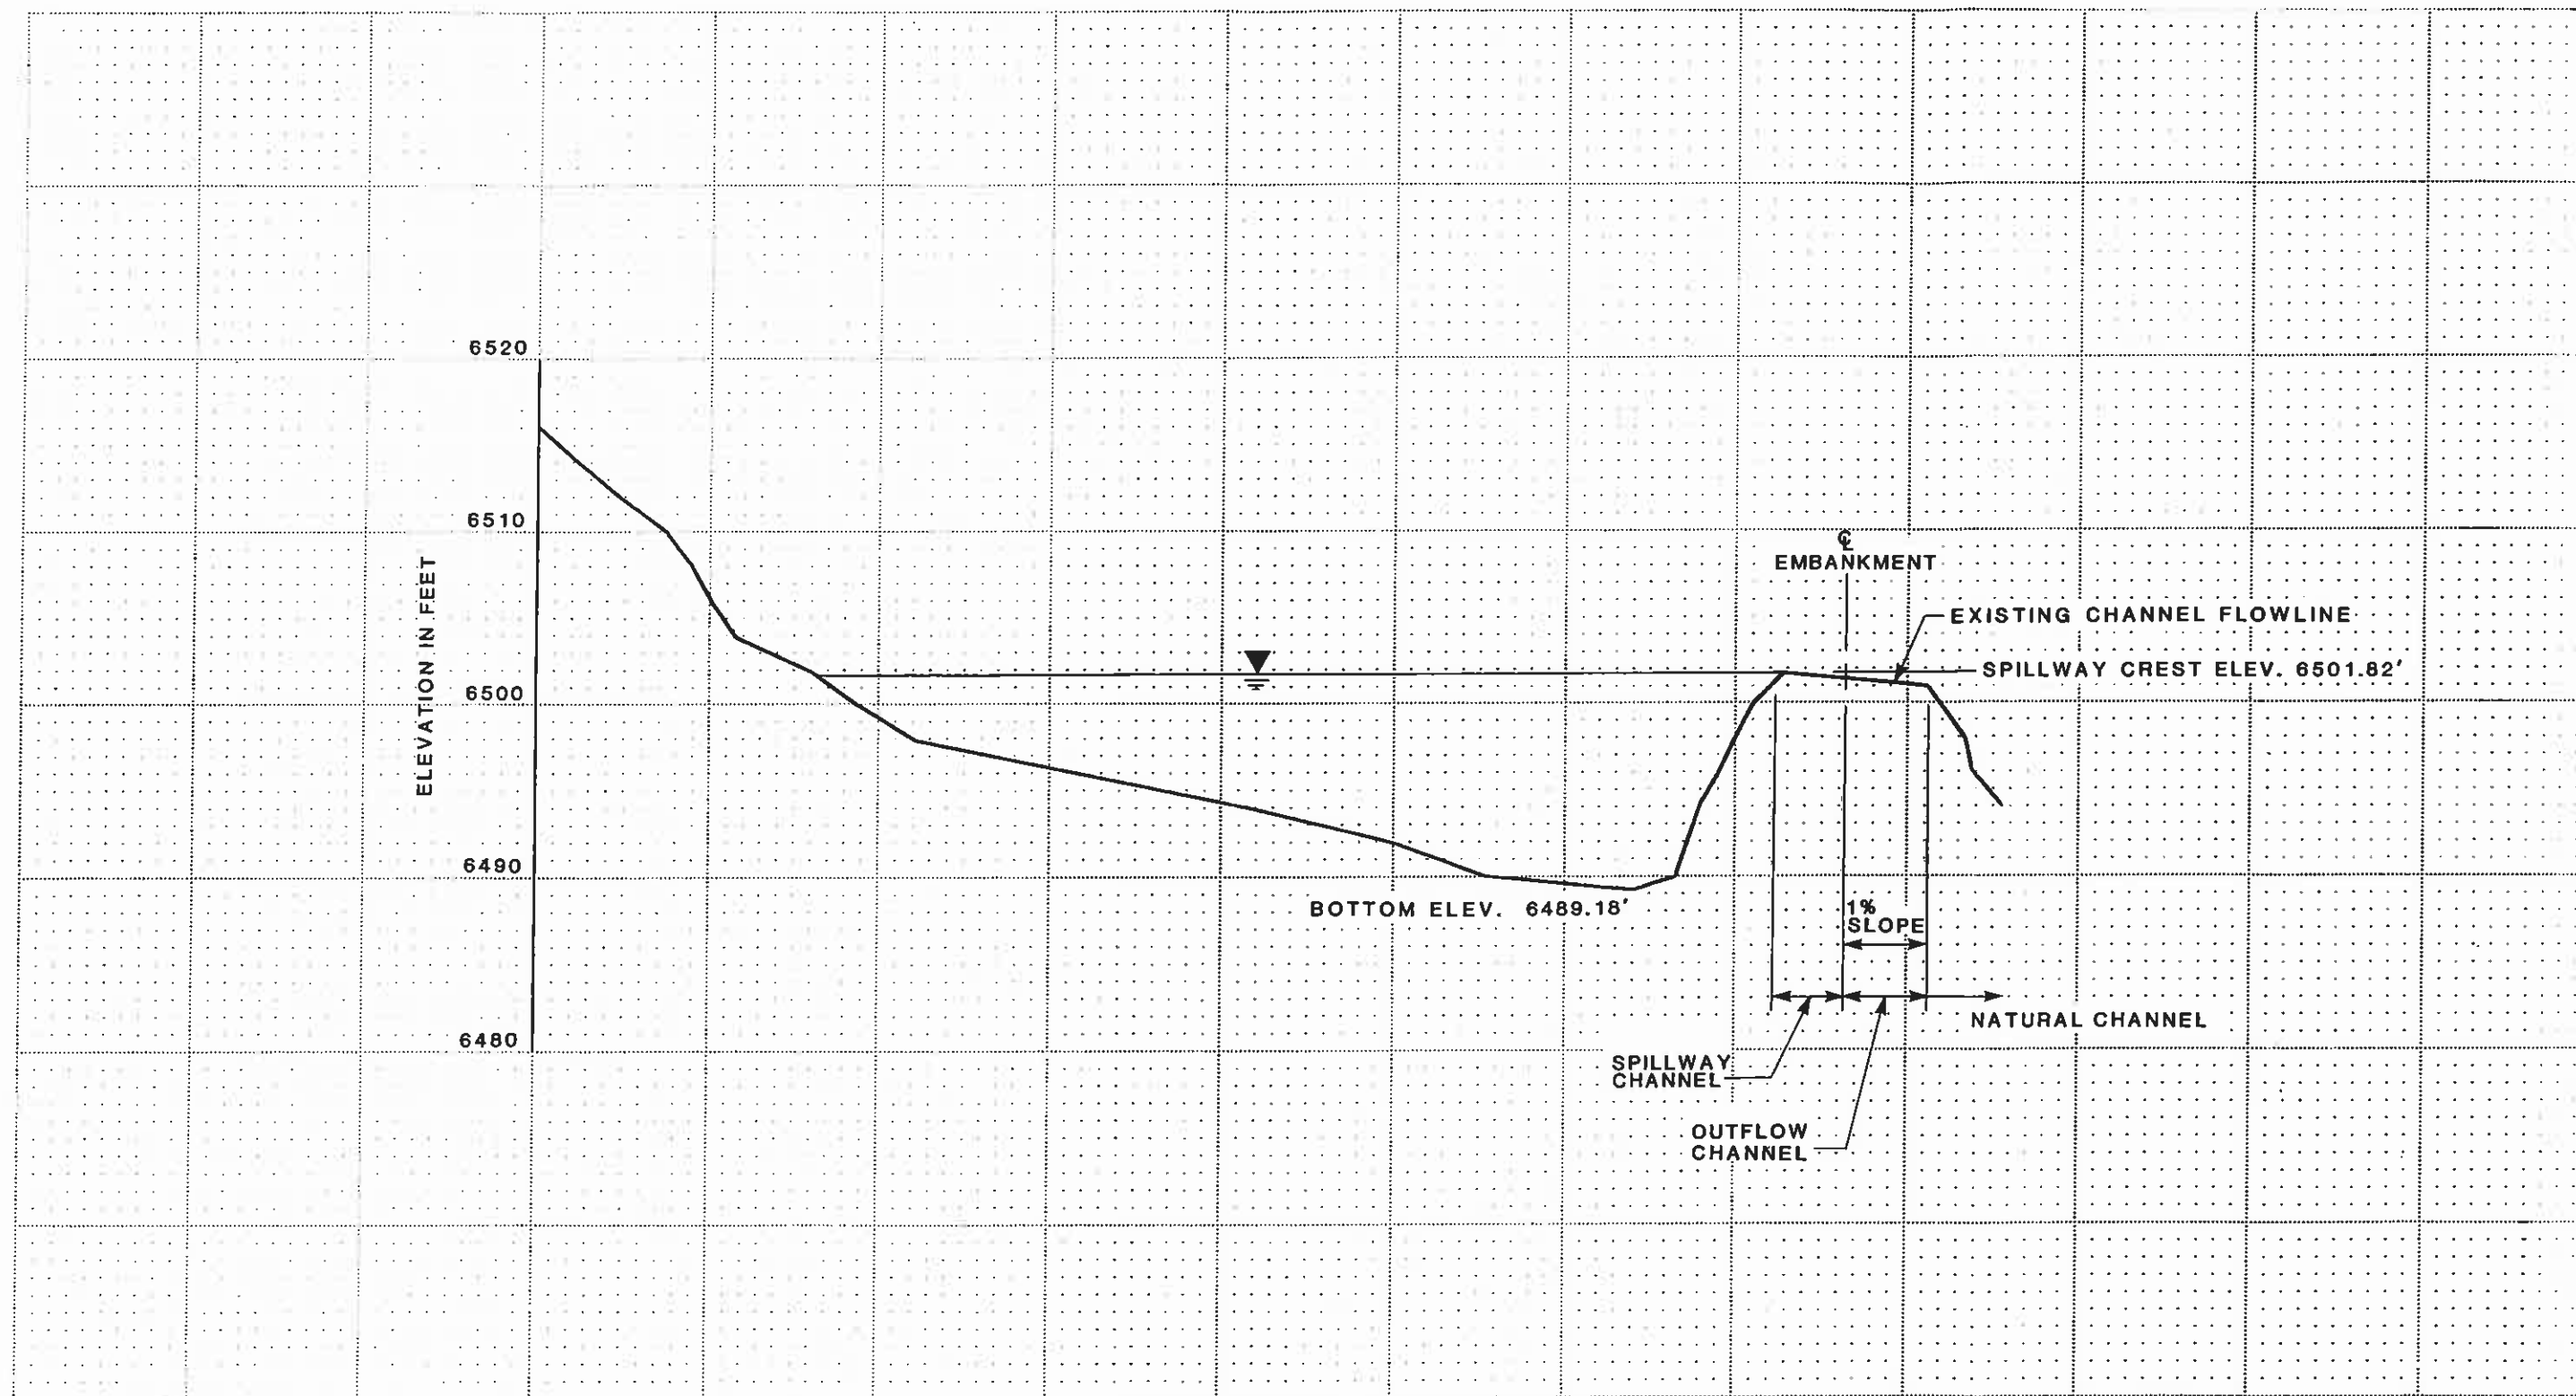
CHANNEL PROFILE B-B'  
N1-L

The storage capacity and spillway capacity of Structure N1-L are adequate; however, the spillway does not have an outflow channel or adequate erosion protection. A trapezoidal outflow channel should be constructed along the alignment B-B' shown in Plate 1. The channel profile is shown in Plate 4 and the required dimensions are shown in Plate 5. Both the spillway and outflow channel should be protected against erosion using geotextile and gravel as shown in Plate 5.

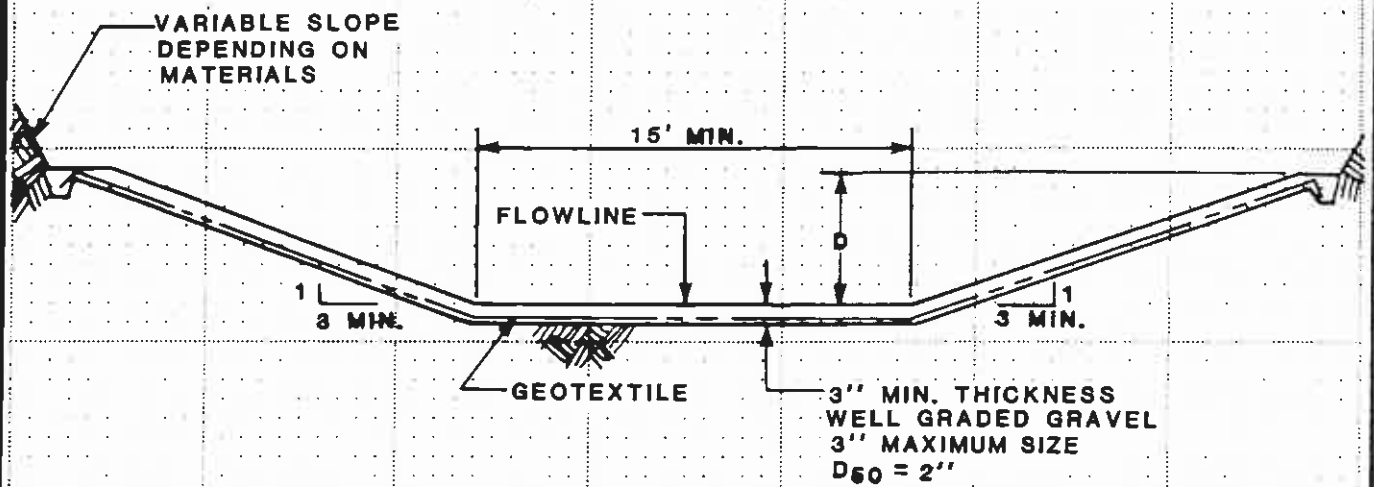
**SPILLWAY AND  
OUTFLOW CHANNEL  
CROSS SECTION  
N1-L**

There is presently no erosion protection within the channel.

The structure presently has no outflow channel.
