INSPECTION REPORT
Sedimentation Structure
N1-M
Kayenta Mine
Navajo County, Arizona
for
PEABODY COAL COMPANY

Dames & Moore
10139-011-22

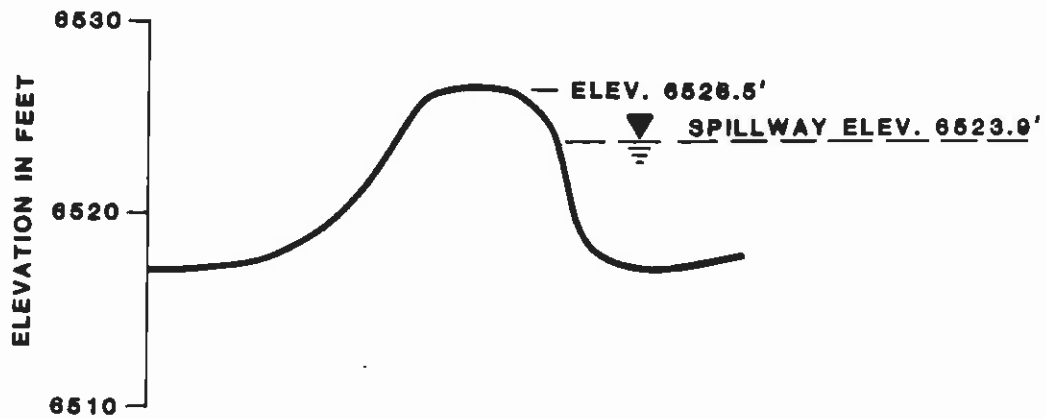
EXISTING
MAXIMUM CROSS-SECTION
A-A'
N1-M

A cross-section of the embankment is shown on Plate 2, Existing Maximum Cross Section N1-M, A-A'. Grass provides erosion protection on the upstream and downstream slopes of the embankment.

The inspection of Structure N1-M indicated that the geotechnical problems consist of rill erosion on the upstream and downstream slopes and the side slopes of the spillway and outlet channel; and two tranverse cracks near the center of the embankment. Correction of erosion is considered a

periodic maintenance task and does not require remedial action. The embankment section with the cracks should be repaired by excavating to the bottom of the crack and replacing with compacted fill.

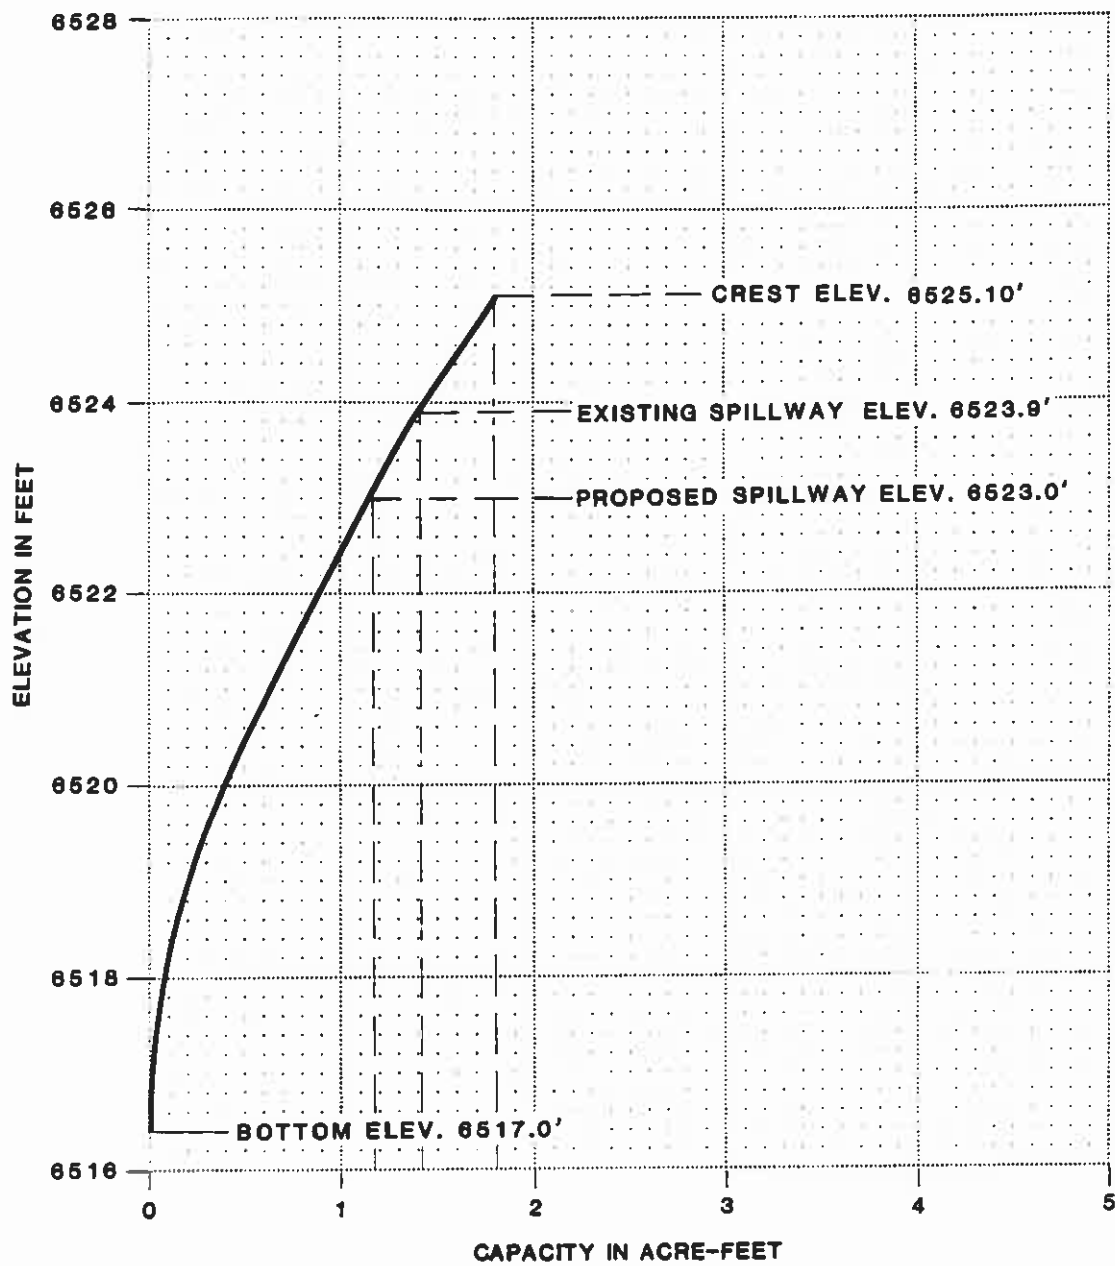
VOLUME-ELEVATION
CURVE
N1-M

The impoundment volume-elevation curve is based on site specific surveys conducted for Peabody Coal Company's August 1984 inspection, and 1985 resurveys, where available. Additionally, the most current topographic maps available were used in developing Plate 3, Volume-Elevation Curve, N1-M.

Total Storage Capacity	1.4	acre-ft
10-year, 24-hour Storm Inflow	0.59	acre-ft
Available Sediment Storage Capacity . .	0.81	acre-ft
Sediment Inflow Rate	0.040	acre-ft/yr
Sediment Storage Life	20	yrs

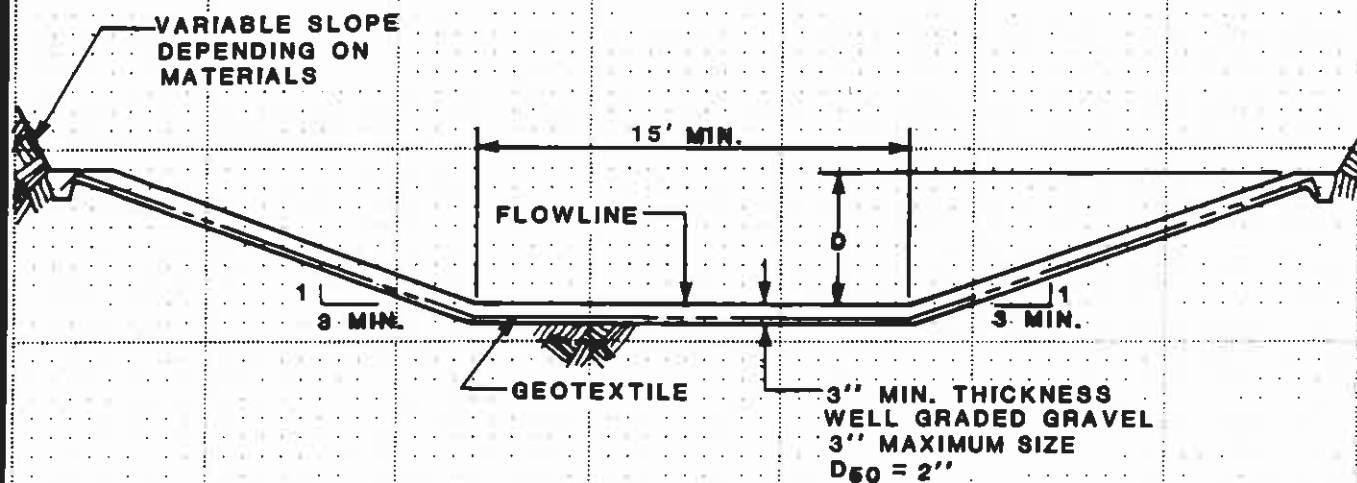
**SPILLWAY AND
 OUTFLOW CHANNEL
 CROSS SECTION
 N1-M**

The storage capacity of Structure N1-M is adequate but the spillway capacity is inadequate. The structure does not have an adequate outflow channel. The bottom elevation of the existing spillway channel should be lowered to elevation 6523.0 feet while maintaining the bottom width of 15 feet as shown on Plate 5. A trapezoidal outflow channel with the same bottom width as the spillway should be constructed along the alignment shown in Plate 1. The channel profile is shown in Plate 4 and required dimensions are shown in Plate 5. Both the spillway and outflow channel should be protected against erosion using geotextile and gravel as shown in Plate 5.
