INSPECTION REPORT  
Sedimentation Structure  
N1-O  
Kayenta Mine  
Navajo County, Arizona  
for  
PEABODY COAL COMPANY

Dames & Moore  
10139-011-22

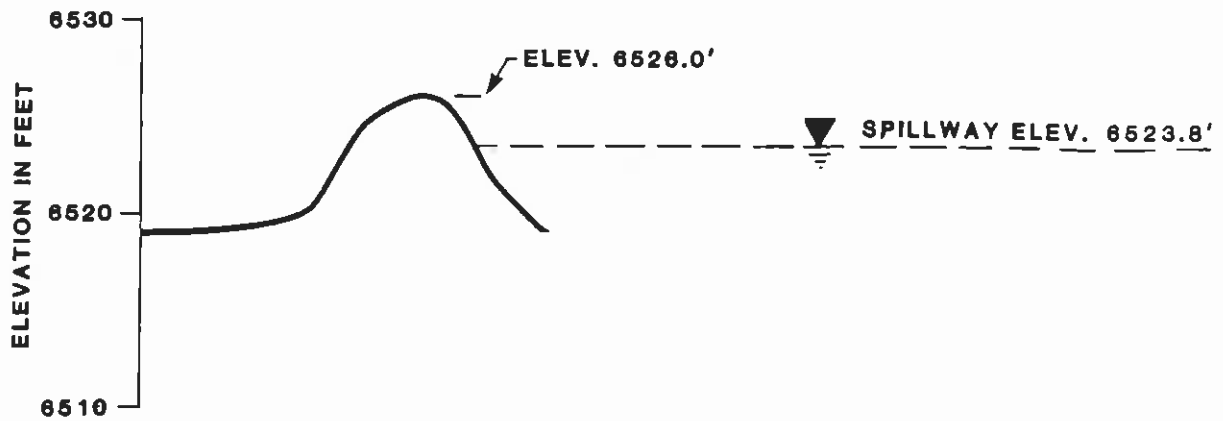
Plate 2

Structure N1-0 is a homogeneous earthen embankment classified as a in-wash embankment. Physical characteristics of the embankment are listed in the following table:

Embankment . . . . .	Alluvium
Foundation . . . . .	Alluvium
Right Abutment . . . . .	Residual Shale
Left Abutment . . . . .	Alluvium
Height . . . . .	9.1 ft
Crest Width . . . . .	18 ft
Upstream Slope . . . . .	3.1 H : 1 V
Downstream Slope . . . . .	3.1 H : 1 V

A cross-section of the embankment is shown on Plate 2, Existing Maximum Cross Section N1-0, A-A'. Grass provides erosion protection on the upstream and downstream slopes of the embankment.

The N1-0 embankment is lower in height and has flatter slopes than the category standard; therefore, the embankment has factors of safety greater than the design minimum.

EXISTING  
MAXIMUM CROSS-SECTION  
A-A'  
N1-O

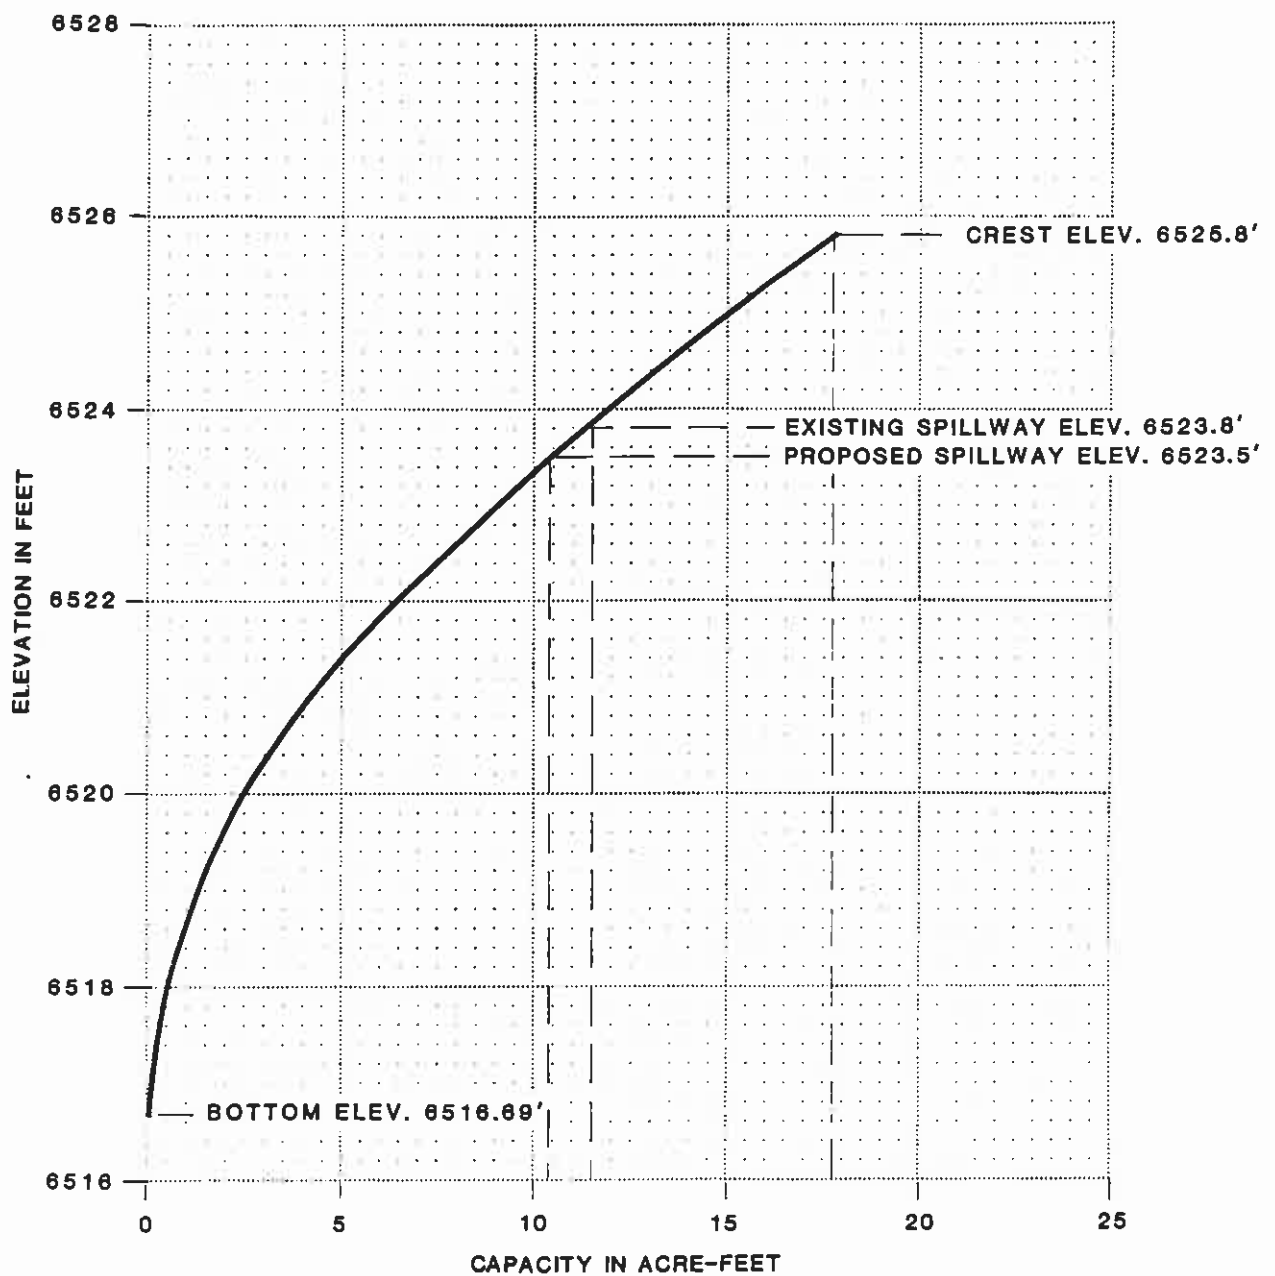
VOLUME-ELEVATION  
CURVE  
N1-O

The impoundment volume-elevation curve is based on site specific surveys conducted for Peabody Coal Company's August 1984 inspection, and 1985 resurveys, where available. Additionally, the most current topographic maps available were used in developing Plate 3, Volume-Elevation Curve, N1-0.

Total Storage Capacity . . . . .	10.88	acre-ft
10-year, 24-hour Storm Inflow . . . . .	7.66	acre-ft
Available Sediment Storage Capacity . .	3.32	acre-ft
Sediment Inflow Rate . . . . .	0.602	acre-ft/yr
Sediment Storage Life . . . . .	5	yrs

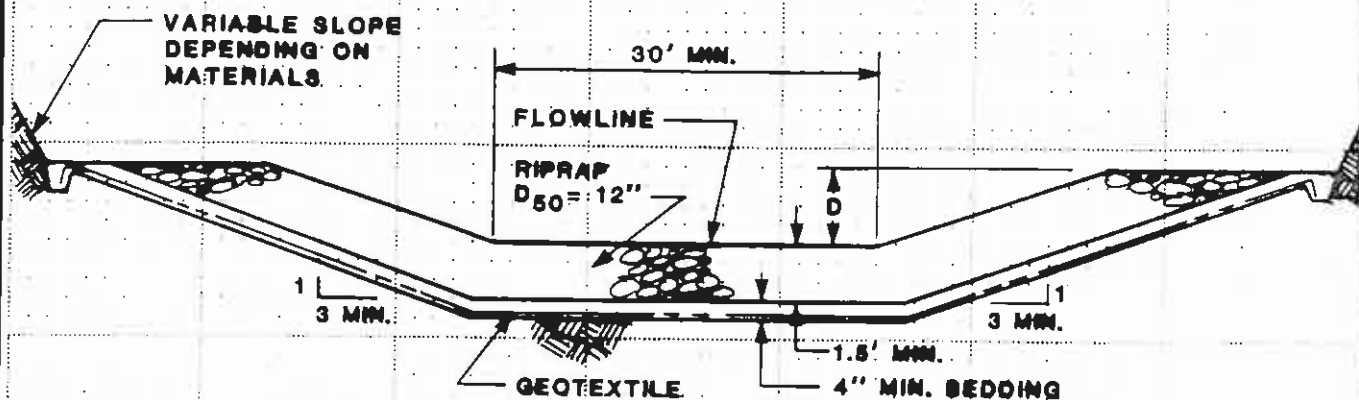
SPILLWAY AND  
 OUTFLOW CHANNEL  
 CROSS SECTION  
 N1-O

There is presently no erosion protection within the channel.

The structure presently has no outflow channel.

SPILLWAY CHANNEL

D = 2.3'  
 LENGTH = 30'  
 FLOWLINE ELEV. = 8523.5'

OUTFLOW CHANNEL

D = 1'

The storage capacity of Structure N1-0 is adequate but the spillway capacity is inadequate. The structure does not have an outflow channel. The bottom elevation of the existing spillway channel should be lowered to elevation 6523.5 feet while maintaining the bottom width of 30 feet as shown on Plate 5. A trapezoidal outflow channel with the same bottom width as the spillway should be constructed along the alignment shown in Plate 1. The channel profile is shown in Plate 4 and required dimensions are shown in Plate 5. Both the spillway and outflow channel should be protected against erosion using geotextile and riprap as shown in Plate 5.

Lowering the spillway elevation to 6523.5 feet decreases the storage capacity and increases the freeboard. The analysis of these conditions is summarized in the following table.
