The inspection of Structure KM-A2 indicated that the only geotechnical problem is rill erosion on the upstream and downstream slopes, the side slopes of the spillway channel. Correction of erosion is considered a periodic maintenance task and does not require remedial action.

REMEDIATION COMPLIANCE PLAN

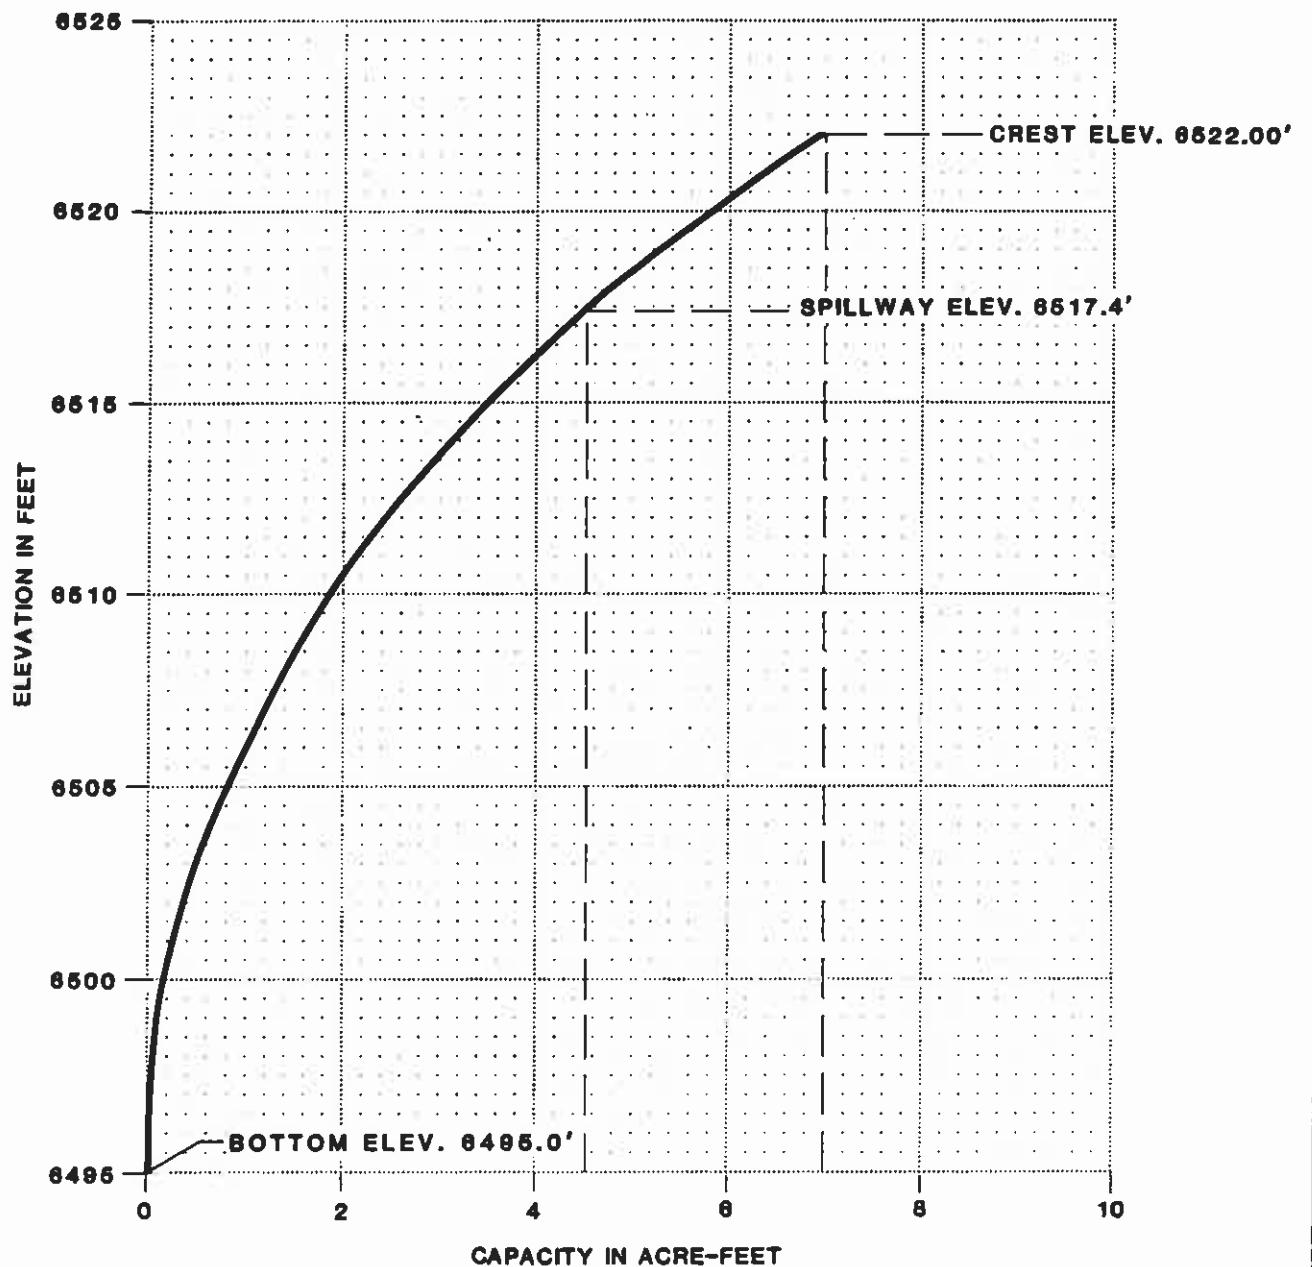
VOLUME-ELEVATION
CURVE
KM-A2

The impoundment volume-elevation curve is based on site specific surveys conducted for Peabody Coal Company's August 1984 inspection, and 1985 resurveys, where available. Additionally, the most current topographic maps available were used in developing Plate 3, Volume-Elevation Curve, maps available were used in developing Plate 3, Volume-Elevation Curve,

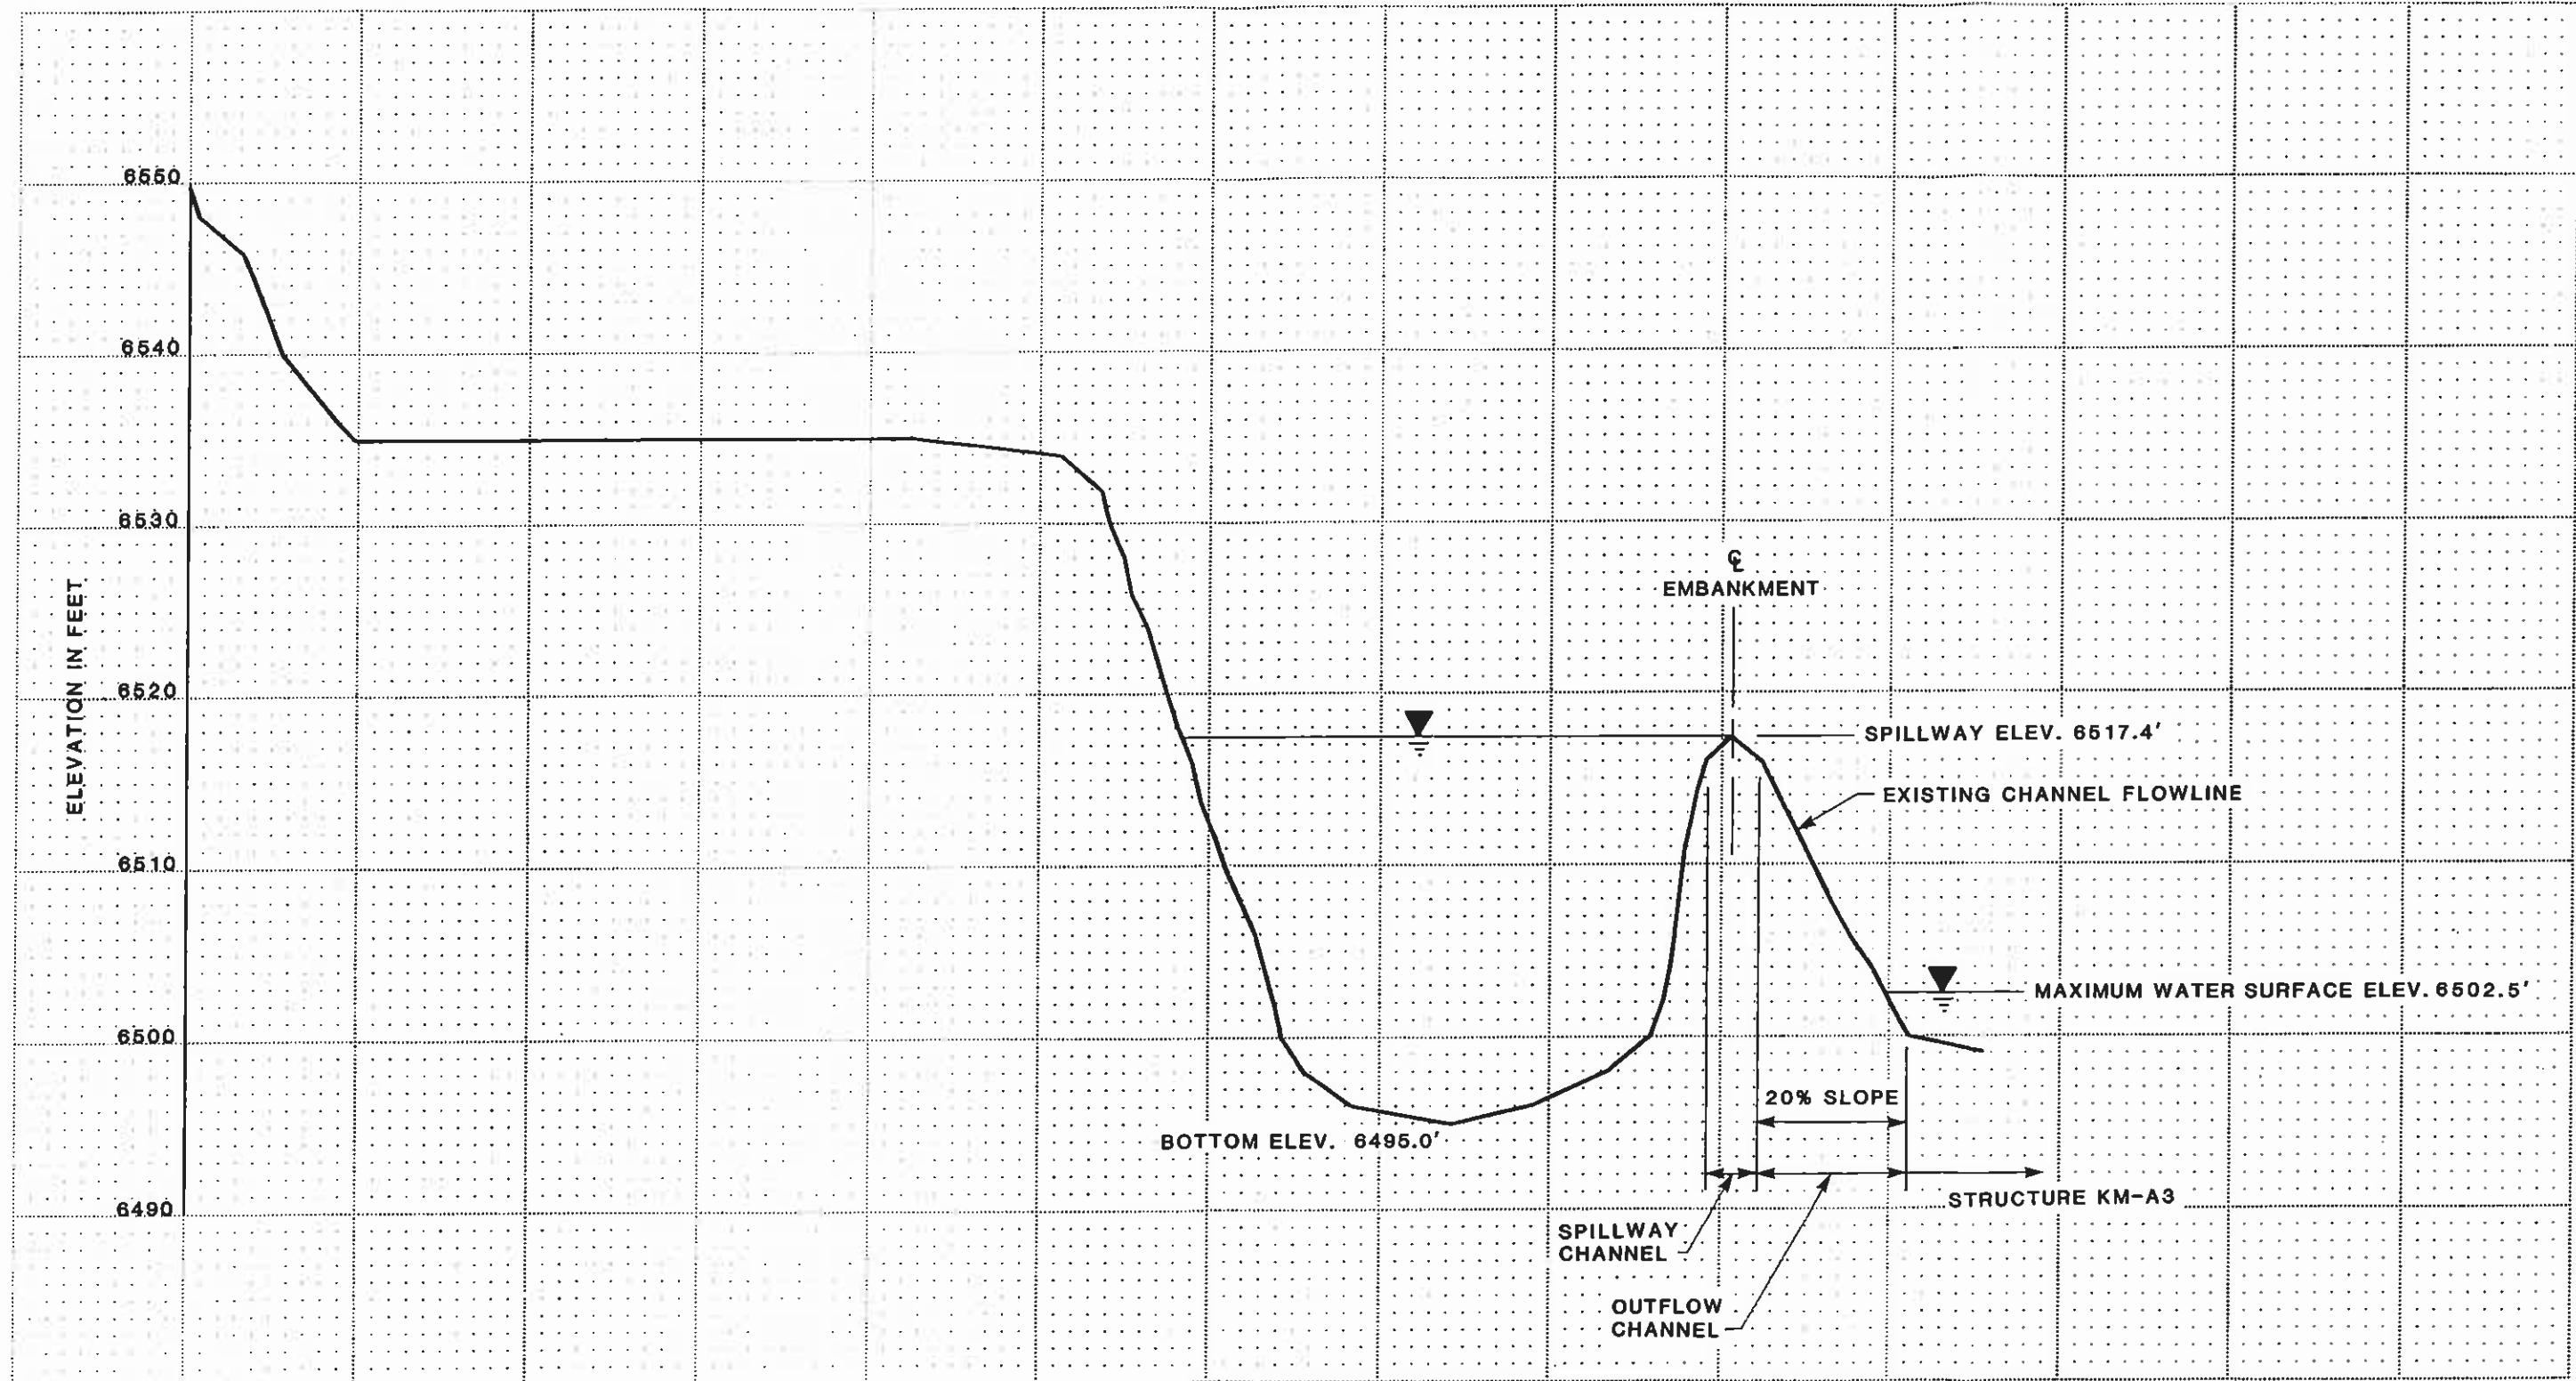
CHANNEL PROFILE B-B'
KM-A2

The storage capacity and spillway capacity of Structure KM-A2 are adequate. The outflow channel is protected with riprap but the spillway channel is not. The spillway channel should be protected against erosion using geotextile and riprap as shown in Plate 5. Plate 4 shows the existing spillway and outflow channel profile and Plate 5 shows the channel dimensions.
