INSPECTION REPORT
Sedimentation Structure
N6-C
Black Mesa Mine
Navajo County, Arizona
for
PEABODY COAL COMPANY

Dames & Moore
10139-011-22

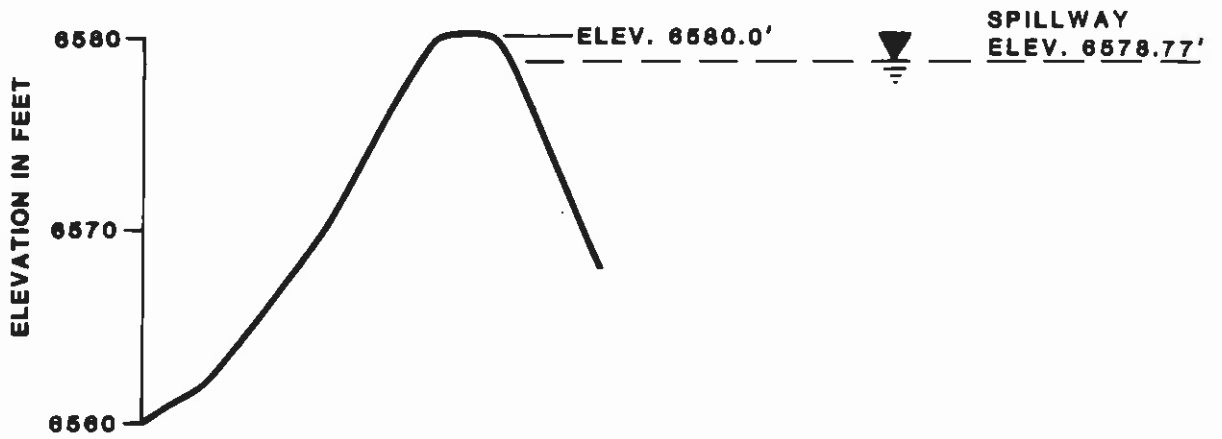
Plate 2

A cross-section of the embankment is shown on Plate 2, Existing Maximum Cross Section N6-C, A-A'. Grass provides erosion protection on the upstream and downstream slopes of the embankment.

EXISTING
MAXIMUM CROSS-SECTION
A-A'
N6-C

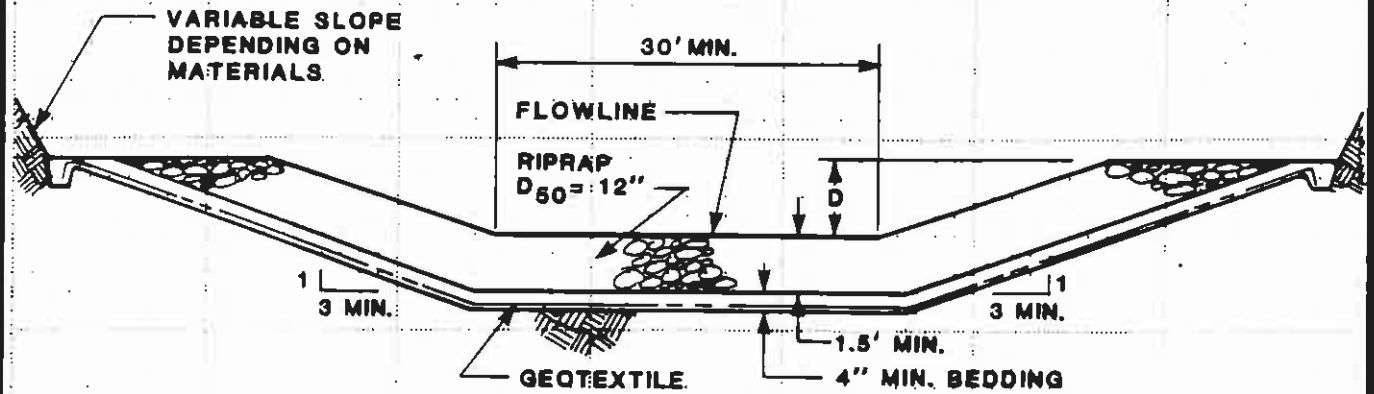
**SPILLWAY AND
OUTFLOW CHANNEL
CROSS SECTION
N6-C**

The storage capacity of Structure N6-C is adequate but the spillway capacity is inadequate. The structure does not have an adequate outflow channel. The bottom elevation of the existing spillway channel should be lowered to elevation 6576.70 feet while maintaining the bottom width of 30 feet as shown on Plate 5. A trapezoidal outflow channel with the same bottom width as the spillway and a stilling basin should be constructed along the alignment shown in Plate 1. The channel and stilling basin profile is shown in Plate 4 and required dimensions are shown in Plate 5 and Plate 6. The spillway, outflow channel and stilling basin should be protected against erosion using geotextile and riprap as shown in Plate 5.

SPILLWAY CHANNEL

D = 2.6'

LENGTH = 30'

FLOWLINE ELEV. = 8576.70'

OUTFLOW CHANNEL

D = 2.0'

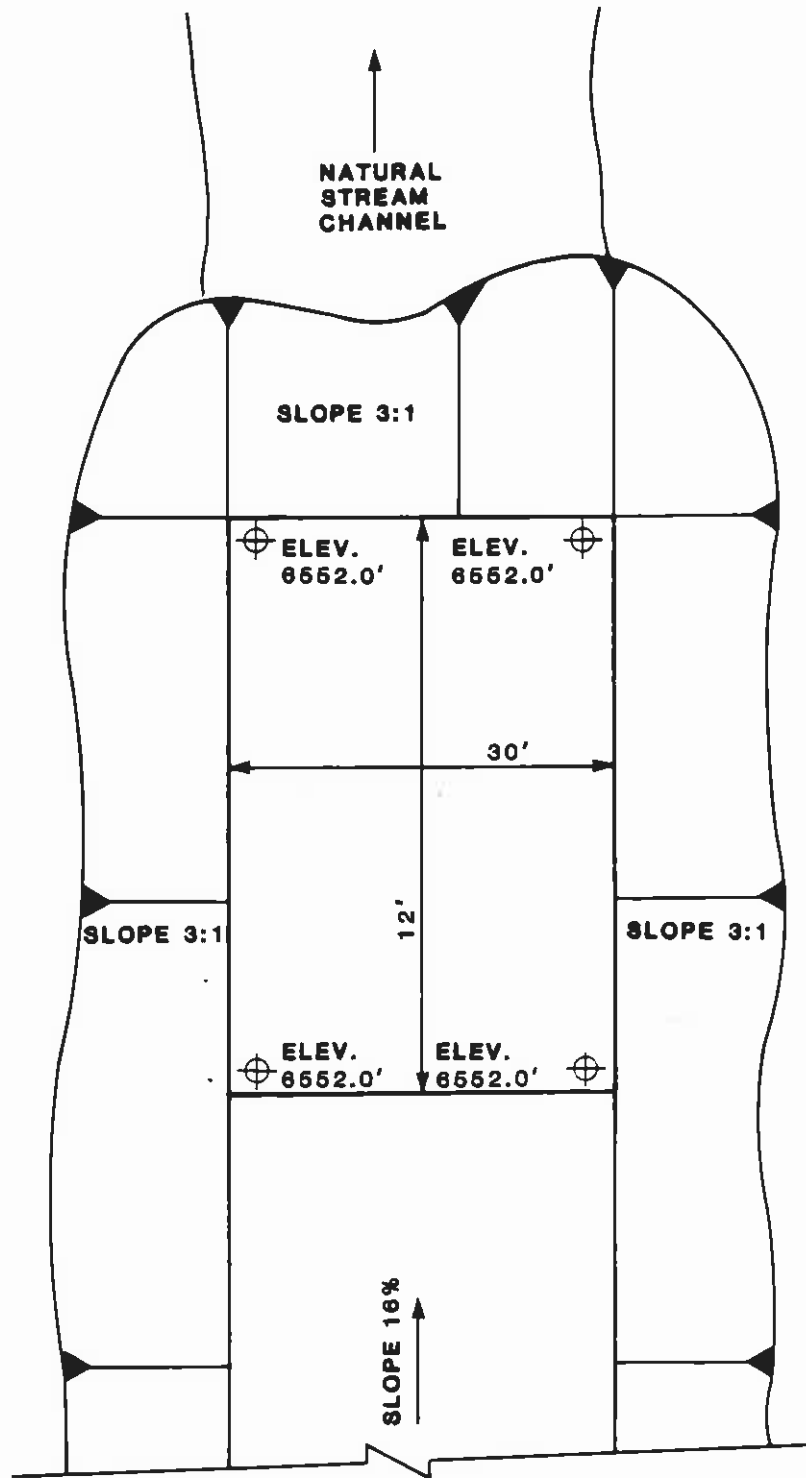
SPILLWAY STILLING BASIN PLAN N6-C

MINIMUM HEIGHT OF RIPRAP
ALONG SIDEWALLS ABOVE
THE BASIN FLOOR = 3.4'

MINIMUM DEPTH OF BASIN FLOOR
BELOW NATURAL STREAMBED = 1.8'
