INSPECTION REPORT
PERMANENT IMPOUNDMENT STRUCTURE
N2-RB
Kayenta Mine
Navajo County, Arizona
by
PEABODY COAL COMPANY

Structure N2-RB is a totally incised impoundment in the N-2 reclaimed area, designed and constructed in 1983 by Peabody Coal Company as a permanent sedimentation structure to control runoff and sediment from the reclaimed mining areas of the Kayenta Mine. The location of Structure N2-RB is shown on Plate 1, Site Plan.

Structure N2-RB was inspected on September 17, 1985 by engineers from Dames and Moore and on November 22, 1985 by engineers from Peabody Coal Company. The purpose of the inspection was to assess the safety and general condition of the structure with respect to United States Department of Interior, Office of Surface Mining (OSM) regulations.

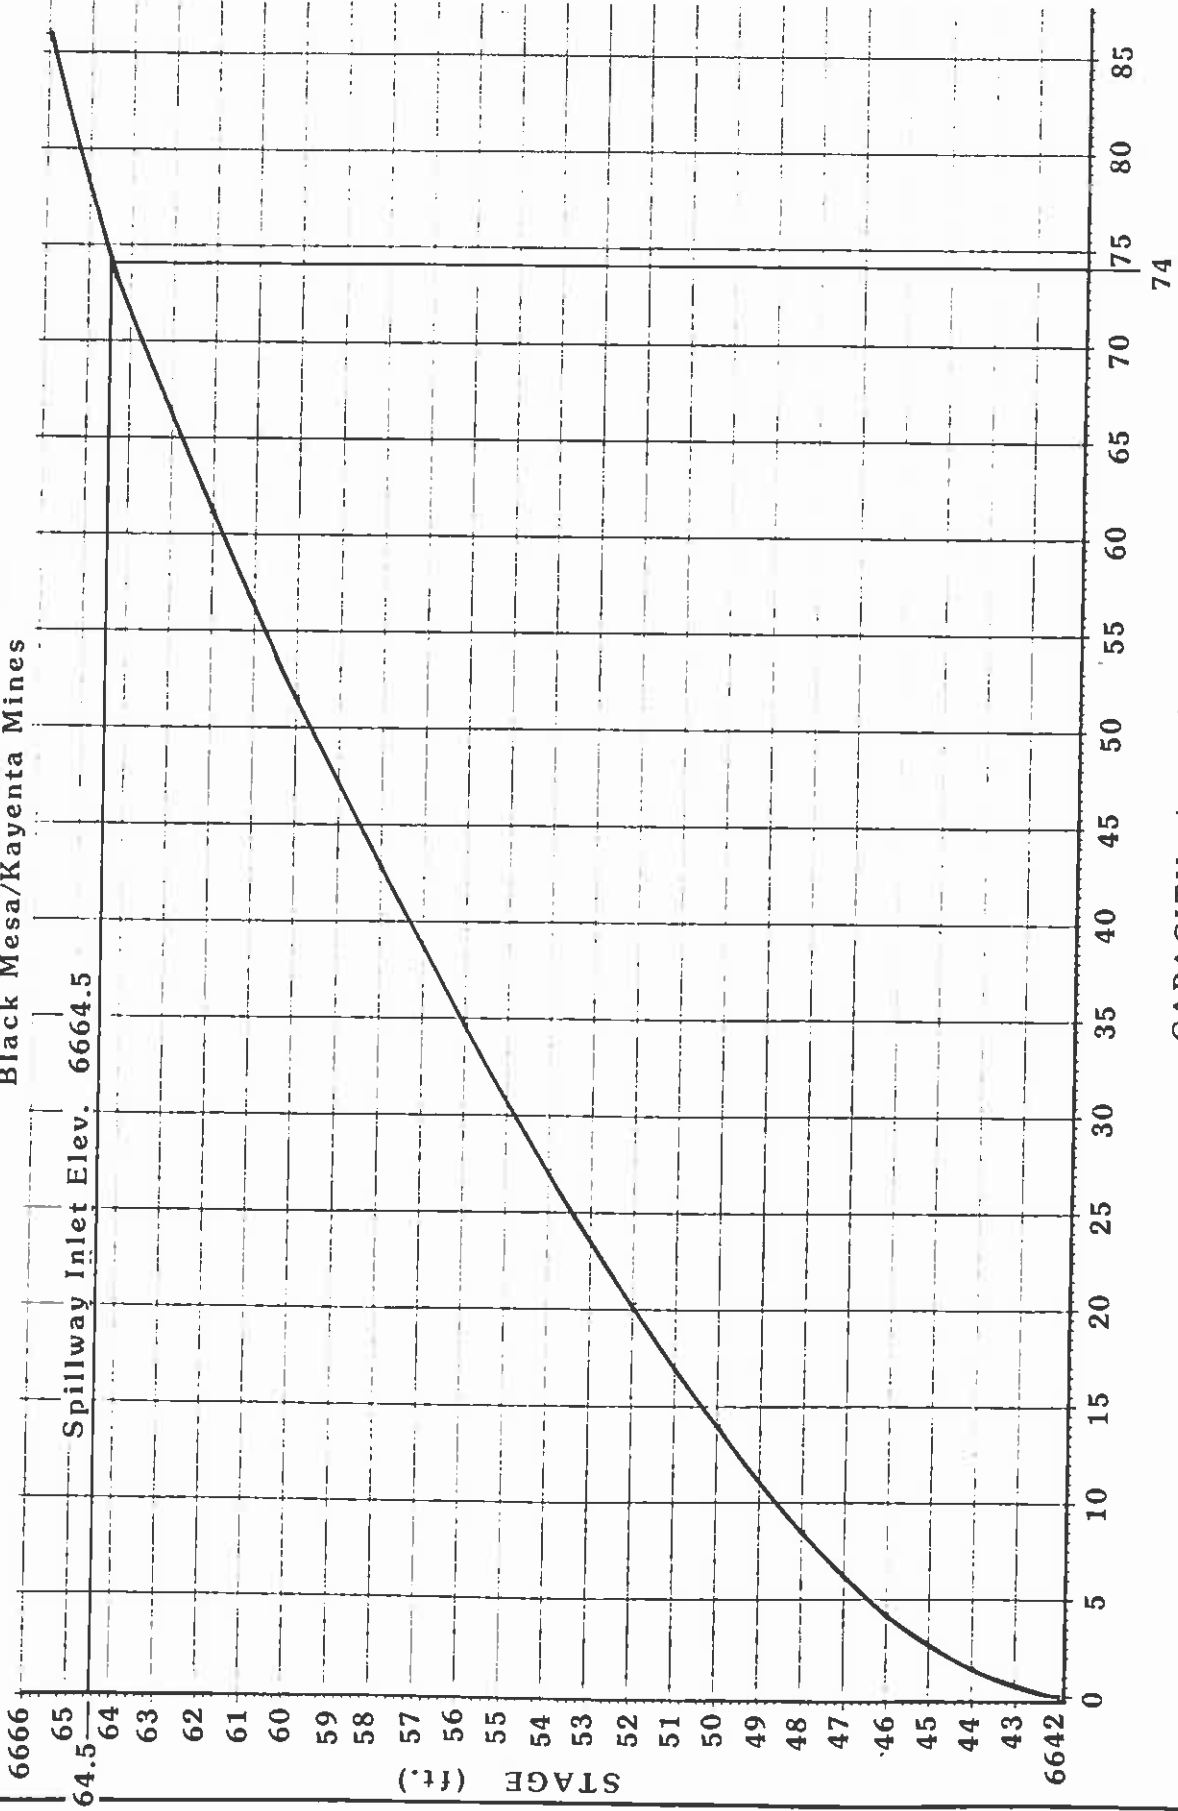
STAGE-CAPACITY CURVE N2-RB

The hydrologic analysis give the storage volume required to contain the 100-year, 24-hour storm event with the remaining storage volume available for sediment storage. The existing storage capacity of N2-RB is shown on Plate 2. Stage-Capacity Curve, N2-RB, and the results of the sediment inflow analysis are summarized in the following table.

Total Storage Capacity	74.2 acre-ft
100-year, 24-hour Inflow	38.3 acre-ft
Available Sediment Storage Capacity	35.9 acre-ft
Sediment Inflow, 10-year, 24-hour Storm (MUSLE)	13.31 acre-ft
Sediment Storage	2.70 10-year, 24-hour Storms
