INSPECTION REPORT  
Sedimentation Structure  
N2-G  
Kayenta Mine  
Navajo County, Arizona  
for  
PEABODY COAL COMPANY

Dames & Moore  
10139-011-22

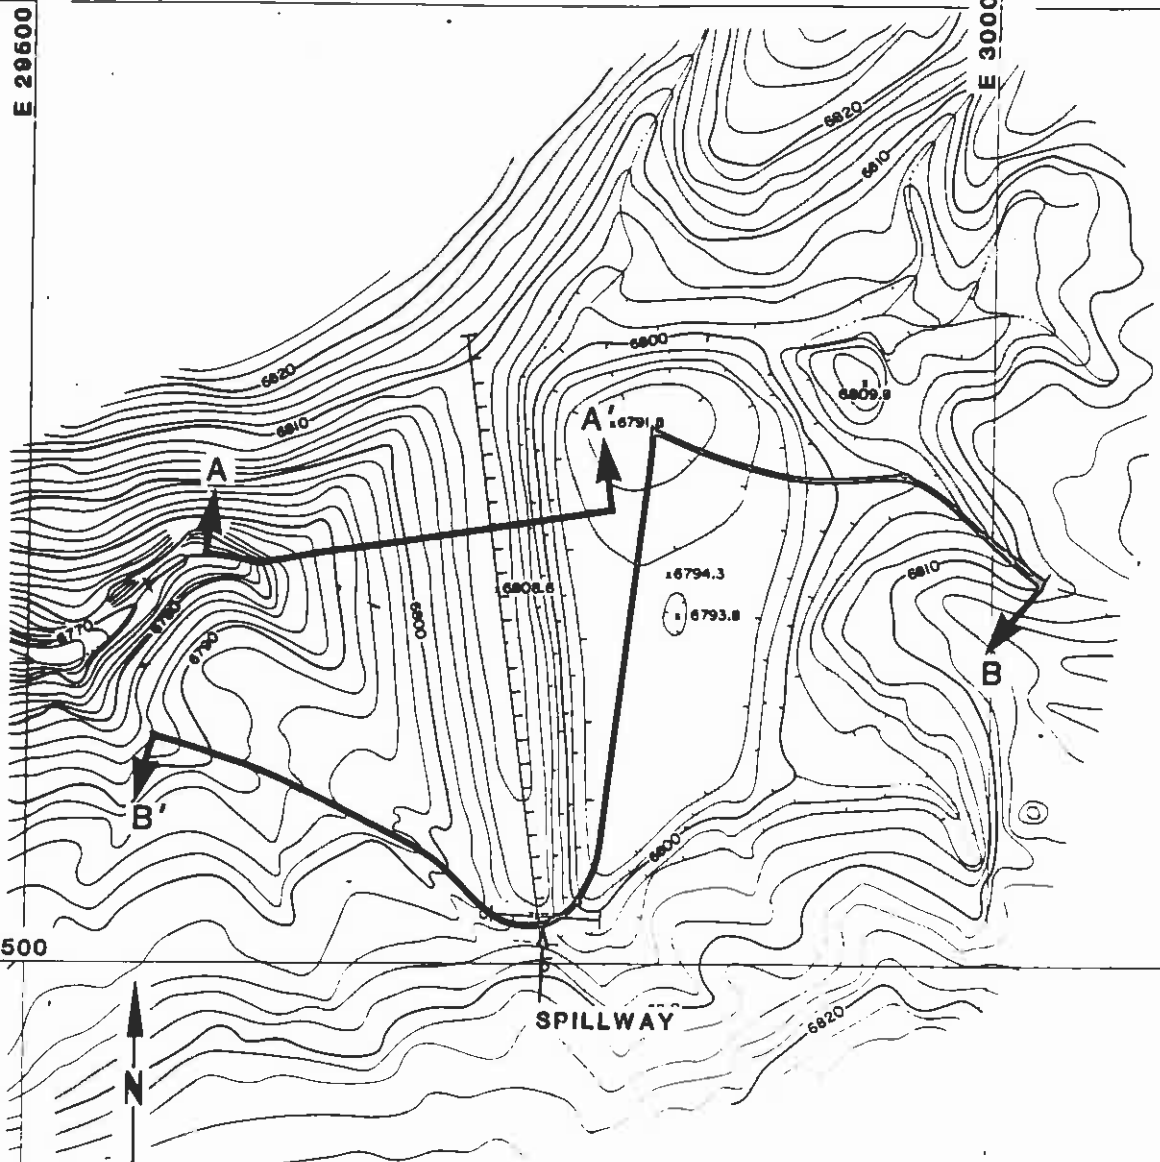
# SITE PLAN N2-G

Sedimentation Structure N2-G is an earthen embankment, designed and constructed in 1981 by Peabody Coal Company as a temporary sedimentation structure to control runoff and sediment from the disturbed mining areas of the Kayenta Mine. The location of Structure N2-G is shown on Plate 1, Site Plan.

The storage capacity and spillway capacity of Structure N2-G are adequate; however, the spillway does not have an adequate outflow channel or adequate erosion protection. A trapezoidal outflow channel should be constructed along the alignment B-B' shown in Plate 1. The channel profile is shown in Plate 4 and the required dimensions are shown in Plate 5. Both the spillway and outflow channel should be protected against erosion using geotextile and gravel as shown in Plate 5.

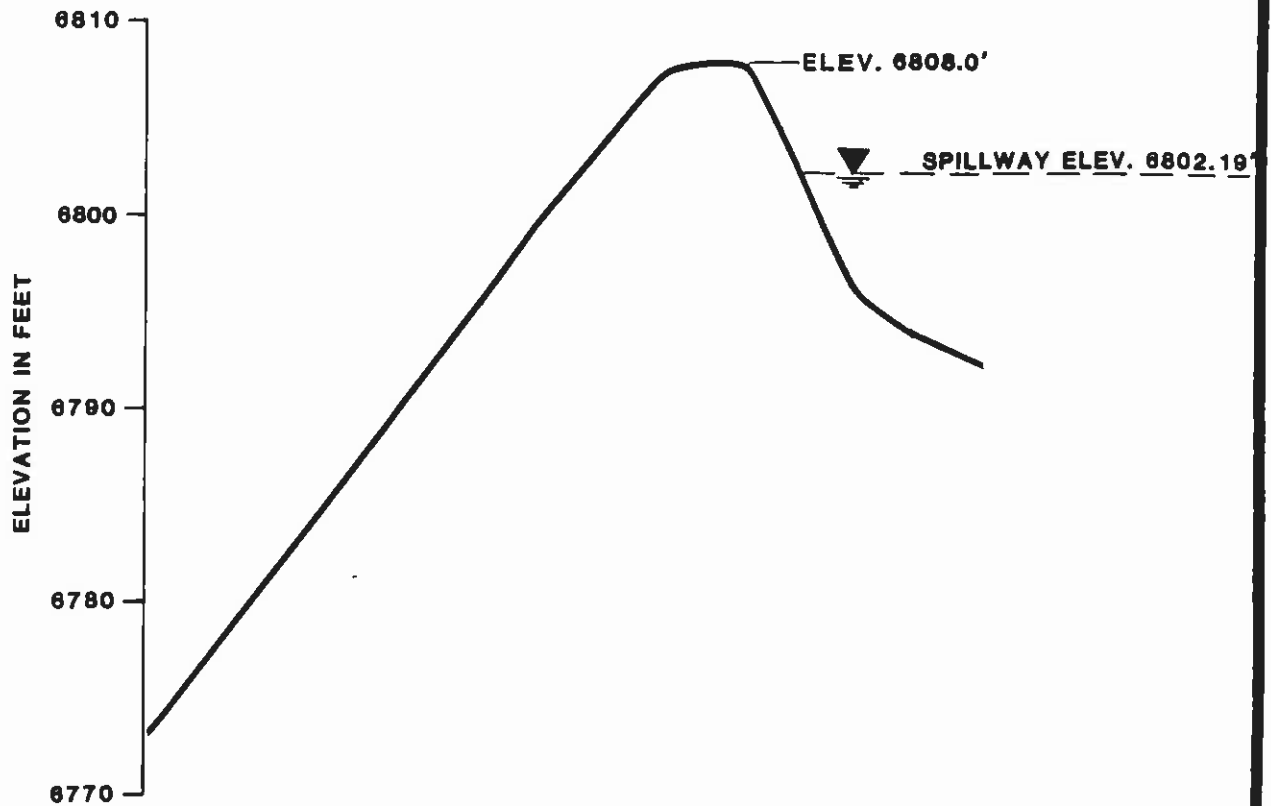
EXISTING  
MAXIMUM CROSS-SECTION  
A-A'  
N2-G

Embankment . . . . .	Residual Shale Soils
Foundation . . . . .	Residual Shale Soils
Right Abutment . . . . .	Residual Shale Soils
Left Abutment . . . . .	Residual Shale Soils
Height . . . . .	9.8 ft
Crest Width . . . . .	12 ft
Upstream Slope . . . . .	2.6 H : 1 V
Downstream Slope . . . . .	3.7 H : 1 V

A cross-section of the embankment is shown on Plate 2, Existing Maximum Cross Section N2-G, A-A'.

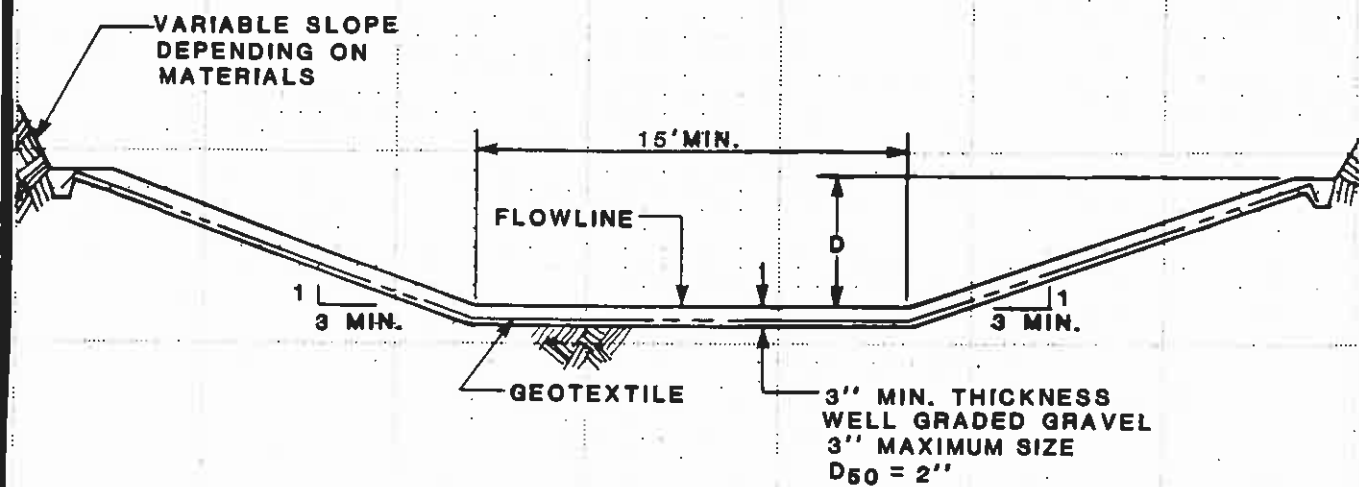
**SPILLWAY AND  
 OUTFLOW CHANNEL  
 CROSS SECTION  
 N2-G**

There is presently no erosion protection within the channel.
