INSPECTION REPORT
PERMANENT IMPOUNDMENT STRUCTURE
N2-RA
Kayenta Mine
Navajo County, Arizona
by
PEABODY COAL COMPANY

N2-RA SITE PLAN

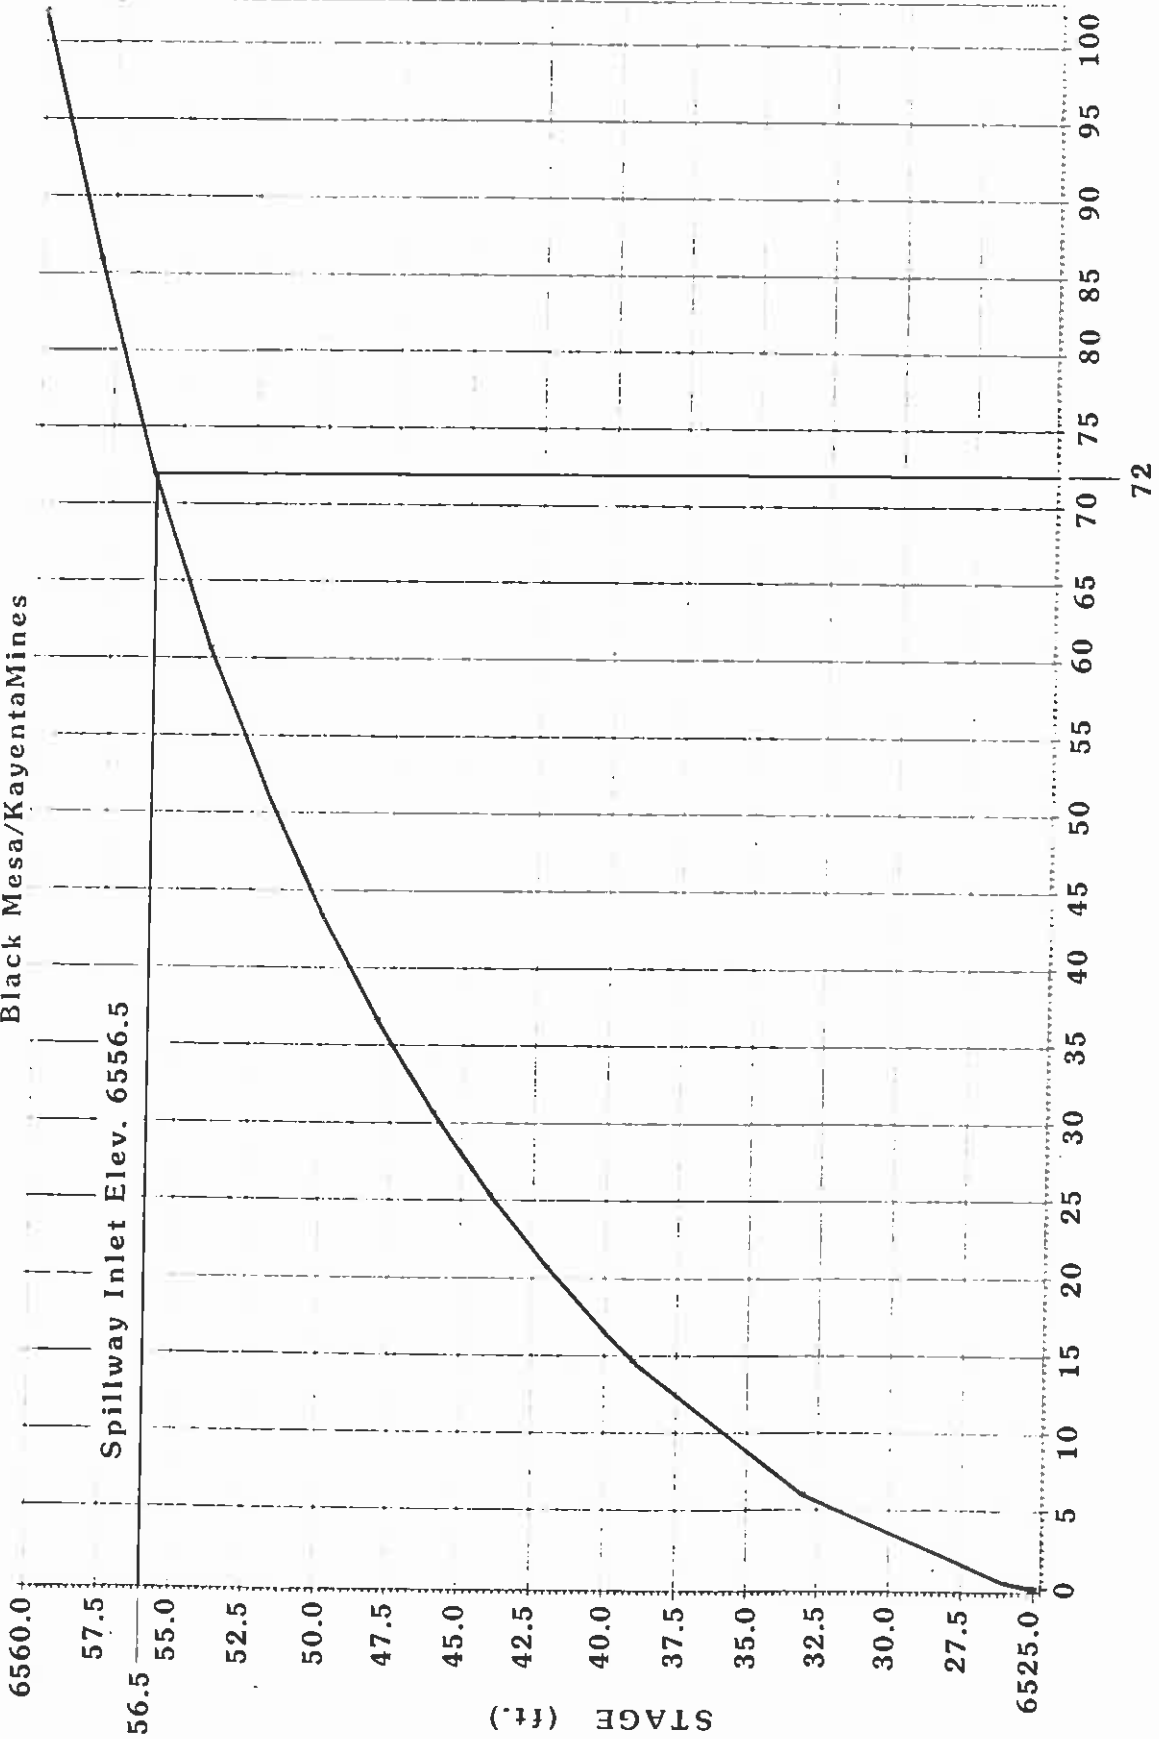
STAGE-CAPACITY CURVE N2-RA

existing storage capacity of N2-RA is shown on Plate 2. Stage-Capacity Curve, N2-RA, and the results of the sediment inflow analysis are summarized in the following table.

Total Storage Capacity (excluding permanent pool	
below elevation 6539.0)	60.51 acre-ft
Total Storage Capacity	72.0 acre-ft
100-year, 24-hour Inflow	34.70 acre-ft
Available Sediment Storage Capacity	25.81 acre-ft
Sediment Inflow, 10-year, 24-hour Storm (M.U.S.L.E.)	8.95 acre-ft
Sediment Storage	2.88 10-year, 24-hour
	Storms
