INSPECTION REPORT
Sedimentation Structure
N2-RC
Kayenta Mine
Navajo County, Arizona
for
PEABODY COAL COMPANY

Dames & Moore
10139-011-22

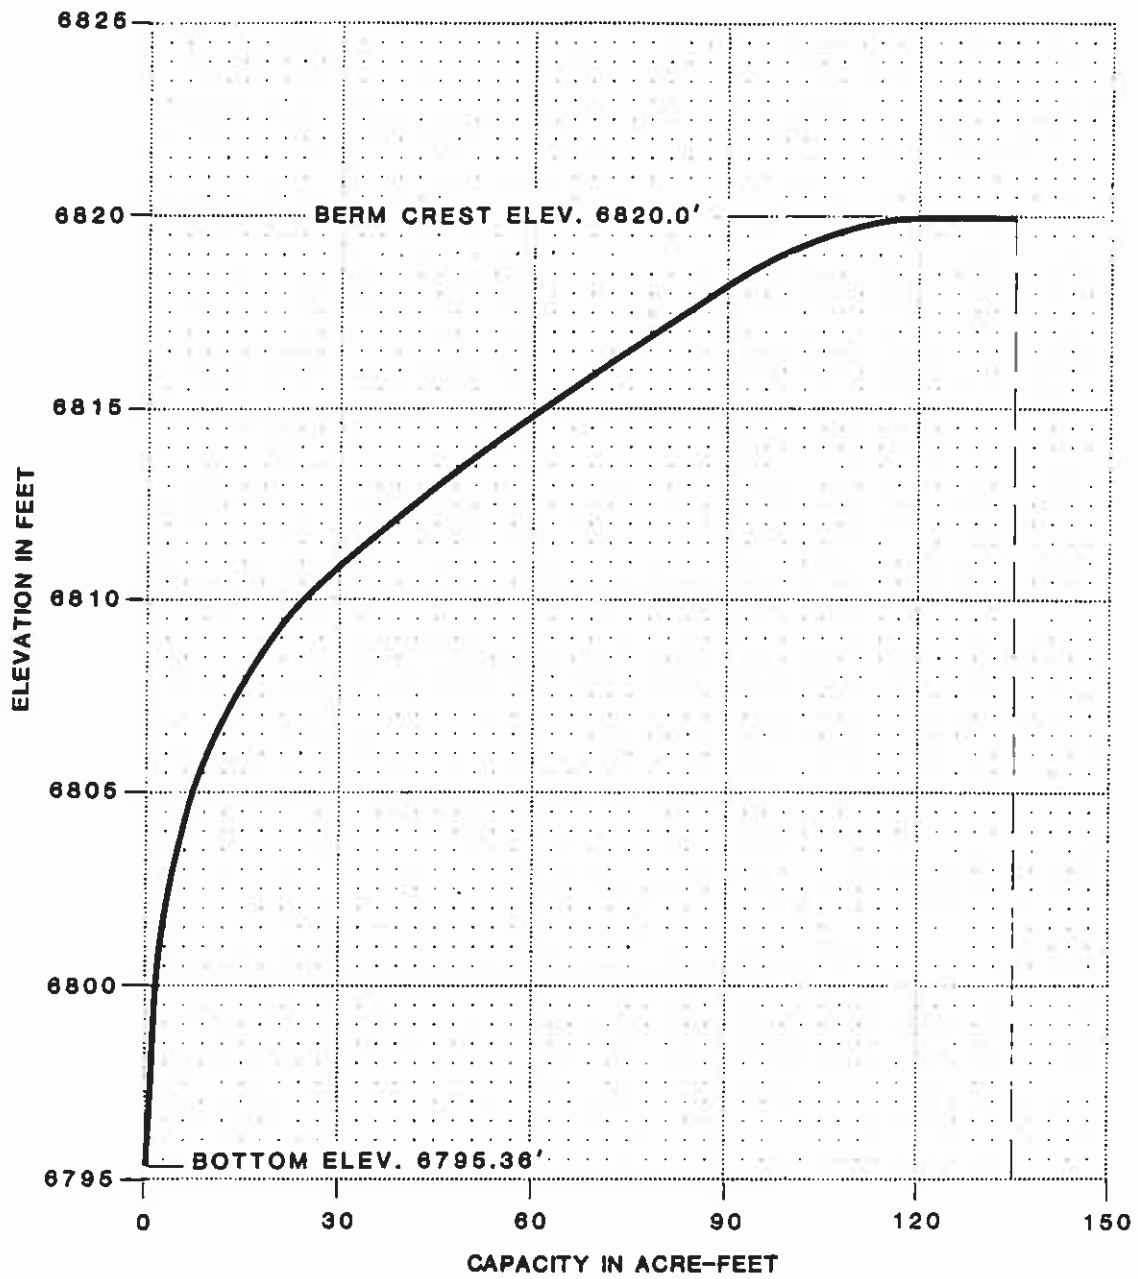
VOLUME-ELEVATION
CURVE
N2-RC

The impoundment volume-elevation curve is based on site specific surveys conducted for Peabody Coal Company's August 1984 inspection, and 1985 resurveys, where available. Additionally, the most current topographic maps available were used in developing Plate 2, Volume-Elevation Curve, N2-RC.
