INSPECTION REPORT
Sedimentation Structure
N5-D
Black Mesa Mine
Navajo County, Arizona
for
PEABODY COAL COMPANY

Dames & Moore
10139-011-22

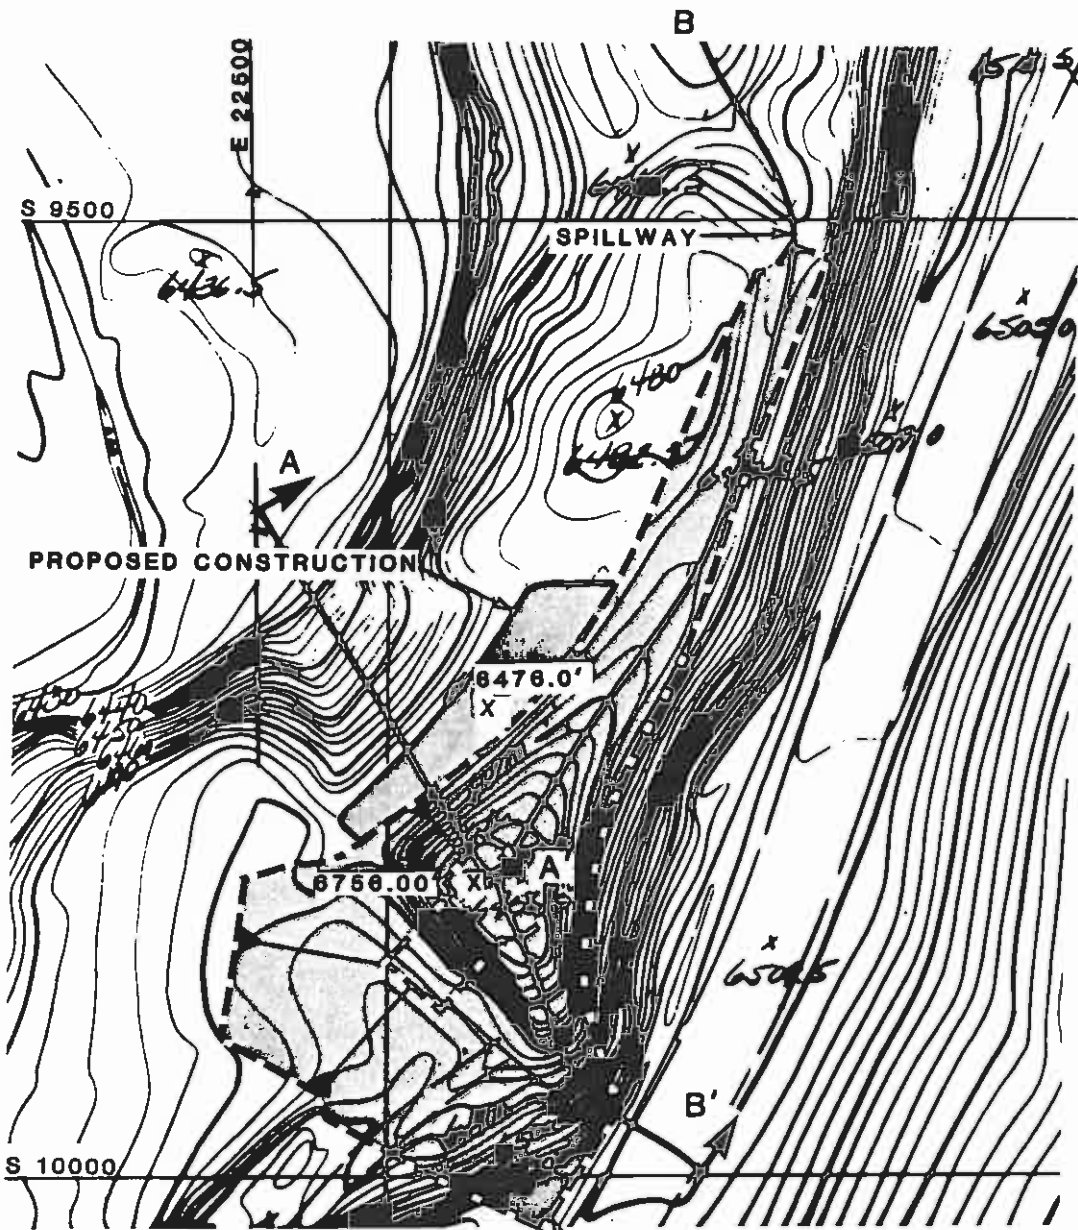
SITE PLAN
N5-D

Sedimentation Structure N5-D is an earthen embankment, designed and constructed in 1983 by Peabody Coal Company as a temporary sedimentation structure to control runoff and sediment from the disturbed mining areas of the Black Mesa Mine. The location of Structure N5-D is shown on Plate 1, Site Plan.

The spillway capacity and storage capacity of Structure N5-D are inadequate. The structure does not have an adequate outflow channel. The storage capacity should be increased to 5.36 acre-feet by excavating the pond and lowering the spillway elevations as shown on Plates 1 and 4. The embankment crest should be raised to elevation 6476.00 feet. A trapezoidal outflow channel should be constructed along the alignment shown in Plate 1. The channel profile is shown in Plate 4 and the required dimensions are shown in Plate 5. Both the spillway and outflow channel should be protected against erosion using geotextile and riprap as shown in Plate 5.

LIMITS OF PROPOSED EXCAVATION

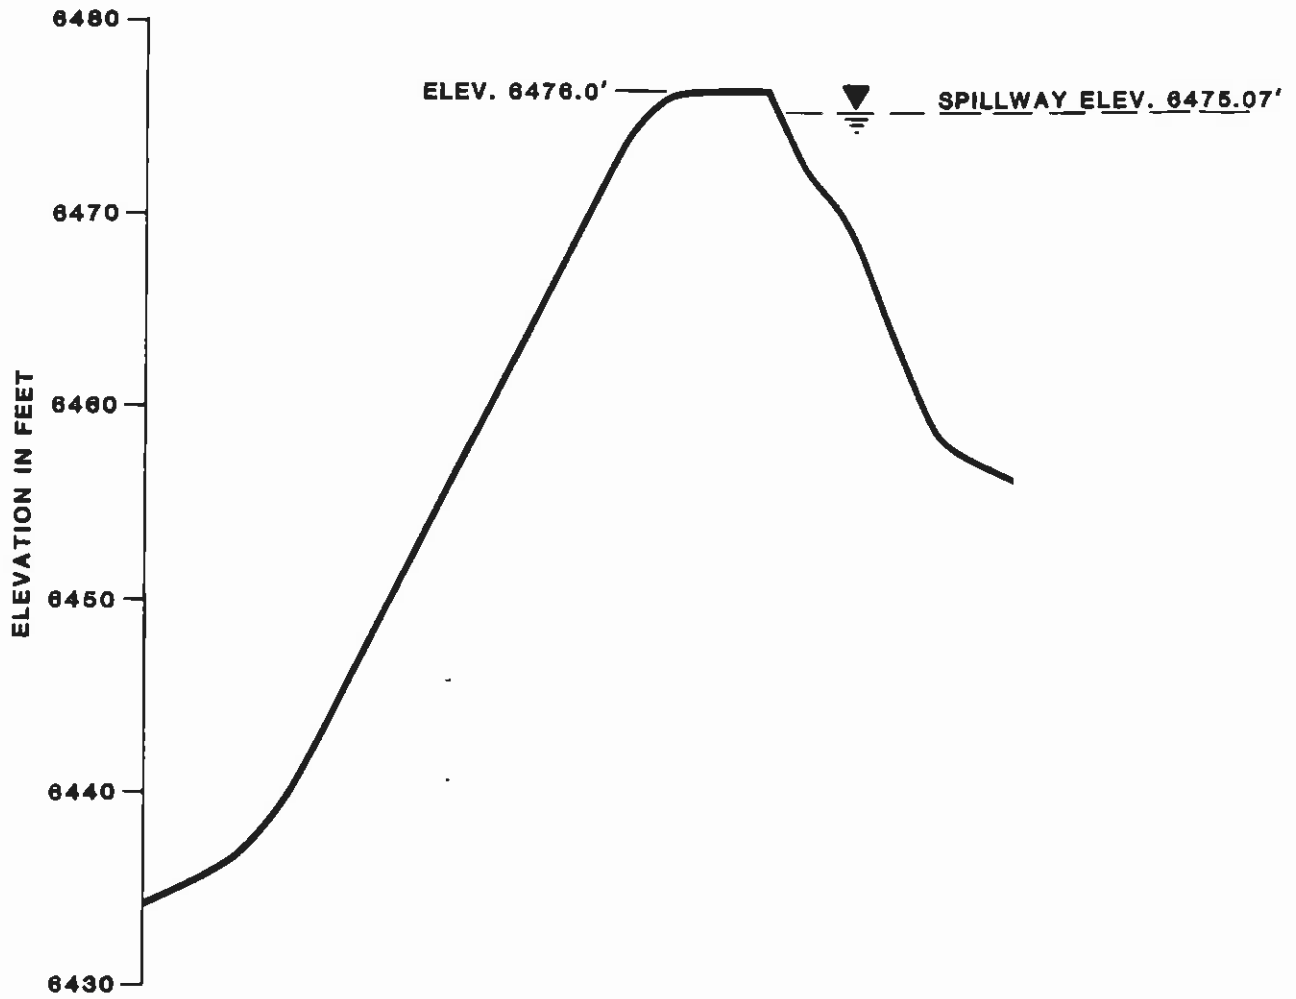
EXISTING
MAXIMUM CROSS-SECTION
A-A'
N5-D

A cross-section of the embankment is shown on Plate 2, Existing Maximum Cross Section N5-D, A-A'.

The N5-D embankment is lower in height; however, the downstream and upstream slopes are steeper than the category standard; therefore, the embankment has factors of safety less than the design minimum.

The inspection of Structure N5-D indicated that the only geotechnical problem is rill and gully erosion on the upstream and downstream slopes and the bottom of the approach channel. Correction of erosion is considered a periodic maintenance task and does not require remedial action. The downstream and upstream slopes should be flattened to 2.0 horizontal to 1 vertical and 2.5 horizontal to 1 vertical, respectively, to meet stability requirements.

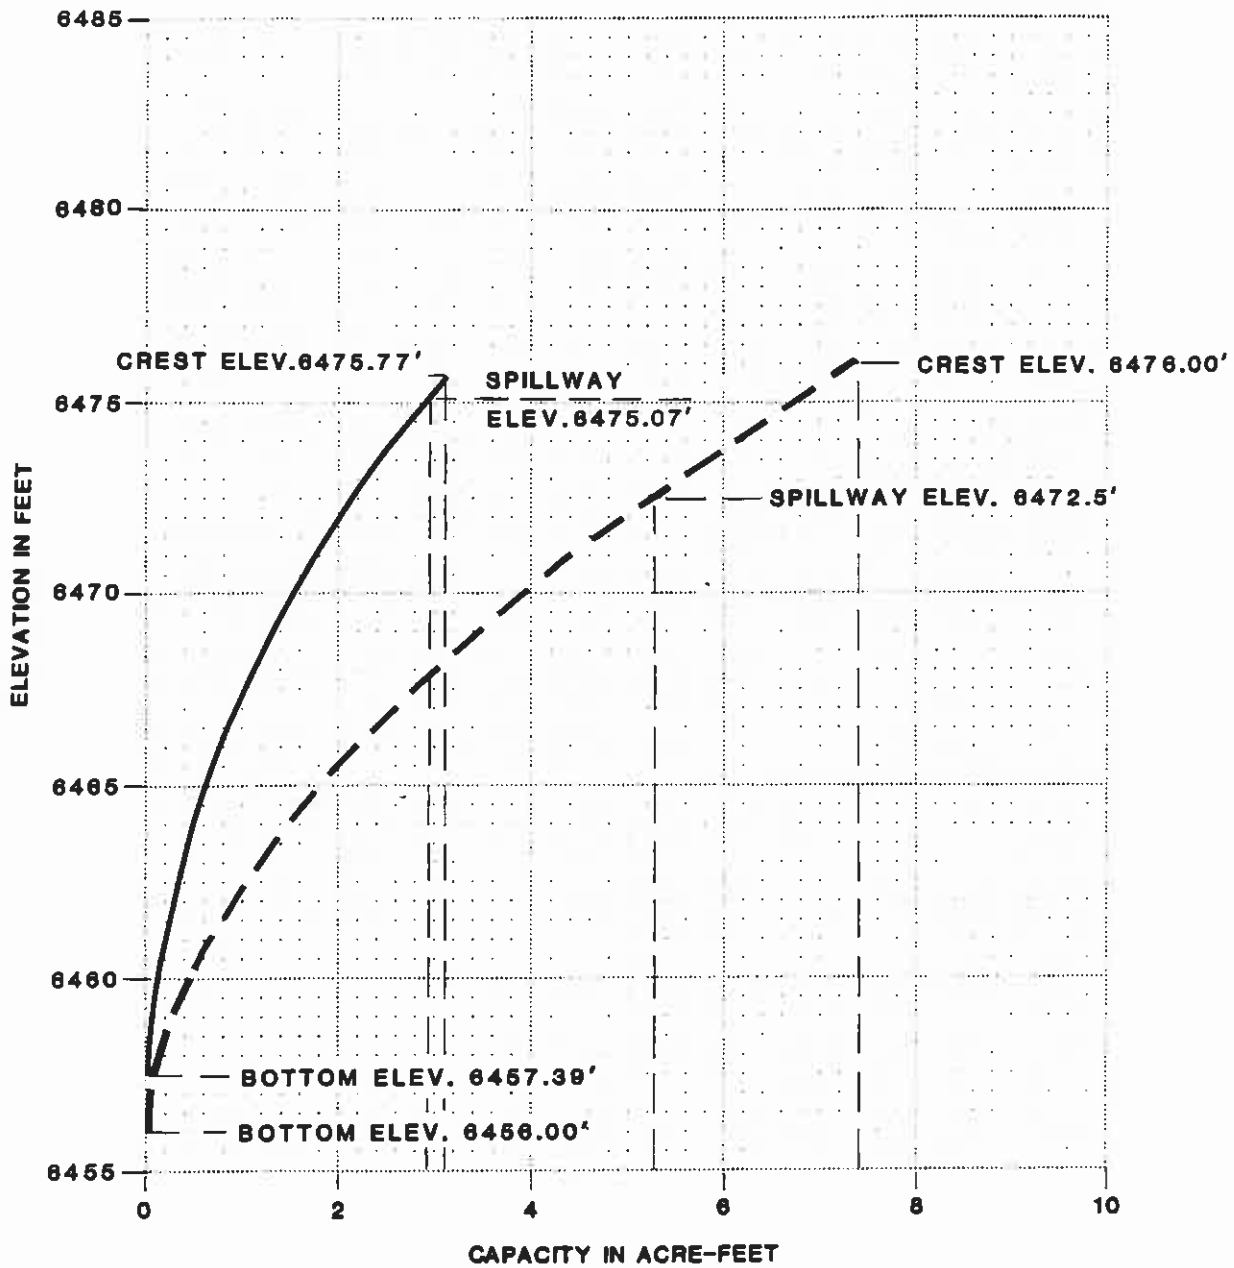
VOLUME-ELEVATION CURVE N-5D

The impoundment volume-elevation curve is based on site specific surveys conducted for Peabody Coal Company's August 1984 inspection, and 1985 resurveys, where available. Additionally, the most current topographic maps available were used in developing Plate 3, Volume-Elevation Curve, N5-D.

Total Storage Capacity	2.92	acre-ft
10-year, 24-hour Storm Inflow	8.48	acre-ft
Available Sediment Storage Capacity	0	acre-ft
Sediment Inflow Rate	0.27	acre-ft/yr
Sediment Storage Life	0	yrs

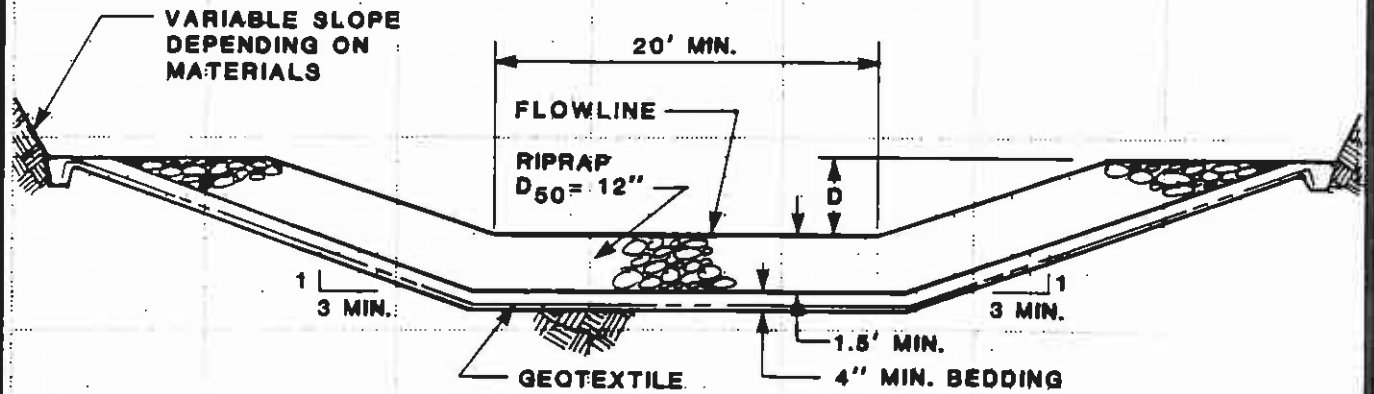
SPILLWAY AND
OUTFLOW CHANNEL
CROSS SECTION
N5-D

There is presently no erosion protection within the channel.
