INSPECTION REPORT
Sedimentation Structure
N5-E
Black Mesa Mine
Navajo County, Arizona
for
PEABODY COAL COMPANY

Dames & Moore
10139-011-22

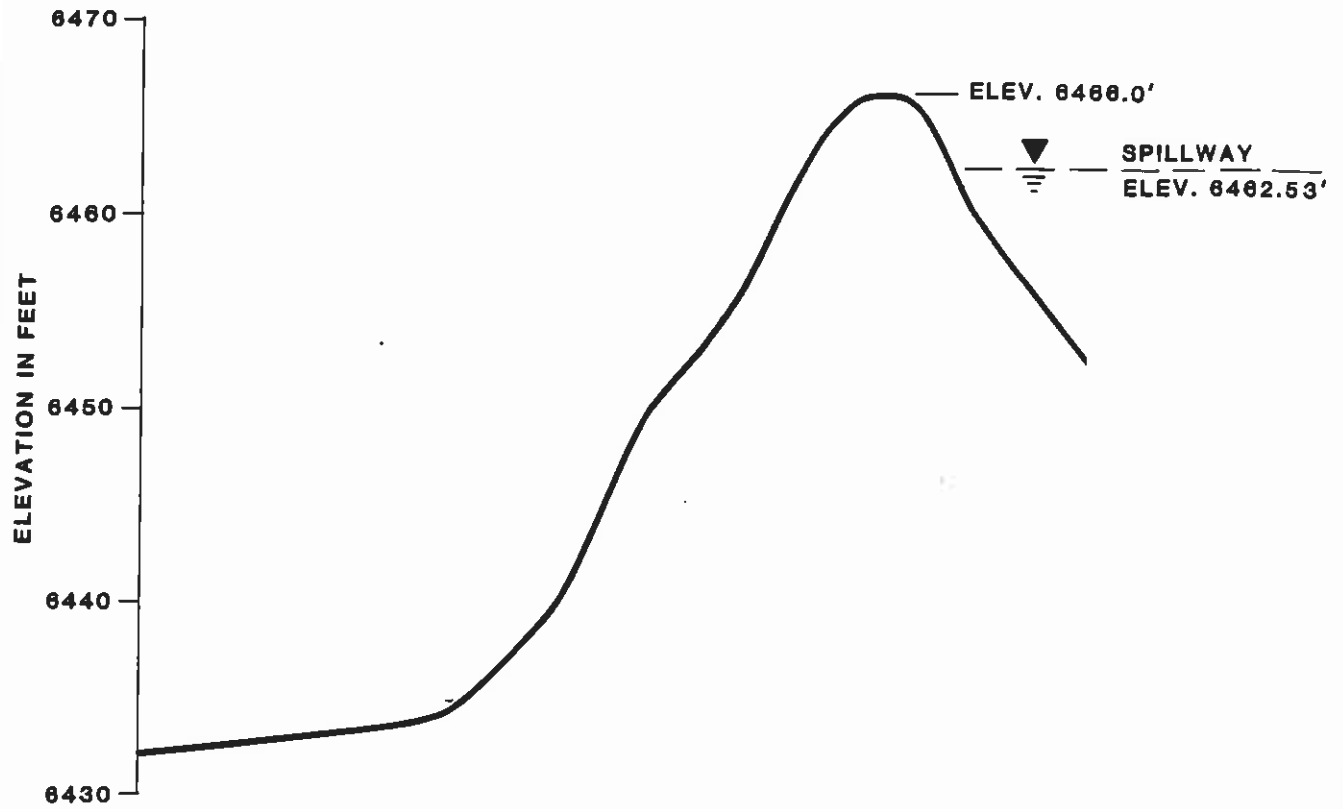
EXISTING
MAXIMUM CROSS-SECTION
A-A'
N5-E

A cross-section of the embankment is shown on Plate 2, Existing Maximum Cross Section N5-E, A-A'.

The N5-E embankment is lower in height; however, the downstream slope is steeper than the category standard; therefore, the embankment has factors of safety less than the design minimum.

The inspection of Structure N5-E indicated that the only geotechnical problem is rill erosion on the upstream slope and the side slopes of the spillway channel. Correction of erosion is considered a periodic maintenance task and does not require remedial action. The downstream slope should be flattened to 2.5 horizontal to 1 vertical to meet stability requirements.

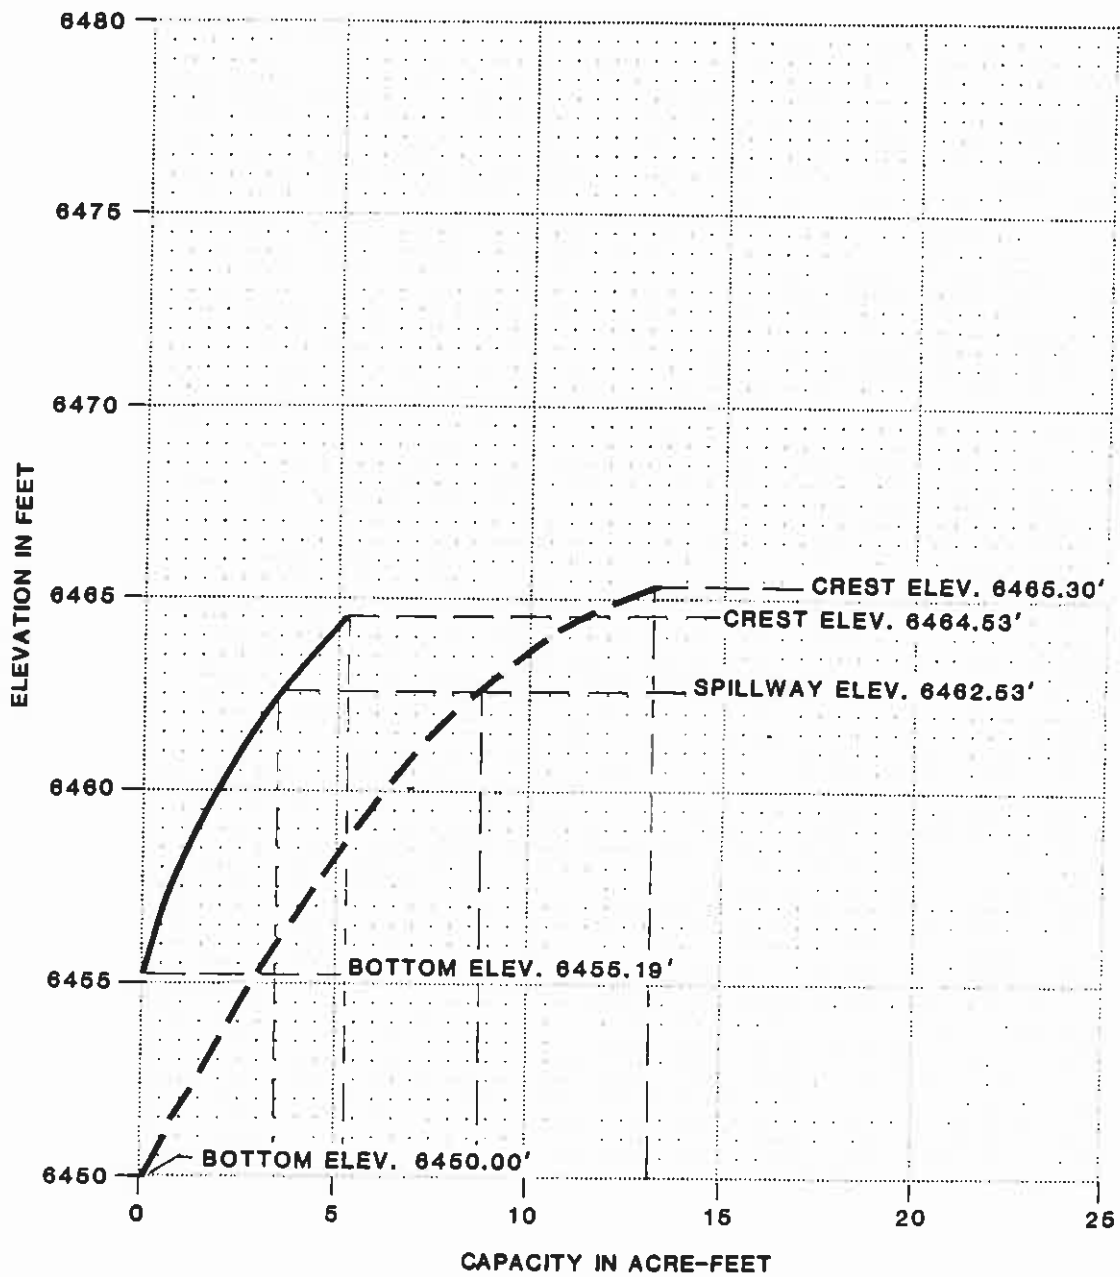
VOLUME-ELEVATION CURVE N5-E

Total Storage Capacity	3.43	acre-ft
10-year, 24-hour Storm Inflow	1.89	acre-ft
Available Sediment Storage Capacity	0	acre-ft
Sediment Inflow Rate	0.122	acre-ft/yr
Sediment Storage Life	0	yrs

The storage capacity and spillway capacity of Structure N5-E are inadequate. The structure does not have an outflow channel. The storage capacity should be increased to 8.7 acre-feet by excavating the pond as shown on Plates 1 and 4. The embankment crest should be raised to elevation 6465.30 feet. A trapezoidal outflow channel should be constructed along the alignment shown in Plate 1. The channel profile is shown in Plate 4 and the required dimensions are shown in Plate 5. Both the spillway and outflow channel should be protected against erosion using geotextile and riprap as shown in Plate 5.

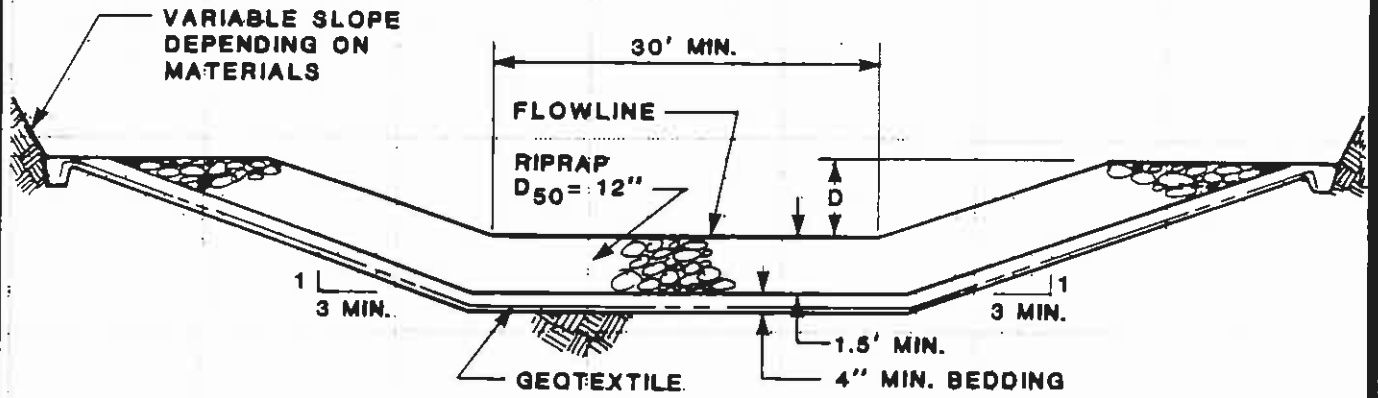
SPILLWAY AND
OUTFLOW CHANNEL
CROSS SECTION
N5-E

There is presently no erosion protection within the channel.

The structure presently has no outflow channel.
