INSPECTION REPORT
Sedimentation Structure
N6-D
Black Mesa Mine
Navajo County, Arizona
for
PEABODY COAL COMPANY

Dames & Moore
10139-011-22

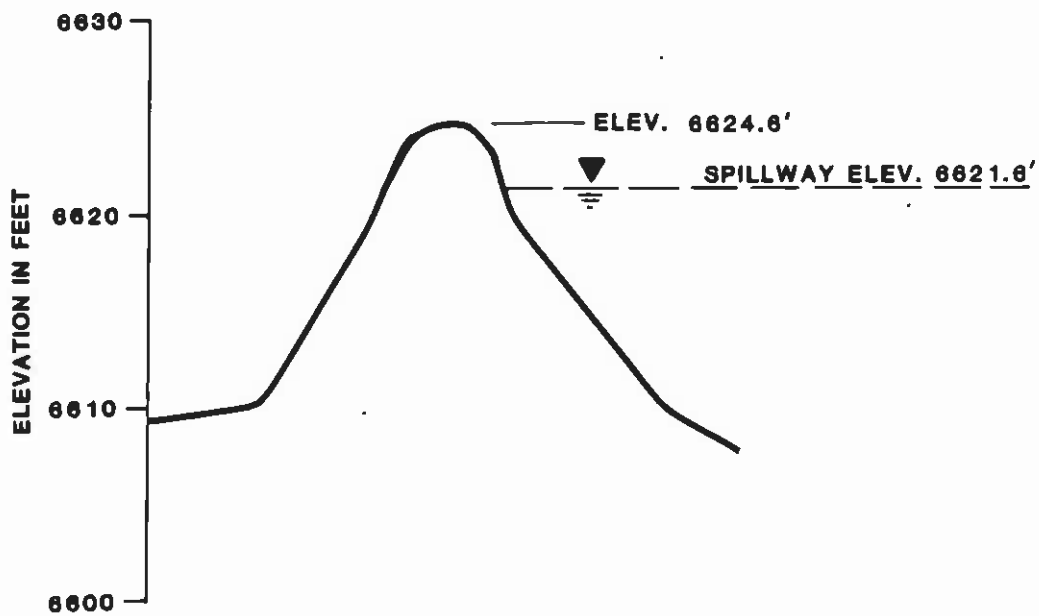
EXISTING
 MAXIMUM CROSS-SECTION
 A-A'
 N6-D

A cross-section of the embankment is shown on Plate 2, Existing Maximum Cross Section N6-D, A-A'. Grass provides erosion protection on the upstream slope of the embankment.

The N6-D embankment is lower in height; however, the downstream slope is steeper than the category standard; therefore, the embankment has factors of safety less than the design minimum.

The downstream slope should be flattened to 3.25 horizontal to 1 vertical to meet stability requirements. The crest and both slopes of the embankment are uneven and should be trimmed flat and smooth, respectively. While this situation is, in our opinion due to a lack of fine grading at the time of construction and not critical at the present time, it may mask potential future problems and therefore, should be corrected.

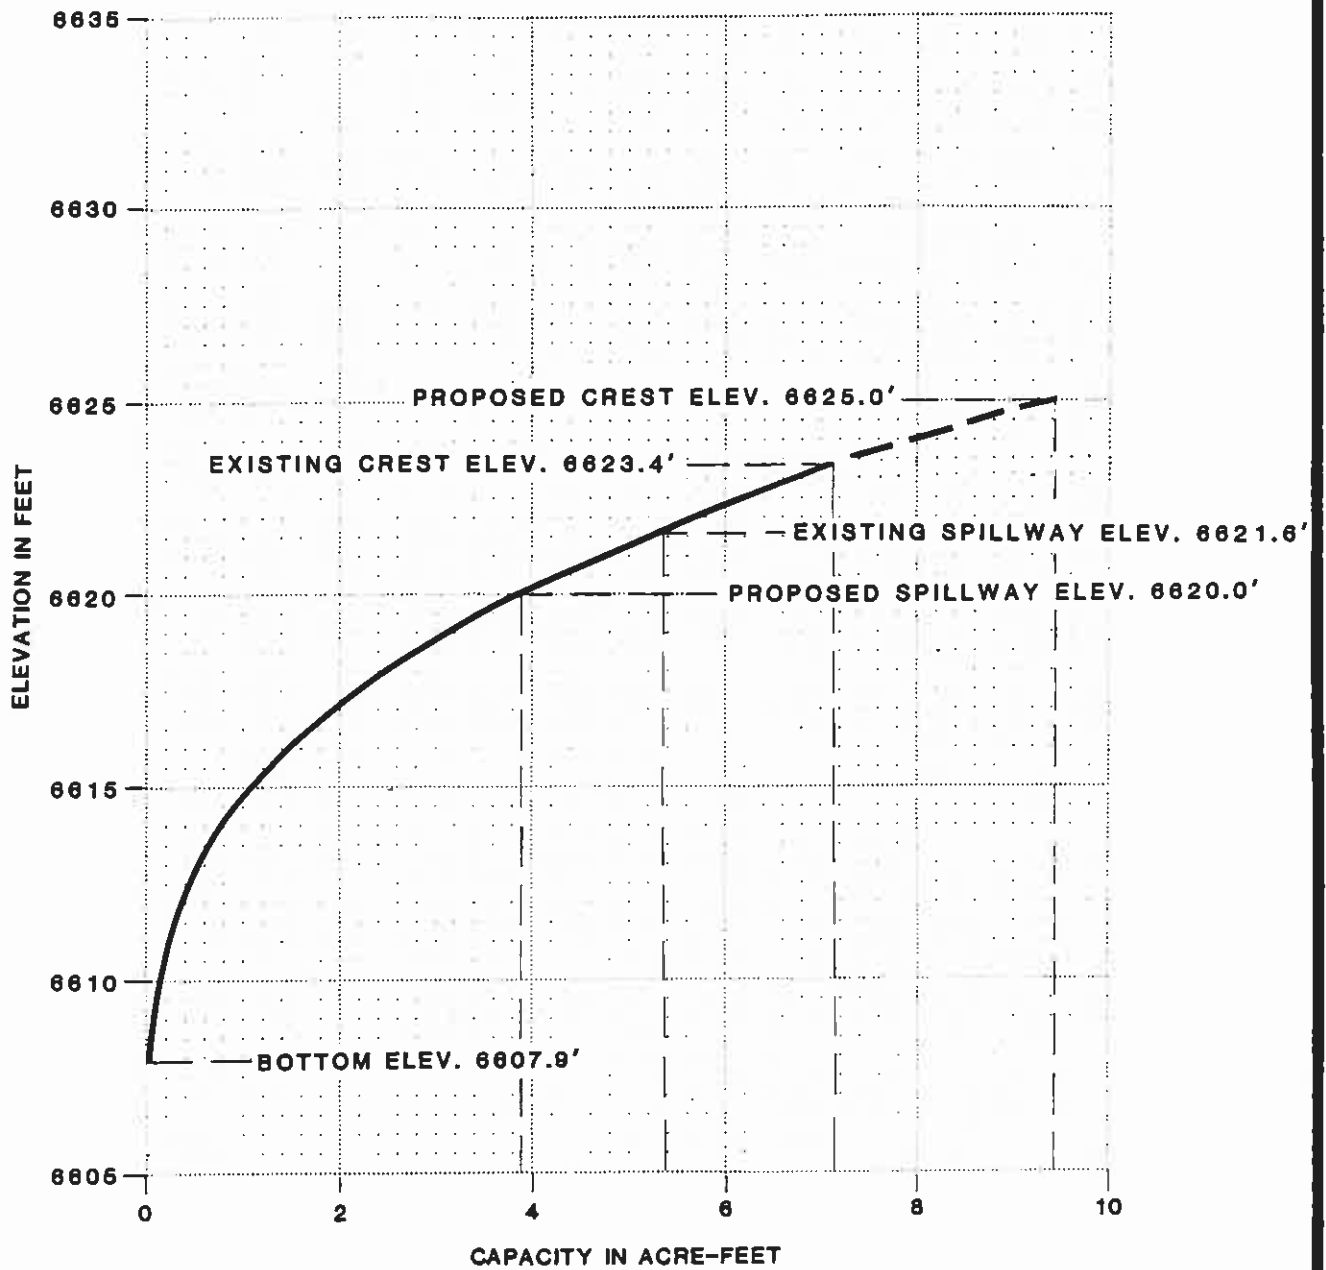
VOLUME-ELEVATION
CURVE
N6-D

The impoundment volume-elevation curve is based on site specific surveys conducted for Peabody Coal Company's August 1984 inspection, and 1985 resurveys, where available. Additionally, the most current topographic maps available were used in developing Plate 3, Volume-Elevation Curve, N6-D.

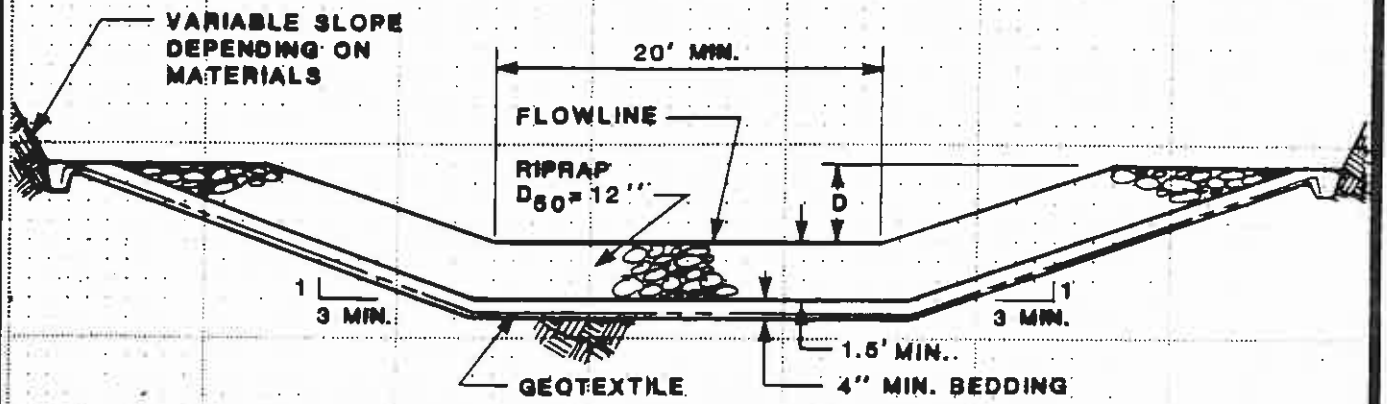
**SPILLWAY AND
 OUTFLOW CHANNEL
 CROSS SECTION
 N6-D**

The storage capacity of Structure N6-D is adequate but the spillway capacity is inadequate. The structure does not have an adequate outflow channel. The bottom elevation of the existing spillway channel should be lowered to elevation 6620.00 feet while maintaining the bottom width of 20 feet as shown on Plate 5. A trapezoidal outflow channel with the same bottom width as the spillway should be constructed along the alignment shown in Plate 1. The channel profile is shown in Plate 4 and required dimensions are shown in Plate 5. Both the spillway and outflow channel should be protected against erosion using geotextile and riprap as shown in Plate 5.
