INSPECTION REPORT
Sedimentation Structure
N6-E
Black Mesa Mine
Navajo County, Arizona
for
PEABODY COAL COMPANY

Dames & Moore
10139-011-22

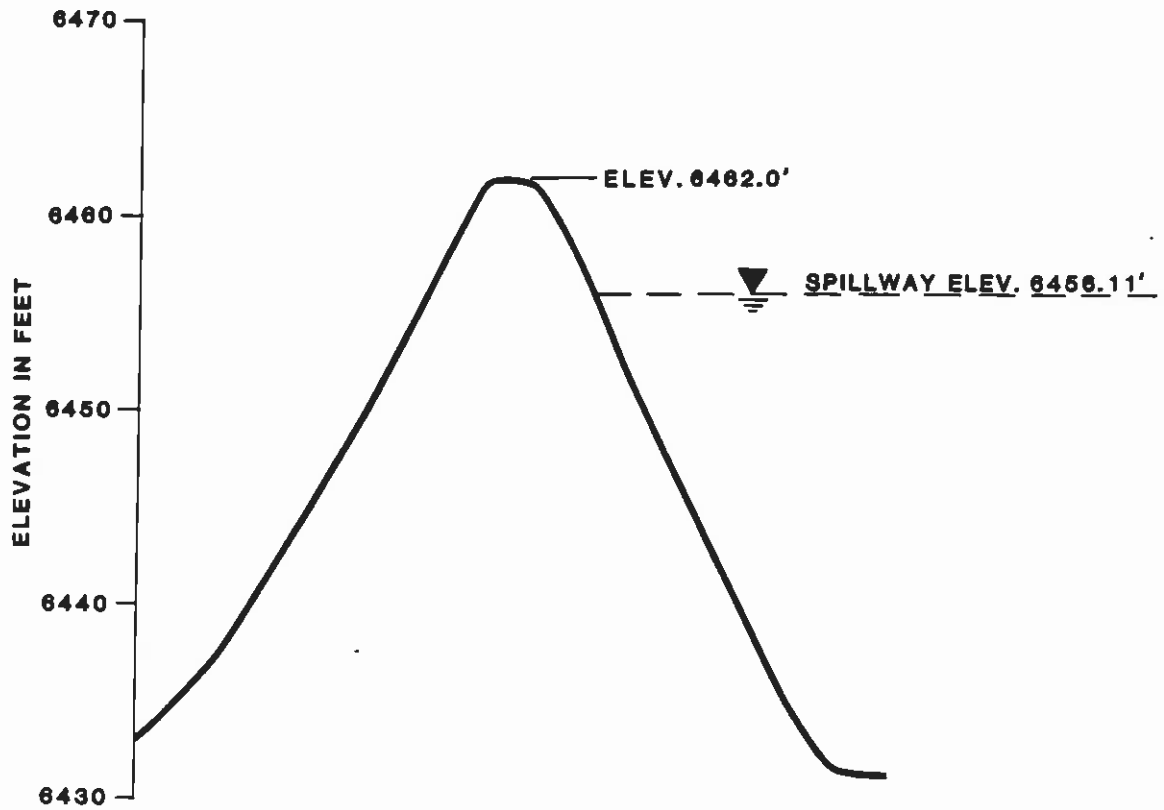
EXISTING
MAXIMUM CROSS-SECTION
A-A'
N6-E

The N6-E embankment is lower in height; however, the downstream slope is steeper than the category standard; therefore, the embankment has factors of safety less than the design minimum.

The inspection of Structure N6-E indicated that the only geotechnical problem is rill and gully erosion on the upstream and downstream slopes. Correction of erosion is considered a periodic maintenance task and does not require remedial action. The downstream slope should be flattened to 3.25 horizontal to 1 vertical to meet stability requirements.

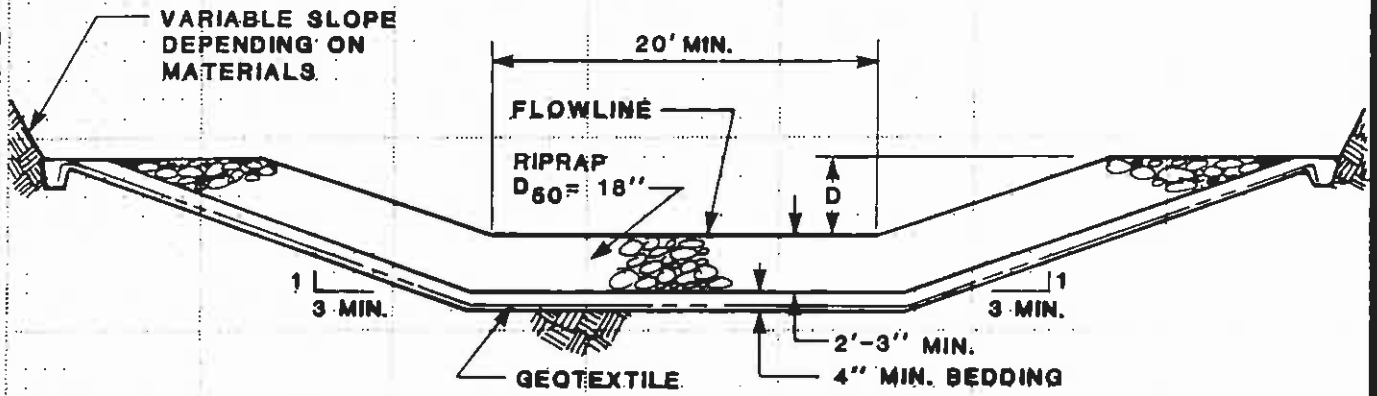
SPILLWAY AND
OUTFLOW CHANNEL
CROSS SECTION
N6-E

There is presently partial erosion protection within the channel.

The storage capacity and spillway capacity of Structure N6-E are adequate. The outflow channel is protected with riprap but the spillway channel is only partially protected with riprap. The spillway channel should be protected against erosion using geotextile and riprap as shown in Plate 5. A stilling basin should be constructed to the dimensions shown in Plate 6 and protected against erosion using geotextile and riprap as shown in Plate 5. Plate 4 shows the profile for the existing spillway, outflow channel and proposed stilling basin.
