INSPECTION REPORT
Sedimentation Structure
N6-F
Black Mesa Mine
Navajo County, Arizona
for
PEABODY COAL COMPANY

Dames & Moore
10139-011-22

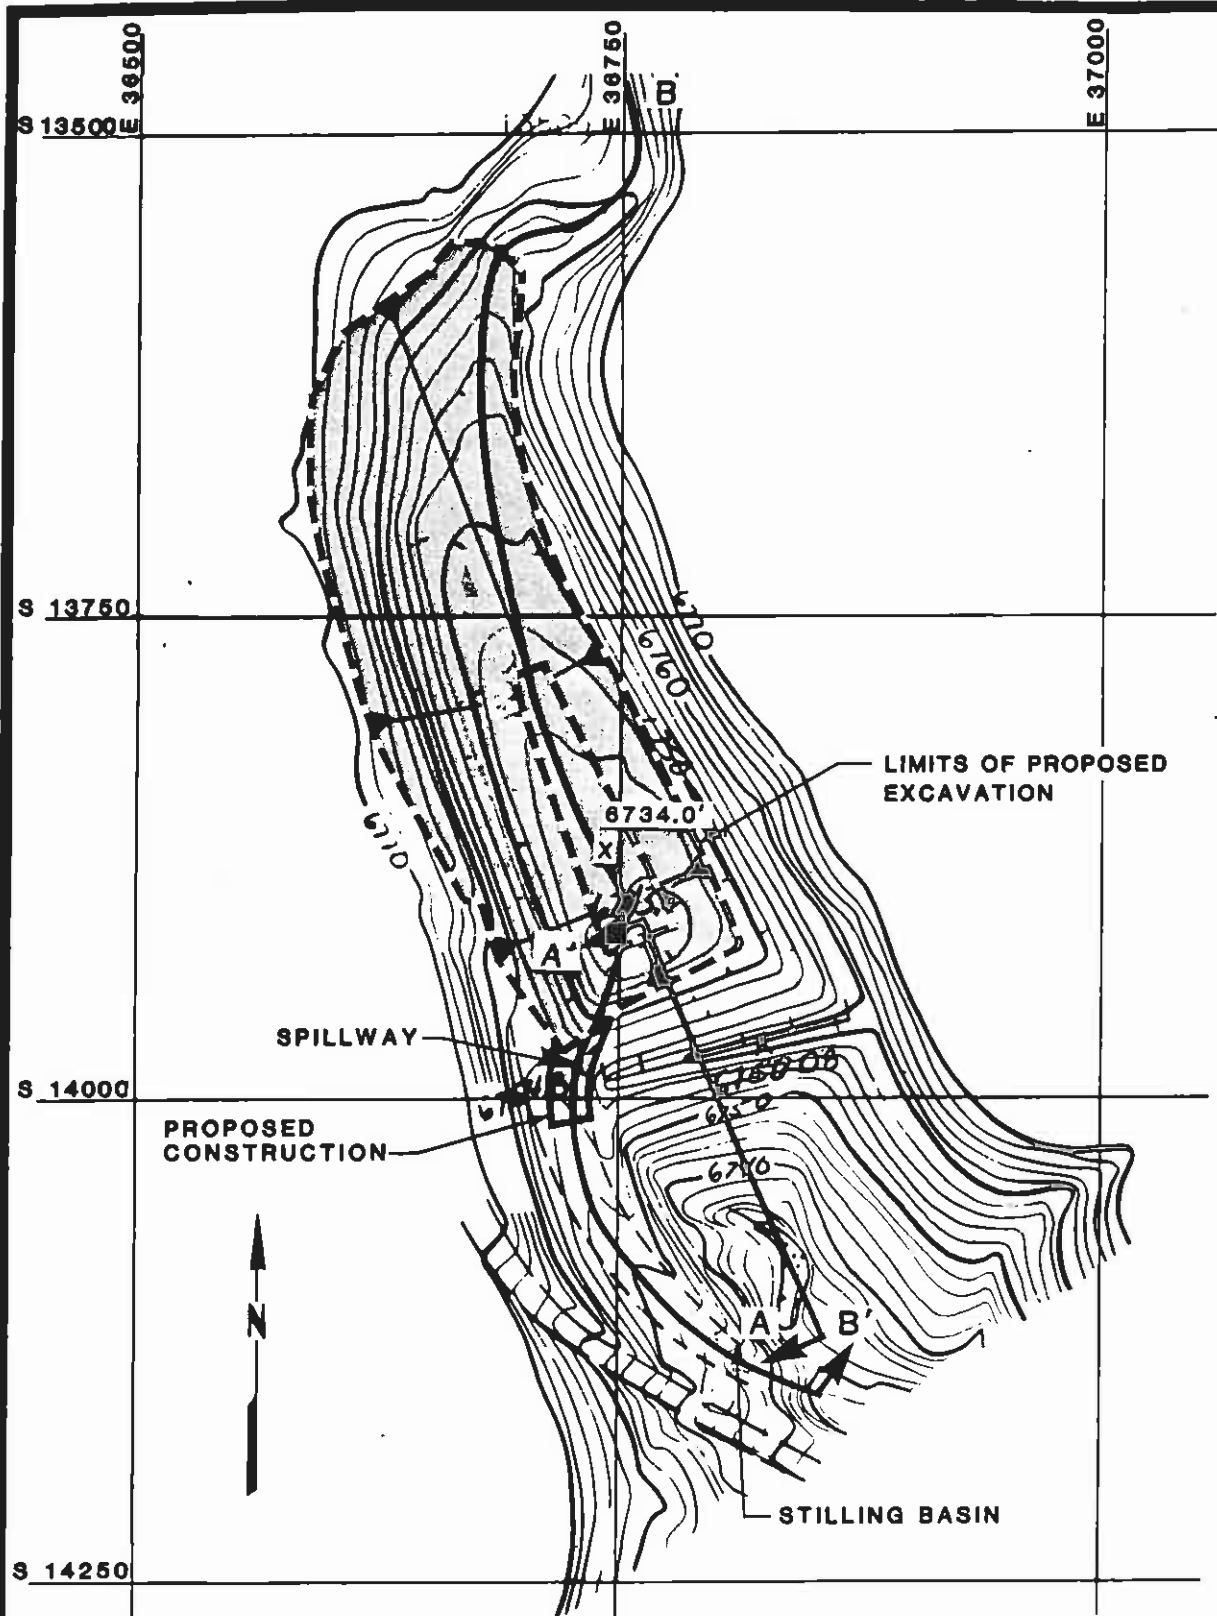
**SITE PLAN
N6-F**

Sedimentation Structure N6-F is a partially incised structure with an earthen embankment, designed and constructed in 1982 by Peabody Coal Company as a temporary sedimentation structure to control runoff and sediment from the disturbed mining areas of the Black Mesa Mine. The location of Structure N6-F is shown on Plate 1, Site Plan.

The spillway capacity of Structure N6-F is adequate but the storage capacity is inadequate. The structure does not have an adequate outflow channel. The storage capacity should be increased to 10.49 acre-feet by raising the spillway crest elevation to 6756.0 feet and by excavating the pond as shown on Plates 1 and 4. A trapezoidal outflow channel and stilling basin should be constructed along the alignment shown in Plate 1. The channel profile and stilling basin are shown in Plate 4 and the required dimensions are shown in Plate 5 and Plate 6. The spillway, outflow channel and stilling basin should be protected against erosion using geotextile and riprap as shown in Plate 5.

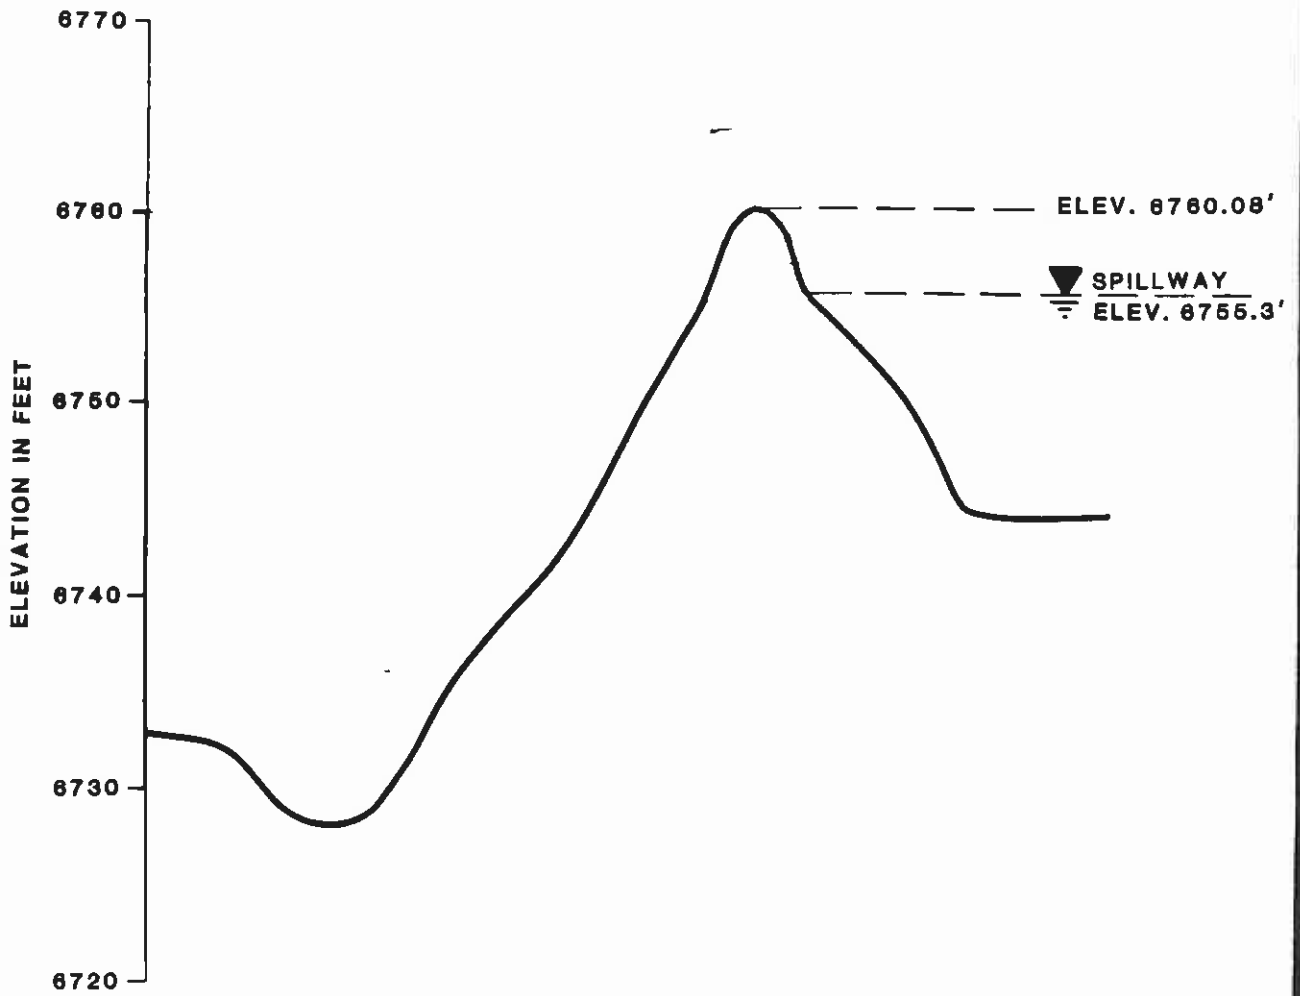
EXISTING
 MAXIMUM CROSS-SECTION
 A-A'
 N6-F

Structure N6-F is a homogeneous earthen embankment classified as a cross-valley embankment. Physical characteristics of the embankment are listed in the following table:

<u>Structure N6-F</u>	
Embankment	Residual Shale Soils
Foundation	Residual Shale Soils/Alluvium
Right Abutment	Residual Shale Soils
Left Abutment	Residual Shale Soils
Height	12.8 ft
Crest Width	13 ft
Upstream Slope	2.4 H : 1 V
Downstream Slope	4.3 H : 1 V

A cross-section of the embankment is shown on Plate 2, Existing Maximum Cross Section N6-F, A-A'.

The N6-F embankment is lower in height and has flatter slopes than the category standard; therefore, the embankment has factors of safety greater than the design minimum.

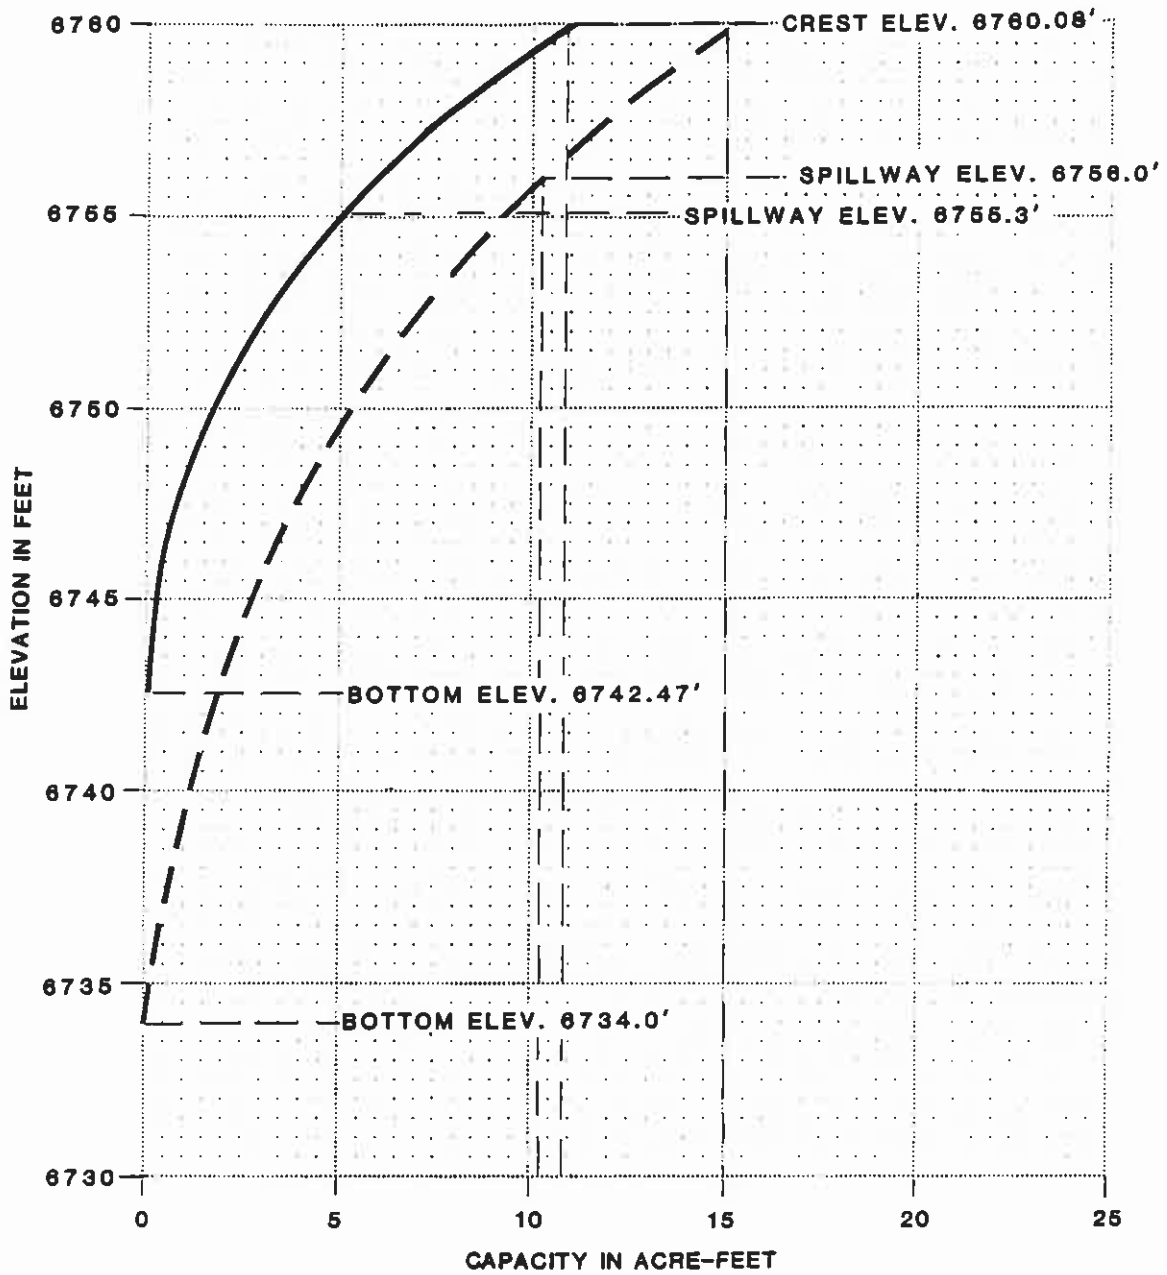
VOLUME-ELEVATION CURVE N6-F

The impoundment volume-elevation curve is based on site specific surveys conducted for Peabody Coal Company's August 1984 inspection, and 1985 resurveys, where available. Additionally, the most current topographic maps available were used in developing Plate 3, Volume-Elevation Curve, N6-F.

Total Storage Capacity	5.23	acre-ft
10-year, 24-hour Storm Inflow	6.69	acre-ft
Available Sediment Storage Capacity	0	acre-ft
Sediment Inflow Rate	0.816	acre-ft/yr
Sediment Storage Life	0	yrs

Enlarging the storage capacity to 10.49 acre-feet gives additional sediment storage. The analysis of these conditions is summarized in the following table.

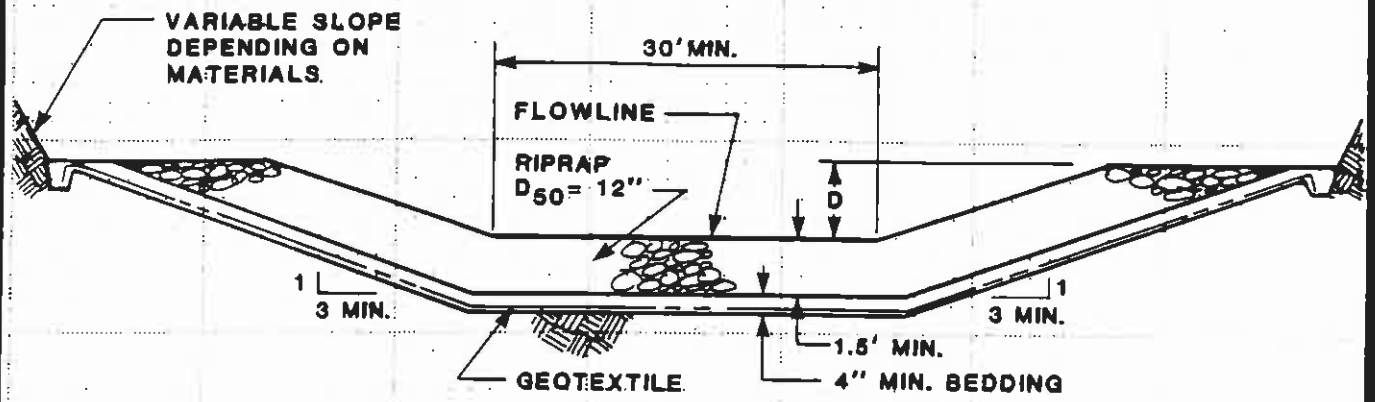
SPILLWAY AND
OUTFLOW CHANNEL
CROSS SECTION
N6-F

There is presently no erosion protection within the channel.

Rock of D50 8-inch size provides some but inadequate erosion protection within the channel.
